ADA Master Plan for the District of Columbia

September 20, 2011

Randall Park Pool

Building #51B
10 I Street, SW
Washington, DC 20024

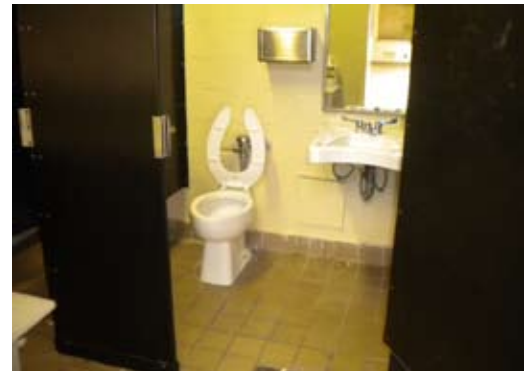
Picture 8

- Typical Locker Room mirror height is greater than required.
Action: Remove and reinstall mirrors at corrected height.
- Accessible toilet stalls are provided in both Men's and Women's Toilet Rooms; however, they include sinks that interfere with the required clear space (Picture 8).
Action: Remove sink and provide accessible toilet stall that meets ADA requirements.

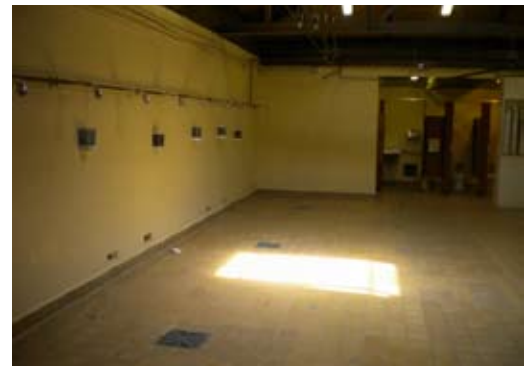
Picture 12

- Shower units are provided on the perimeter walls of both the Male and Female Changing Rooms. Accessible showers with required accessories are not provided, which is not ADA compliant (Picture 12).
Action: Provide accessible shower unit in each shower bay.

NOTE	ADA REF	ITEM	REQUIREMENT	COMPLIES	REPAIR	RENOVATE	STRUCTURALLY INFEASIBLE	FINDINGS AND ACTION ITEMS
BUILDING INTERIOR								
3-700	607	<u>Bathing / Locker Facilities</u>						
3-720	608	Showers						No accessible shower units provided which is not ADA compliant (Picture 12). Action: Provide accessible shower unit in each shower bay.
3-736	608.2.2	Roll-in type shower	60" x 30" min clear inside					
3-737			36"W clear entry					
3-738		Clearance	60"x 30"min area, from front of control wall					
3-739		Threshold if any	1/2" curb/recess					
3-740		Folding Seat optional						
3-741	608.3.2	Grab bars (no seat shower)	3 walls (1 bent or 3 bars), if 3, 6" max from angles					Action: Provide required grab bars at accessible shower unit.
3-742		Grab bars (shower with seat)	2 walls (1 bent or 2 bars), 27" min from seat wall					
3-743	608.5.2a	Controls (no seat shower)	any wall above grab bar/48"AFF max					Action: Provide accessible shower controls to meet ADA requirements.
