Facility Condition Assessment

**Anacostia High School
1601 16th Street SE
Washington, DC
20020**

Date of Report: August 31, 2018

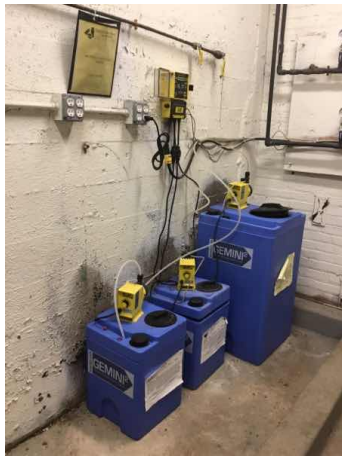
Water Filtration System

Item	Description
Water Treatment, Filtration System	Water Treatment, Filtration System
Condition	Fair - Good
Quantity	1 EA
Remaining Useful Life (RUL)	9 Year(s)
Location	Boiler Room

Uniformat	Component Description	Plan Type	Year	Expenditures
D2023	Replace Water Treatment, Filtration System	CRP	2027	\$8,976

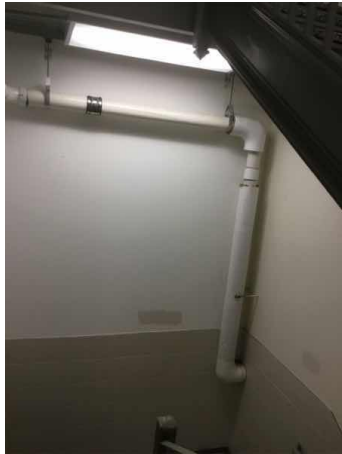
Rain Drainage Piping

Item	Description
Light Density Rainwater Drainage Syst (Black/PVC)	Rainwater Drainage Piping
Condition	Good
Quantity	204,105 SF
Remaining Useful Life (RUL)	19 Year(s)

Uniformat	Component Description	Plan Type	Year	Expenditures
D2041	Fix the storm drainage piping that leaks in the main office, when using Emergency Eye wash and Shower.	RM	2018	\$5,000

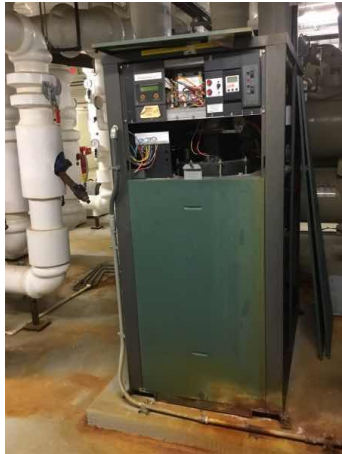
Item	Description
Boiler, Gas, Hot Water/Steam, 1,250~1,500 MBH	Boiler 3, Gas-fired, 1500 Mbh (x1)
Condition	Poor
Quantity	1 EA
Remaining Useful Life (RUL)	0 Year(s)
Location	Boiler Room

Boiler 3...not Working

Uniformat	Component Description	Plan Type	Year	Expenditures
D3021	Replace Boiler 3, Gas-fired, 1500 Mbh (x1)	CRP	2018	\$55,545
D3021	Repair the leak of flue piping for Boiler 1.	RM	2018	\$2,000
D3021	Replace Boiler 3, which is down.	CRP	2018	\$55,545

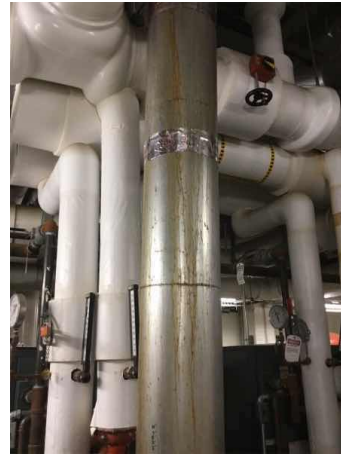
Flue Piping Leaking...Boiler 1

Uniformat	Component Description	Plan Type	Year	Expenditures
D3021	Replace Boiler 3, which is down.	RM	2018	\$55,545
D3021	Repair the leak of flue piping for Boiler 1.	RM	2018	\$2,000

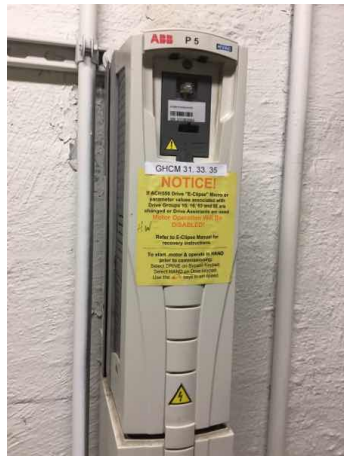
Broken VFD Controller of Hot Water Pump 5

Uniformat	Component Description	Plan Type	Year	Expenditures
D3068	Replace VFD Controller for Pump 5.	CRP	2018	\$3,000
D3068	Reattach the thermostat detached from the wall of room M211.	RM	2018	\$100
D3068	Replace HVAC Control System	CRP	2027	\$551,084

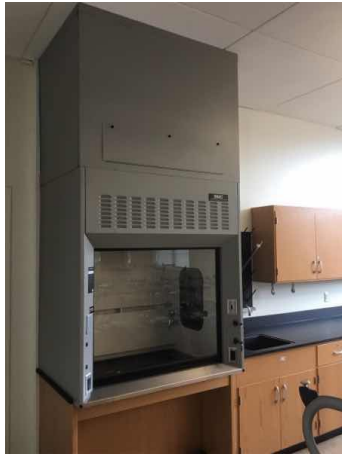
Item	Description
Laboratory Exhaust Hood, 4 Ln Ft	Laboratory Exhaust Hood
Condition	Fair - Good
Quantity	3 EA
Remaining Useful Life (RUL)	9 Year(s)

Uniformat	Component Description	Plan Type	Year	Expenditures
E1027	Replace Laboratory Exhaust Hood	CRP	2027	\$7,373

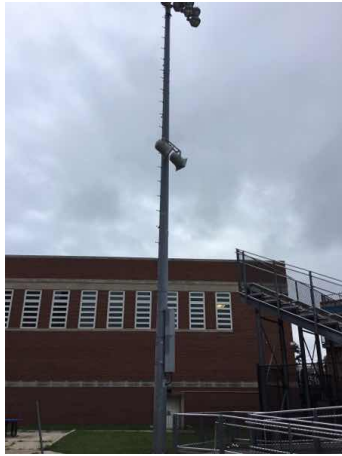
Football Site Light Pole

Item	Description
Site Lighting, Poles, Steel (40')	Site Lighting, Poles, Steel (40')
Condition	Good
Quantity	6 EA
Remaining Useful Life (RUL)	34 Year(s)
Location	Football Field

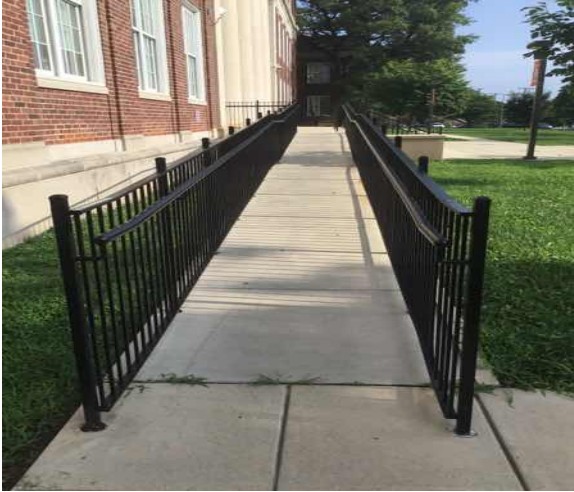
B1014 Ramps:- View of Exterior Concrete Ramps

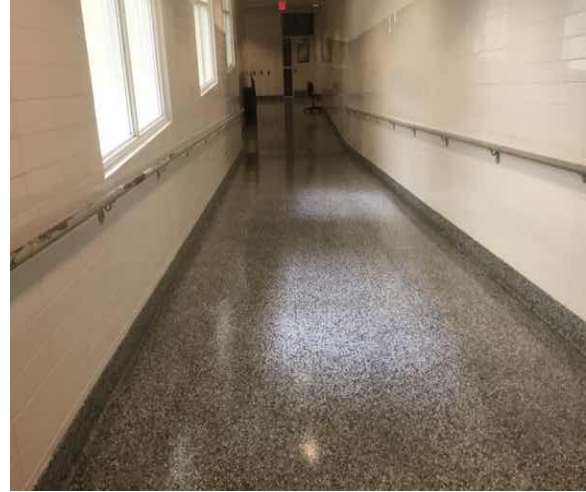
B1014 Ramps:- View of Interior Concrete Ramp

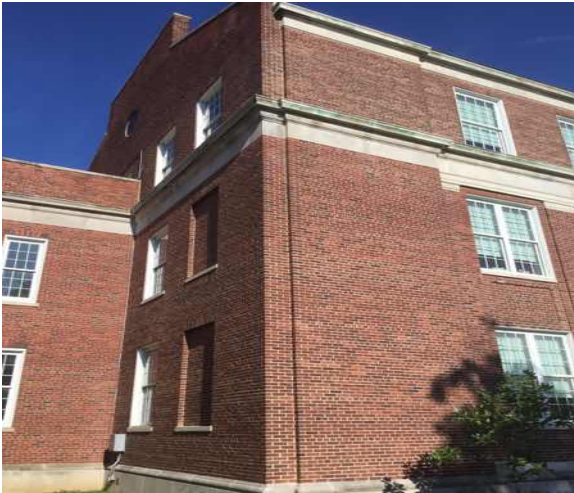
B2011 Exterior Wall Construction:- View of Clay Brick Exterior Wall

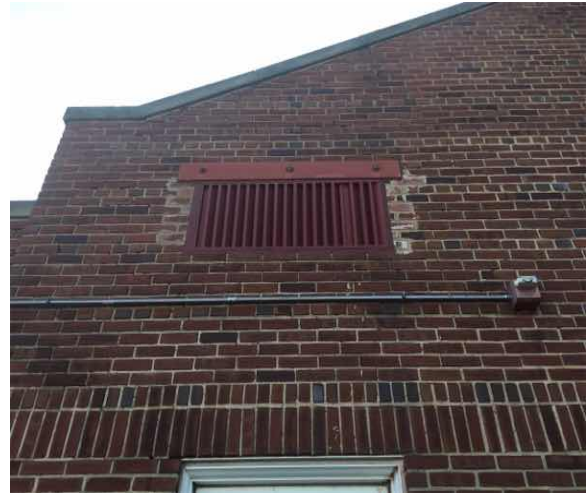
B2013 Exterior Louvers, Screens, and Fencing:- View of Aluminum Louver

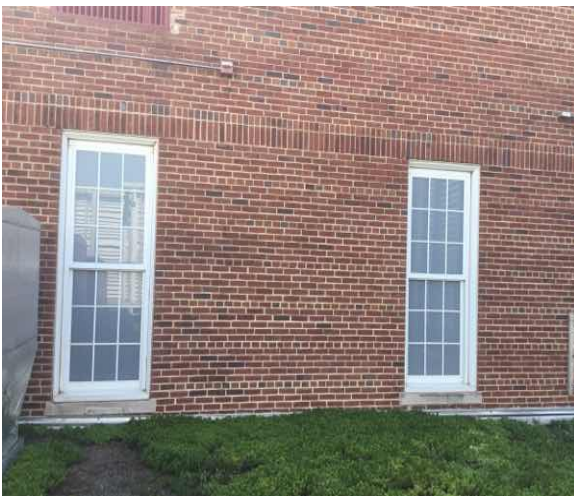
B2021 Windows:- View of Aluminum Fixed Window

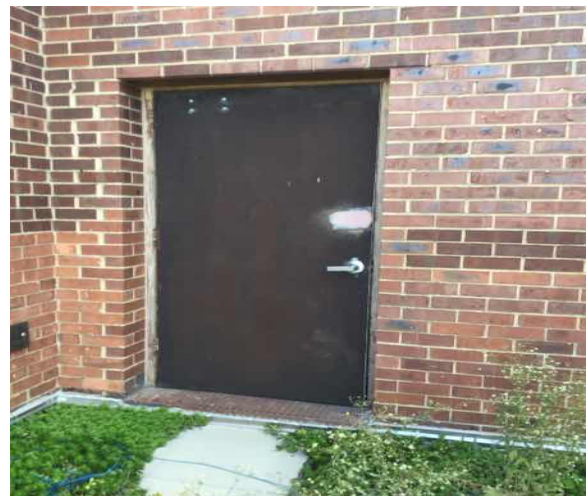
B2031 Glazed Doors & Entrances:- View of Steel Exterior Door

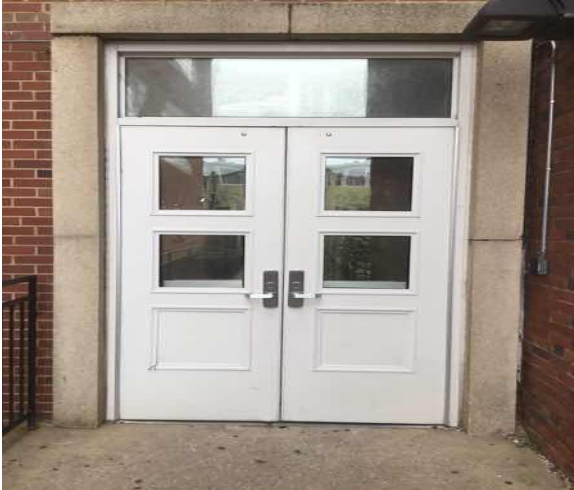
B2031 Glazed Doors & Entrances:- View of Steel w/ Safety Glass Exterior Door

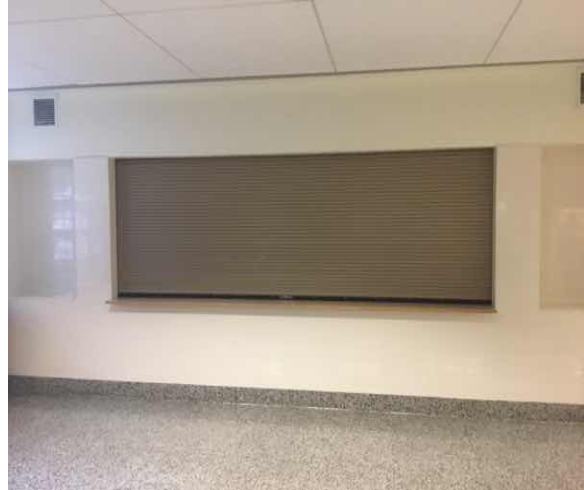
B2039 Other Doors & Entrances:- View of Steel Doors & Entrances, Rolling Door

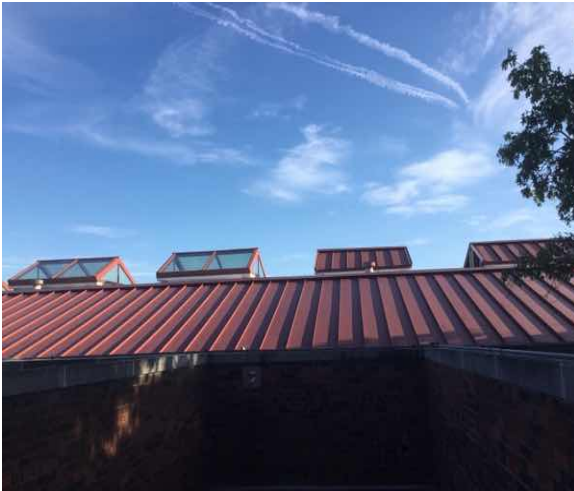
B3011 Roof Finishes:- View of Corrugated Roof Covering

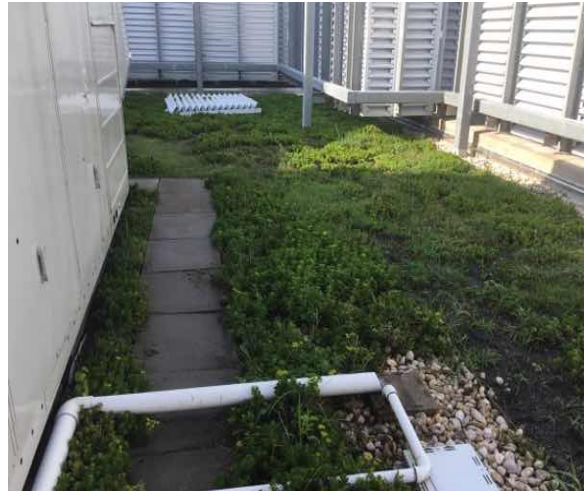
B3011 Roof Finishes:- View of Green Roof w Growing Medium

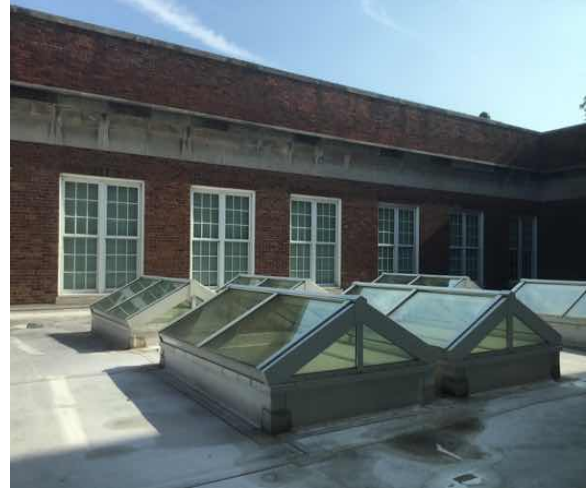
B3021 Glazed Roof Openings:- View of Metal Frame Skylights

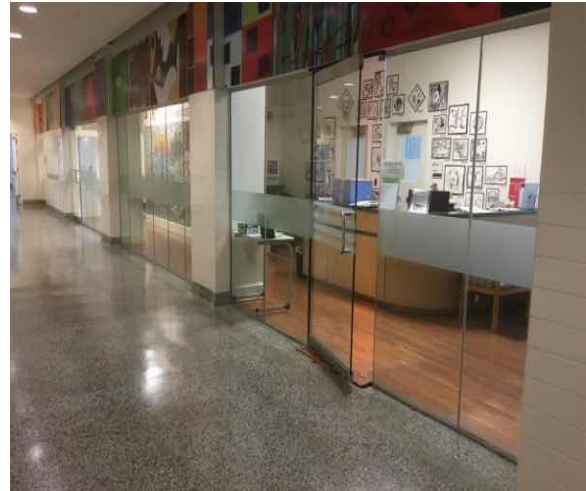
C1017 Interior Windows & Storefronts:- View of Interior Windows & Storefronts - Standard

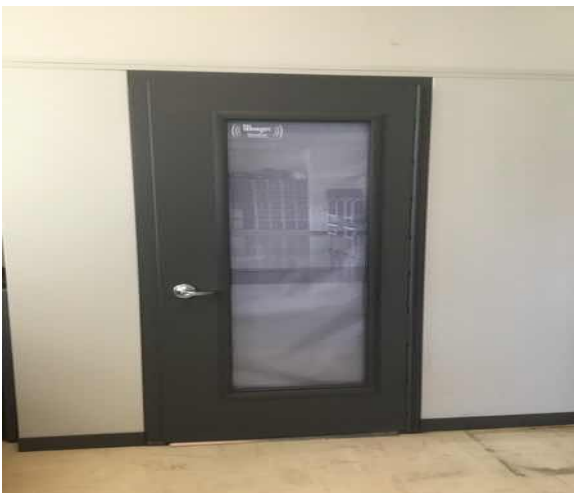
C1021 Interior Doors:- View of Aluminum Fully Glazed Interior Door

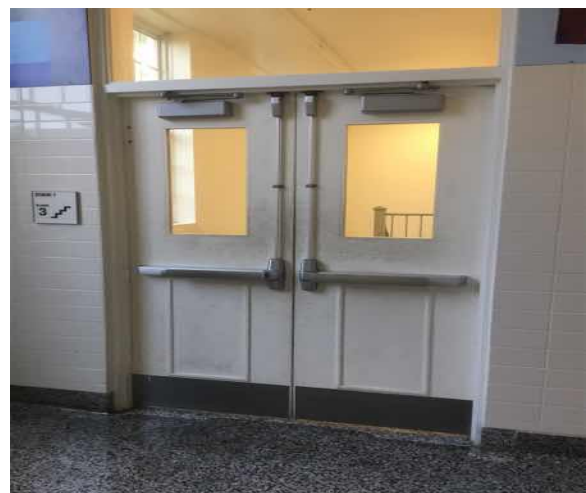
C1021 Interior Doors:- View of Fire Doors

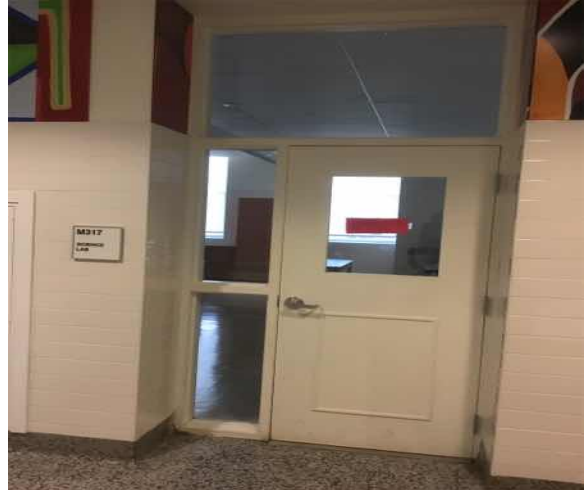
C1021 Interior Doors:- View of Wood Safety Glass Painted Interior

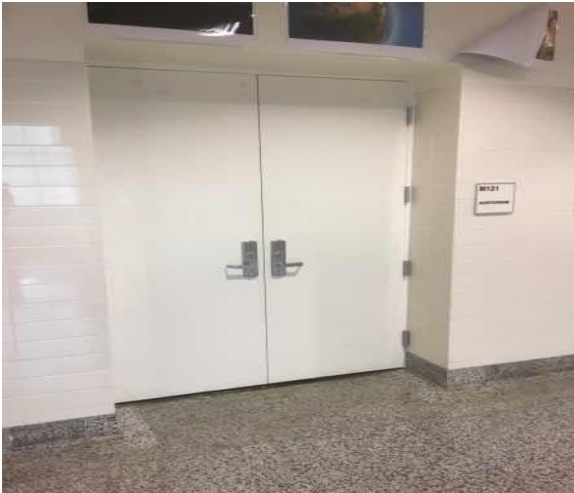
C1021 Interior Doors:- View of Wood Solid Core Interior Door

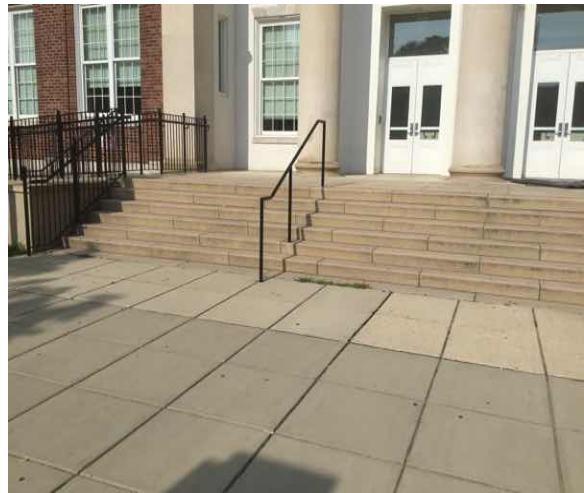
C2011 Regular Stairs:- View of Concrete Exterior Stairs

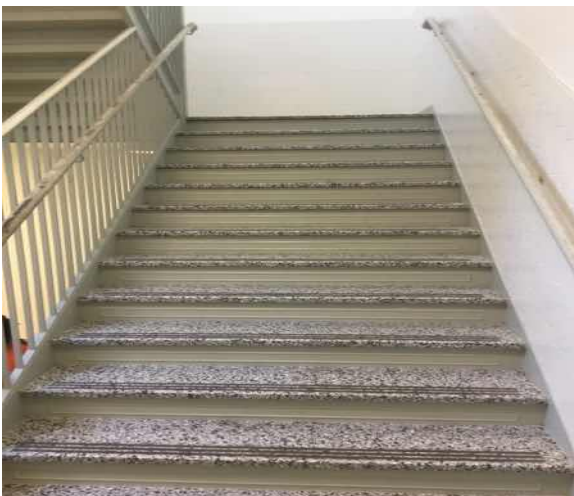
C2011 Regular Stairs:- View of Concrete Filled Metal Pan Type Interior Stair

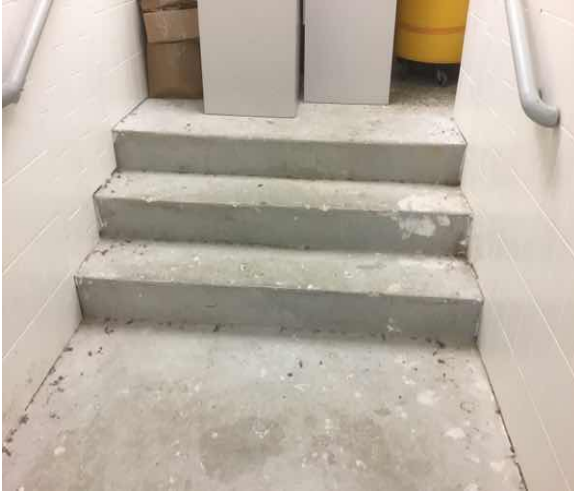
C2011 Regular Stairs:- View of Concrete Interior Stairs

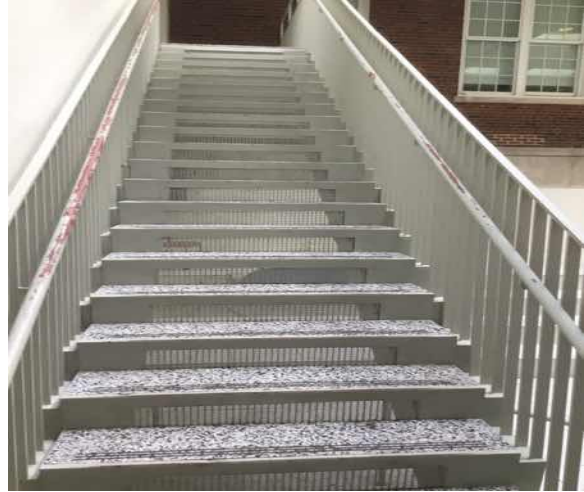
C2011 Regular Stairs:- View of Metal Interior Stairs

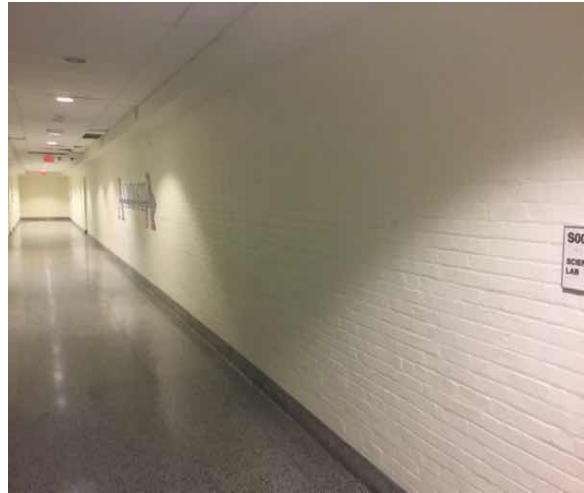
C3012 Wall Finishes to Interior Walls:- View of Clay Brick Interior Wall Finish

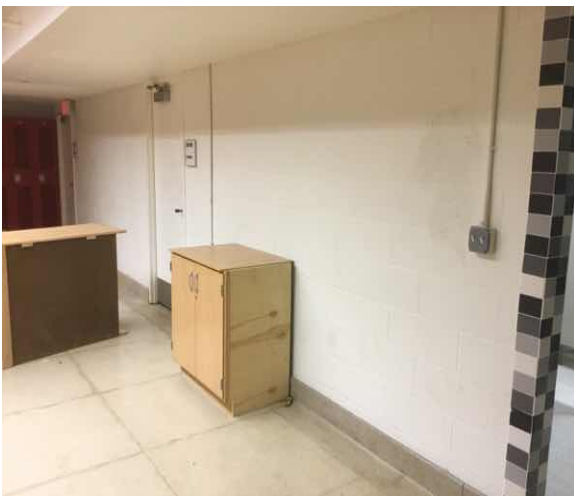
C3012 Wall Finishes to Interior Walls:- View of Concrete Block Interior Wall Finish

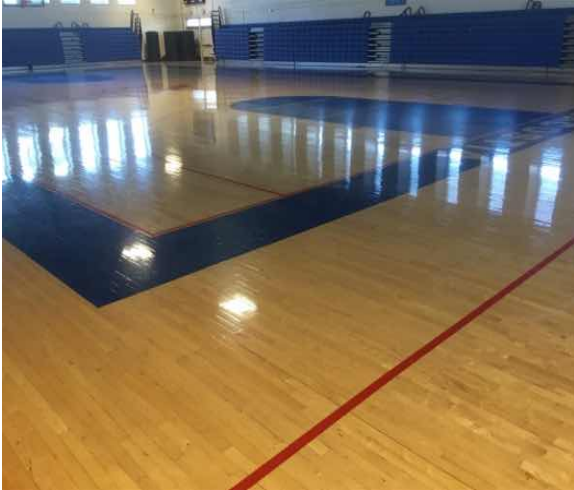
C3024 Flooring:- View of Athletic Wood Floor Finish

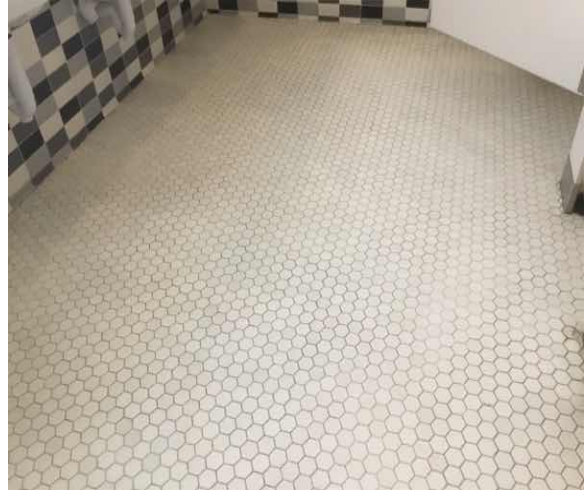
C3024 Flooring:- View of Ceramic Tile Flooring

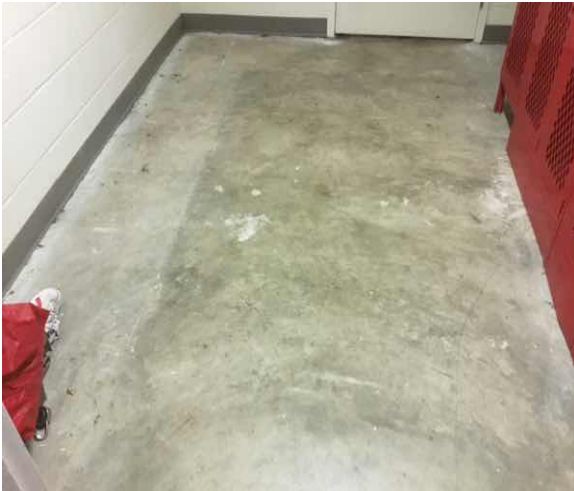
C3024 Flooring:- View of Concrete Flooring

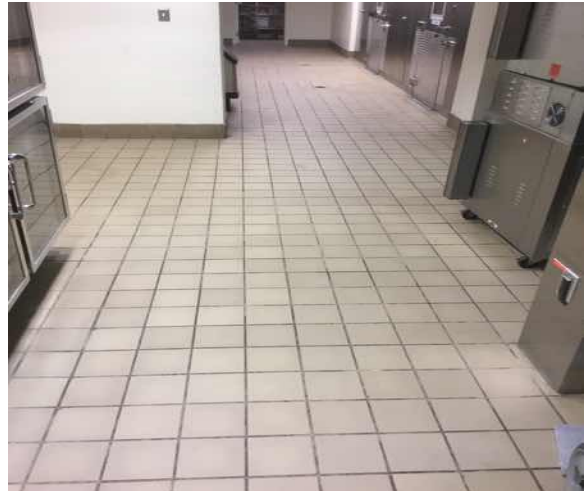
C3024 Flooring:- View of Quarry Tile Flooring

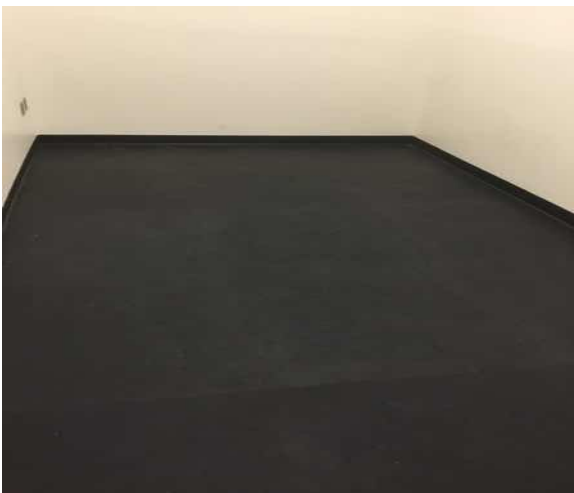
C3024 Flooring:- View of Rubber Floor Finish

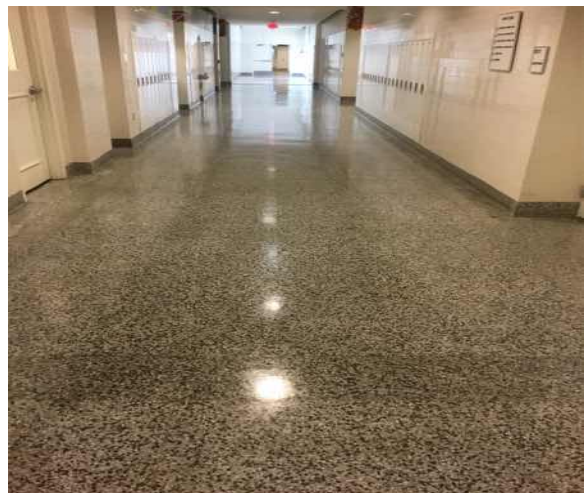
C3024 Flooring:- View of Terrazzo Floor Finish

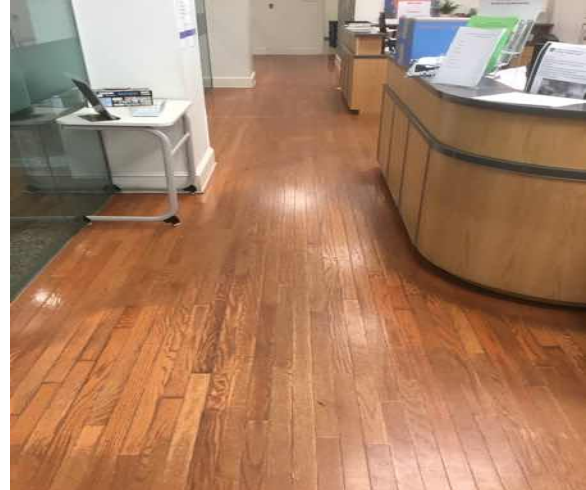
C3024 Flooring:- View of Wood Strip Floor Finishes

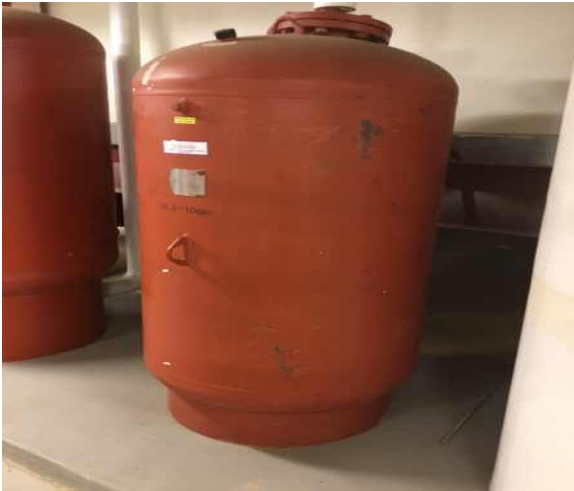
D3021 Boilers:- Boiler 3...not Working

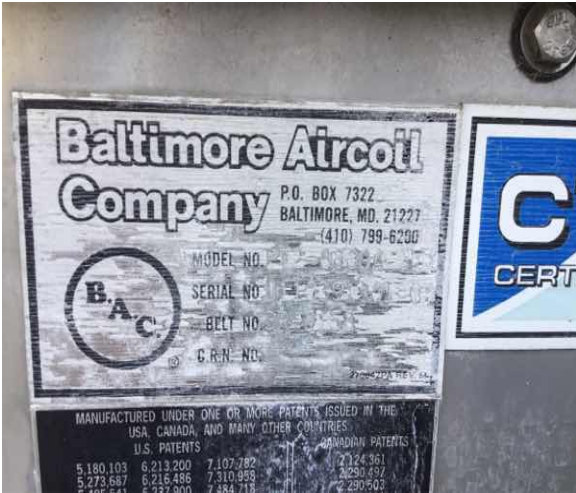
D3031 Chilled Water Systems:- View of Cooling Tower, 250 Ton (x2)

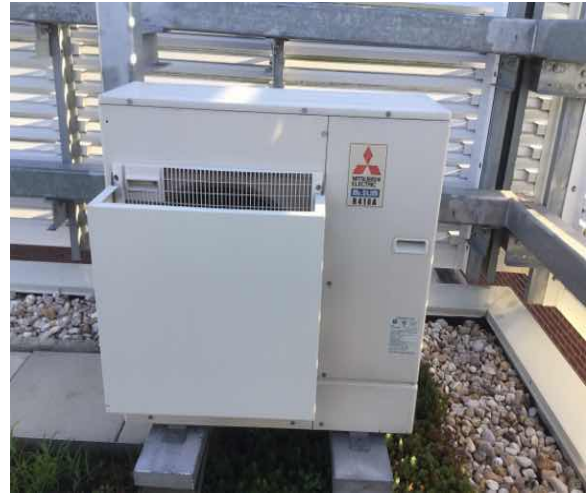
D3032 Direct Expansion Systems:- Air-Cooled Condenser

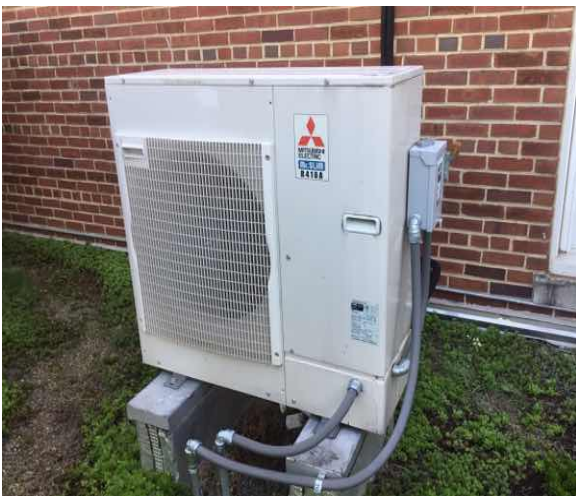
D3032 Direct Expansion Systems:- Air Cooled Condenser

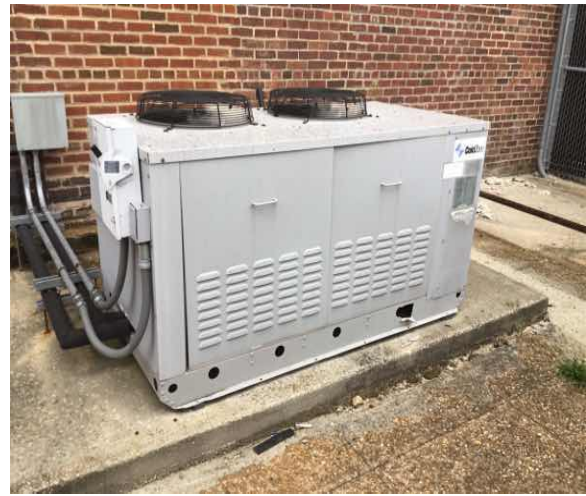
D3032 Direct Expansion Systems:- Condensing Unit

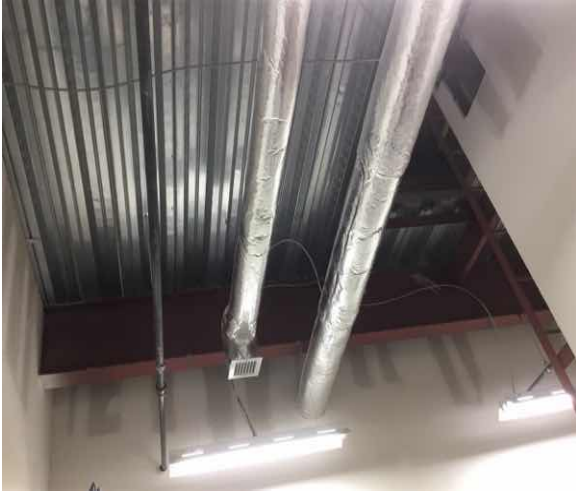
D3041 Air Distribution Systems:- Ductwork

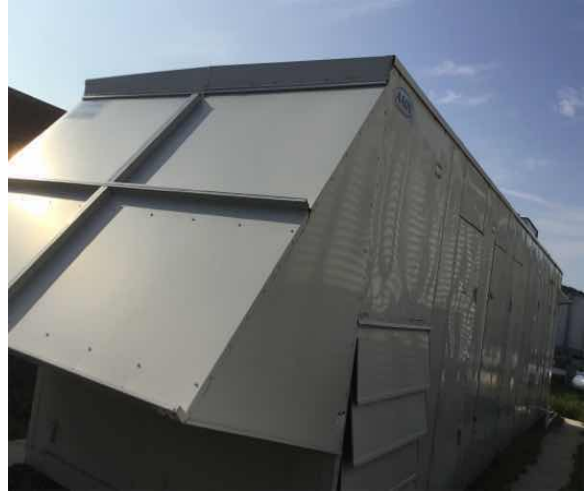
D3041 Air Distribution Systems:- Rooftop Unit

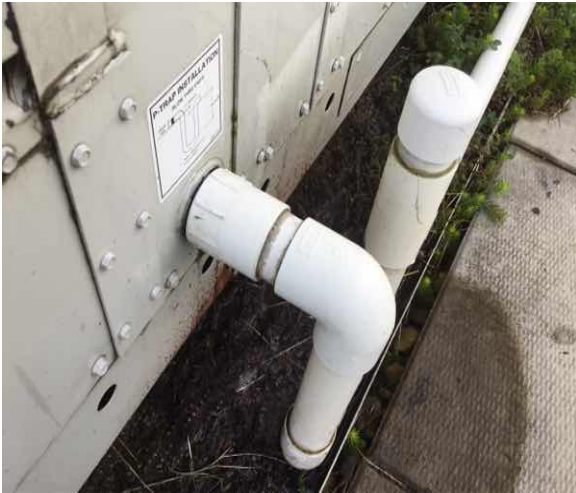
D3041 Air Distribution Systems:- Condensate piping leaking

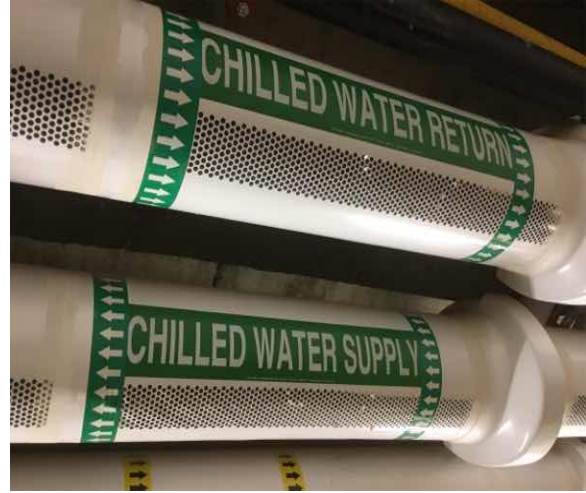
D3045 Chilled Water Distribution:- Chilled Water Piping

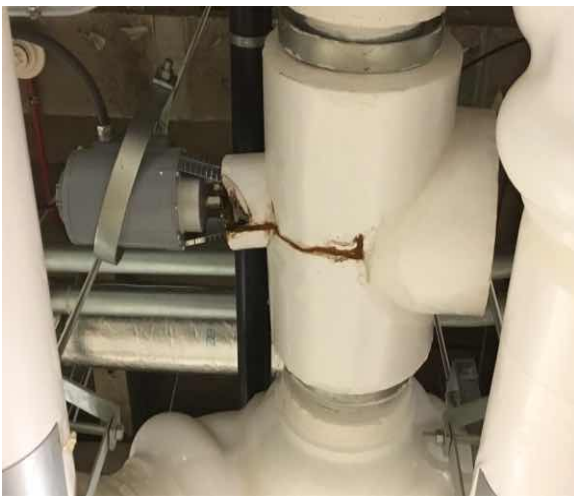
D3045 Chilled Water Distribution:- Cracked Chilled Water Piping at a Valve Controller- Leakng

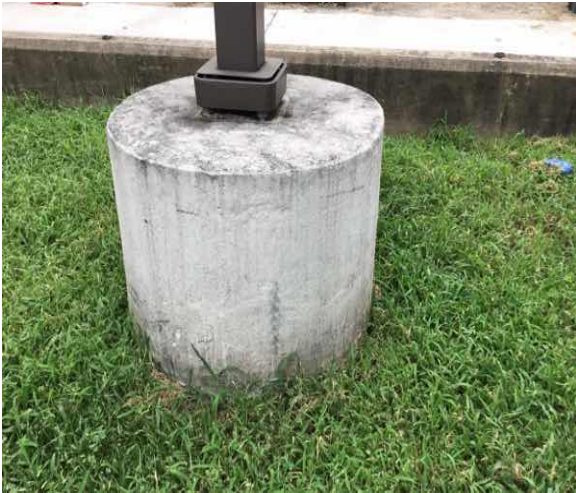
Item	Description
Site Lighting, Flood Light, 175W HID (1 Fixture)	Site Lighting, Flood Light, Stadium Lights
Condition	Fair - Good
Quantity	60 EA
Remaining Useful Life (RUL)	14 Year(s)
Location	Football Field

G4021 Fixtures & Transformers:- Stadium Lighting
