Attachment M
Condition Assessment

**BUILDING 90: W.W. ELDRIDGE BUILDING
CONDITION ASSESSMENT**

2700 Martin Luther King Jr. Ave SE
Washington, DC 20032

Report Date	February 20, 2015
WPM Project No.	D01.14013.00

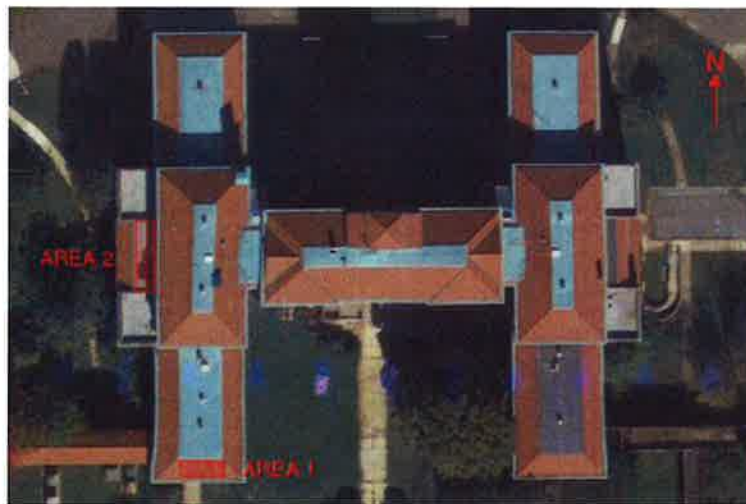
Figure 1. Aerial photo of Building 90 (Google Earth, Inc, 2015)

Walter P. Moore and Associates, Inc. has completed an initial condition assessment of the referenced structure. This assessment consisted of a walkthrough visual review of only two areas of the building which had been identified as having structural roof failure, in order to identify the nature and extent of the damage. See Figure 1 for location of the two areas.
