**Attachment B- Feasibility Study  
Part 1**

**DISTRICT OF COLUMBIA PUBLIC SCHOOLS**  
**JOHN EATON ELEMENTARY SCHOOL MODERNIZATION**  
**FEASIBILITY ASSESSMENT AND CONCEPTUAL DESIGN**  
**JULY 3, 2018**

# EXISTING FACILITY CONDITION ASSESSMENTS & FEASIBILITY RECOMMENDATIONS

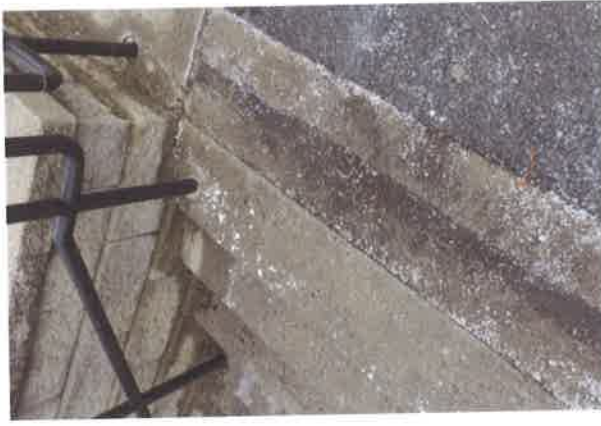
Badly clogged trench drain at top of site stairs

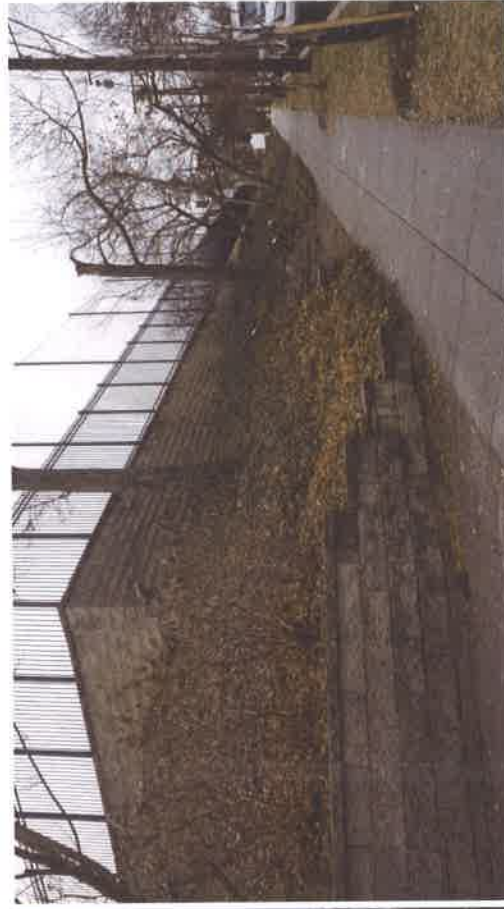
Figure 4 - Separation and isolation, 33rd Street and Macomb Street walls

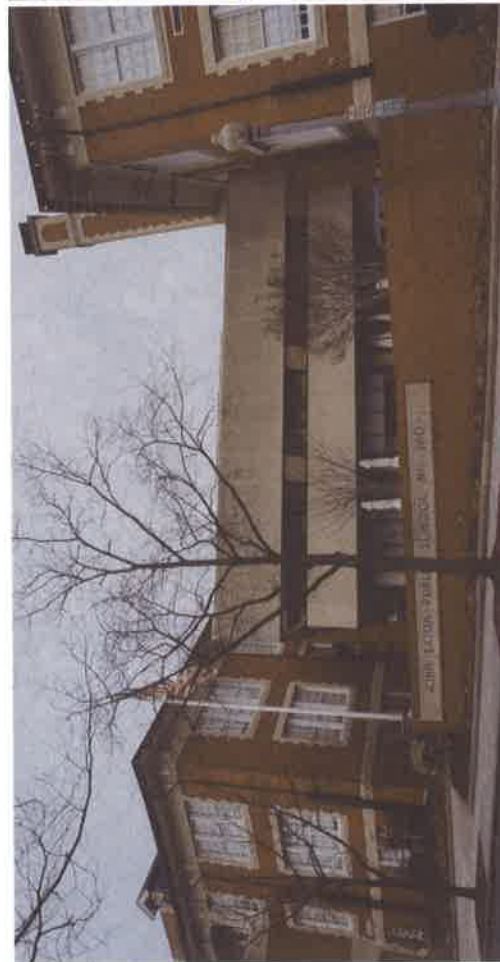
Figure 1 - Separation and isolation, Lowell Street wall

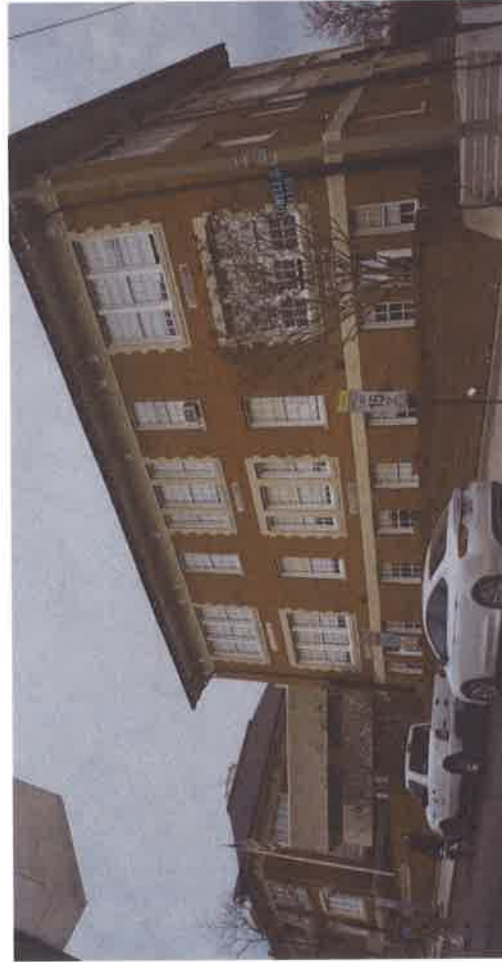
Figure 2 - Separation and isolation, Lowell Street and 33rd Street walls

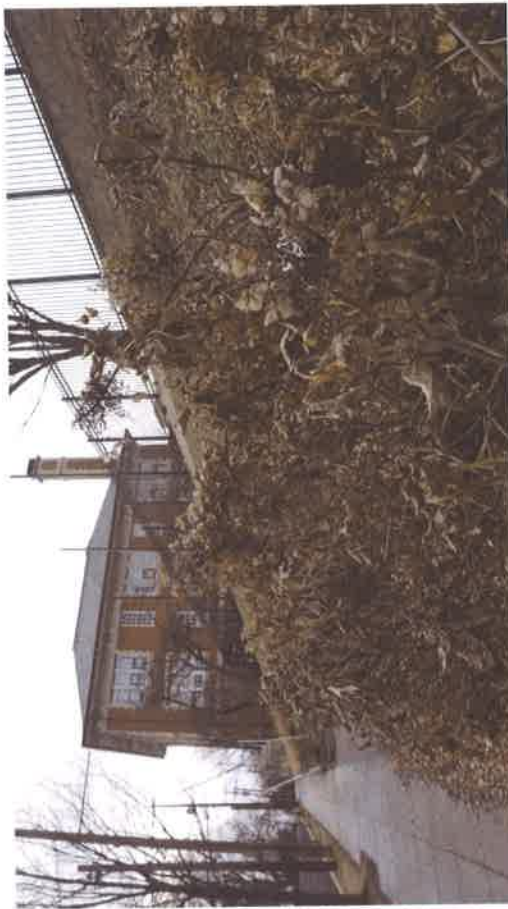
Figure 3 - Steep grade and retaining wall, 33rd Street

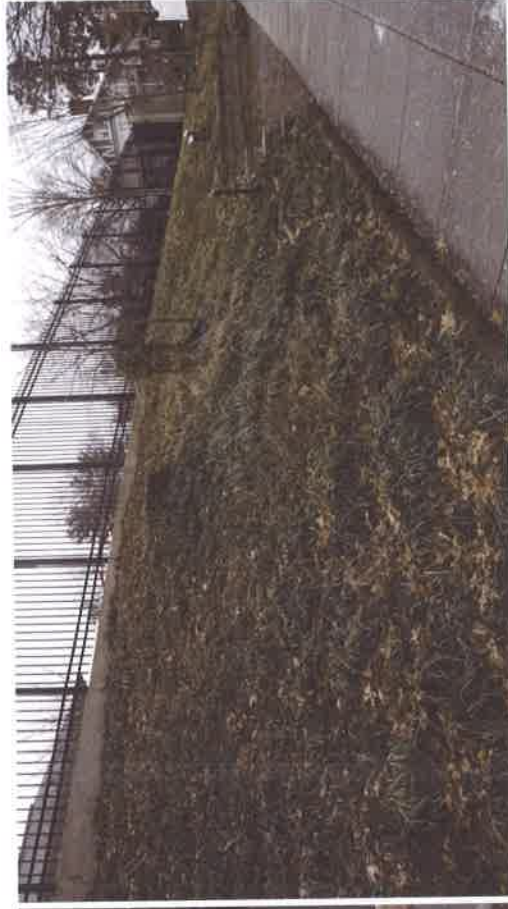
Figure 4 - Steep grade and retaining wall, Macomb Street

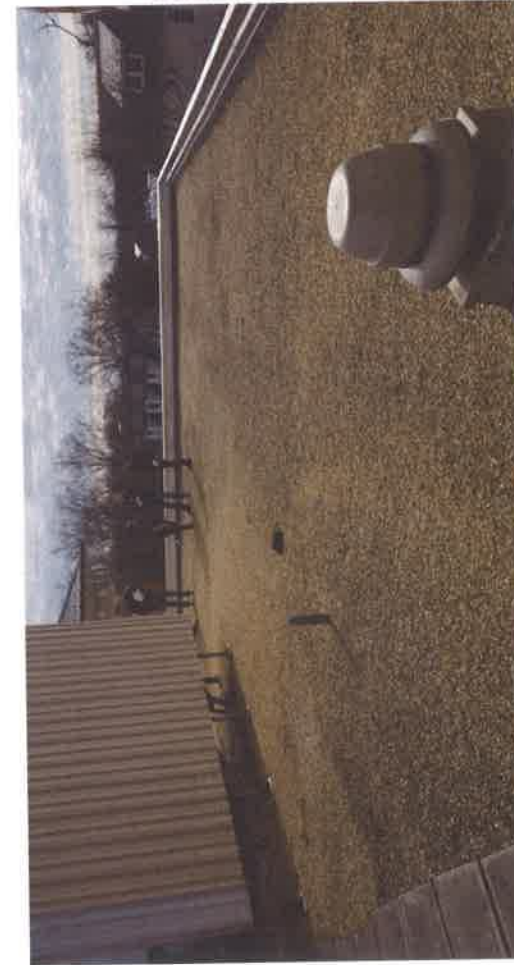
Figure 2 - Limited and under utilized space, roof

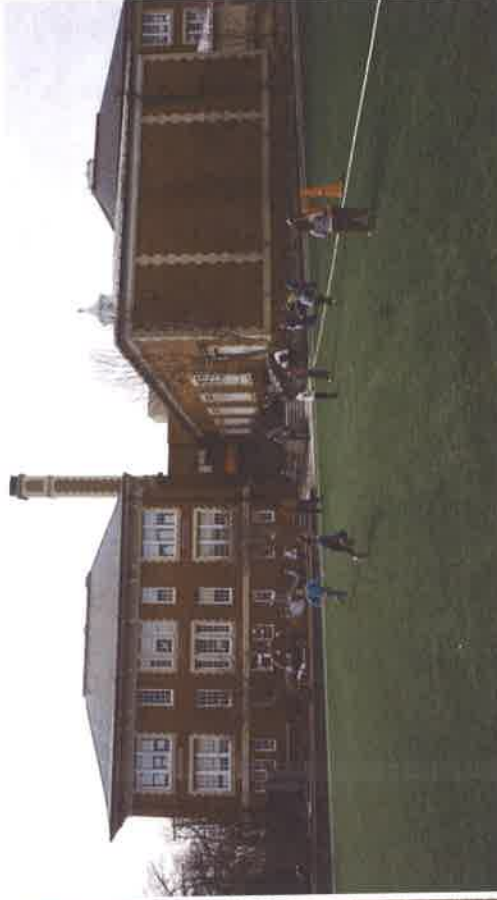
Figure 4 - limited functional space, oversized sports field, currently used for morning assembly

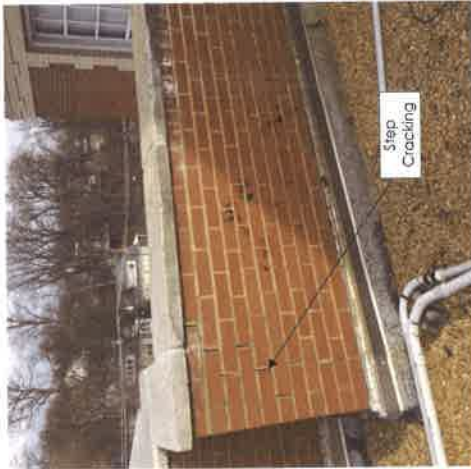
Exterior masonry parapets projecting above the 1980's building roof level are cracked and displaced at several locations (Figure 3). We did not observe flashings beneath the parapet copings at these locations.

Figure 3 – Parapet distress at northwest corner of 1980's bldg.

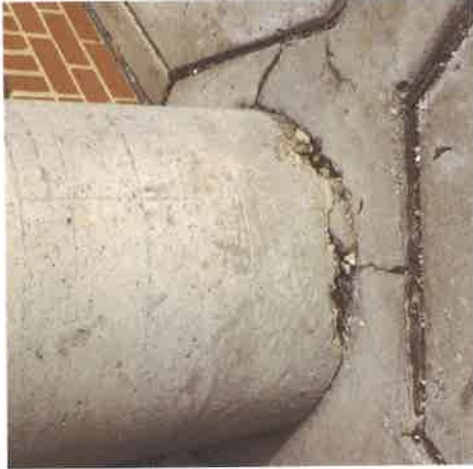
We saw spalls at the base of the 1980's circular concrete column where it intersects the exterior walking surface (Figure 5).

Figure 5 – Concrete distress at base of 1980's building column.

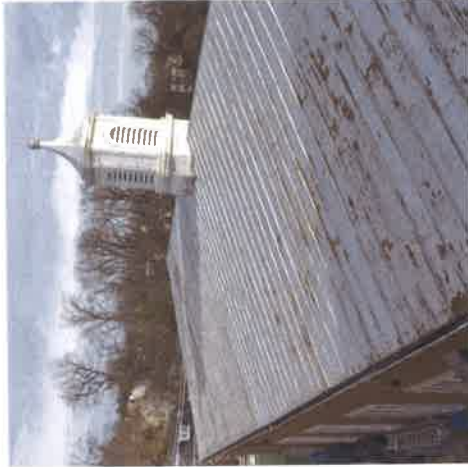
The protective coating at the 1930's building roof appears to be weathered and is permitting corrosion of the metal roofing (Figure 6).

Figure 6 – 1930's building roof distress.
