Reference: Phase I Environmental Site Assessment
Eastern Market MetroPark
Pubic Right -of- Way 7th, 9th and D Street, SE,
Washington, D.C

PHASE I ENVIRONMENTAL SITE ASSESSMENT REPORT

Eastern Market MetroPark Pennsylvania Avenue, SE Washington, DC 20003

February 23, 2016

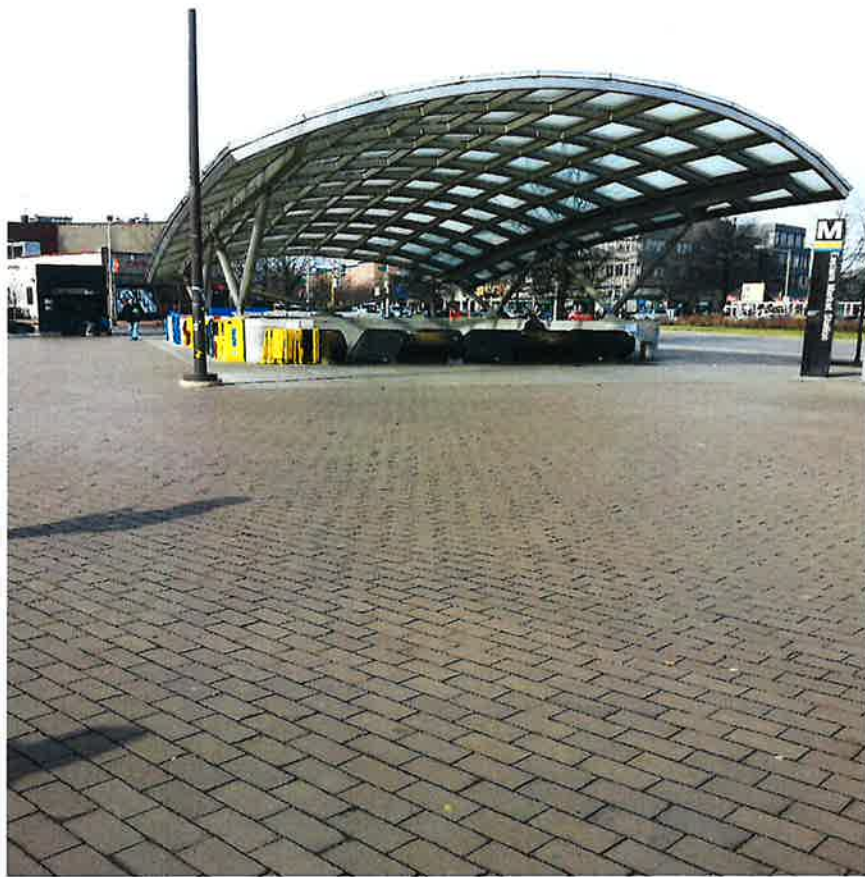
**Photo 1a – looking northwest at the Metro entrance.
Note: the escalators in the foreground and the elevator to the left.**

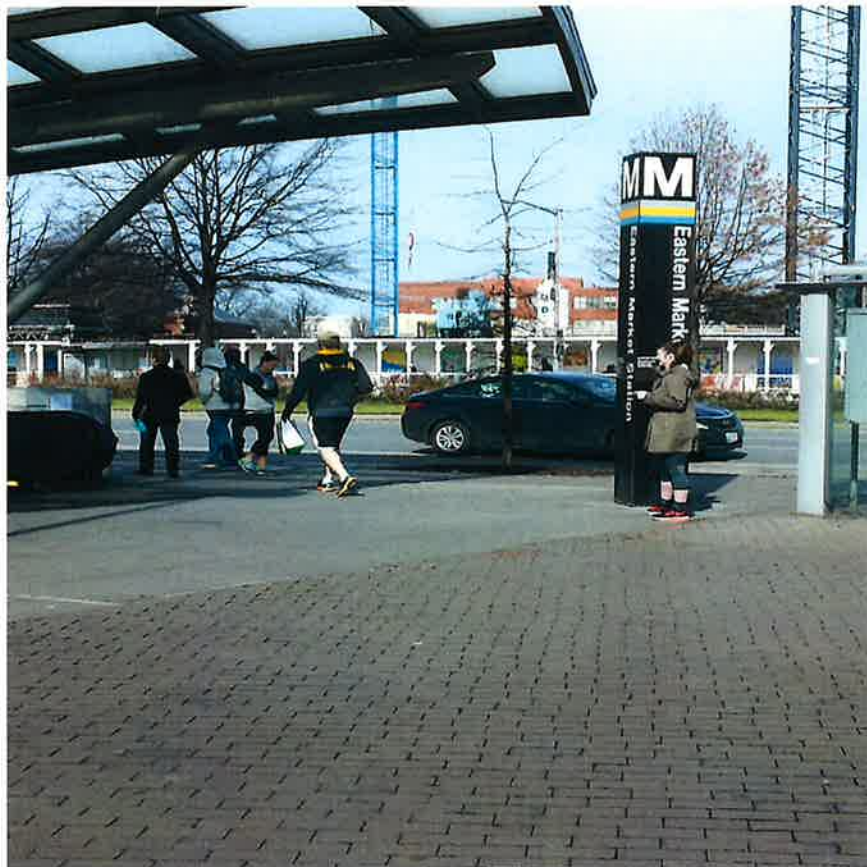
**Photo 1b – looking north at the Metro entrance with escalators to the left.
Note: construction crane in background as seen in Photo 4a.**

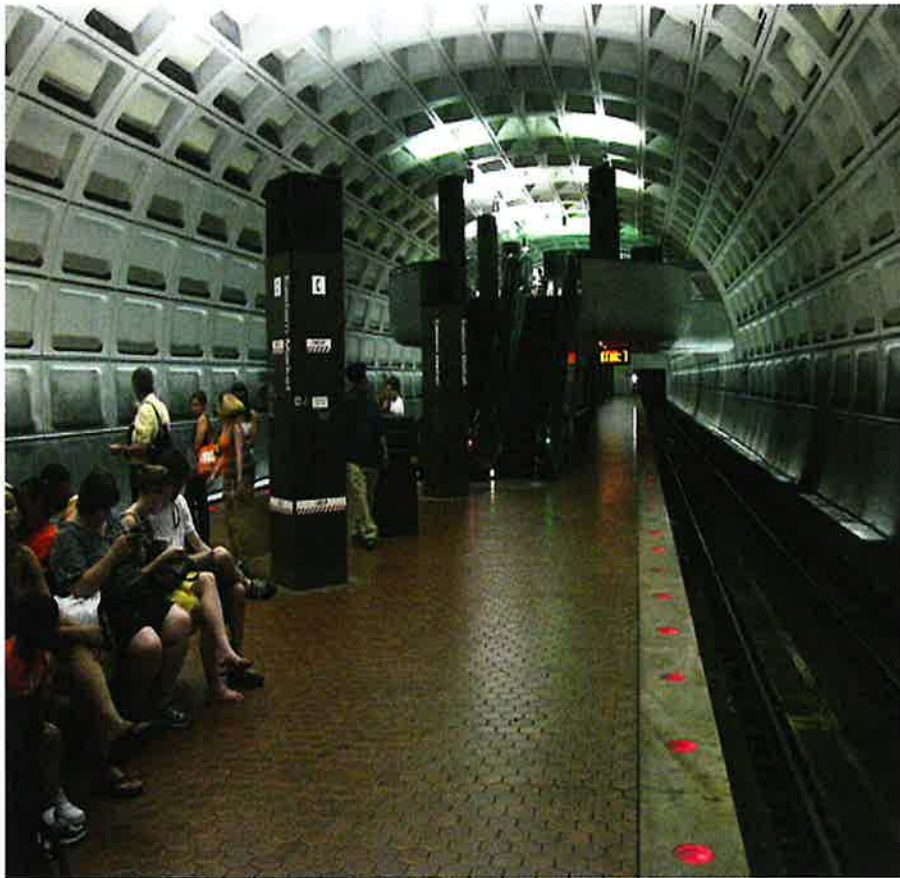
Photo 3a – photo of the island platform on the lower-level with benches and a crossover platform.

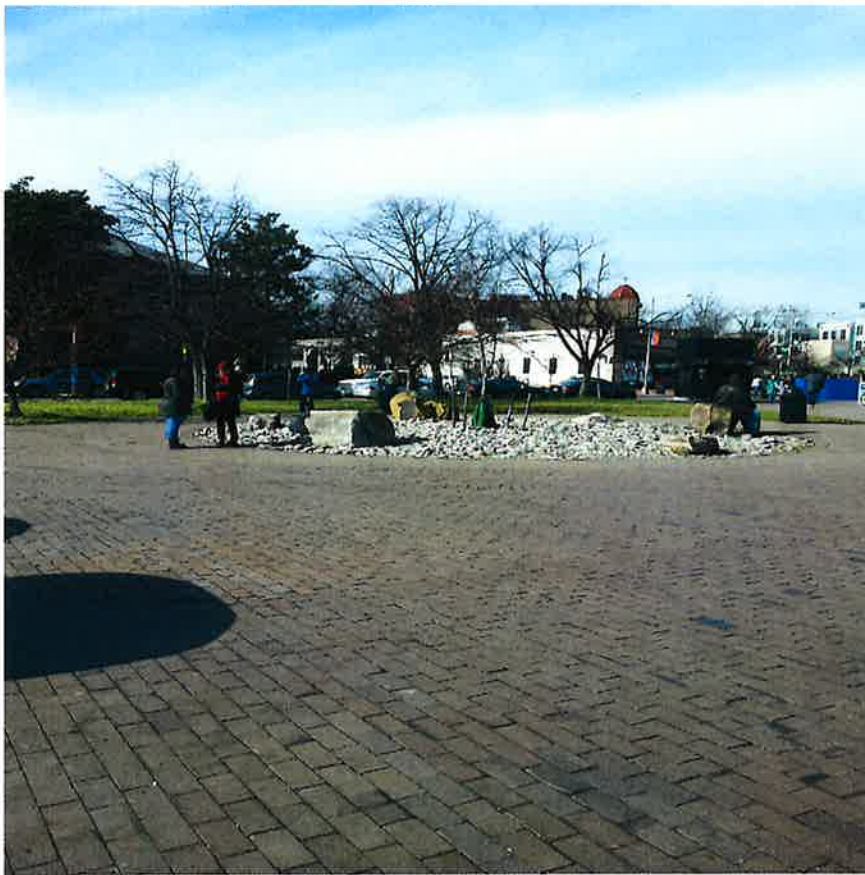
Photo 4a – South Plaza looking west.
Note: the library is to the left and the Metro entrance is to the right.

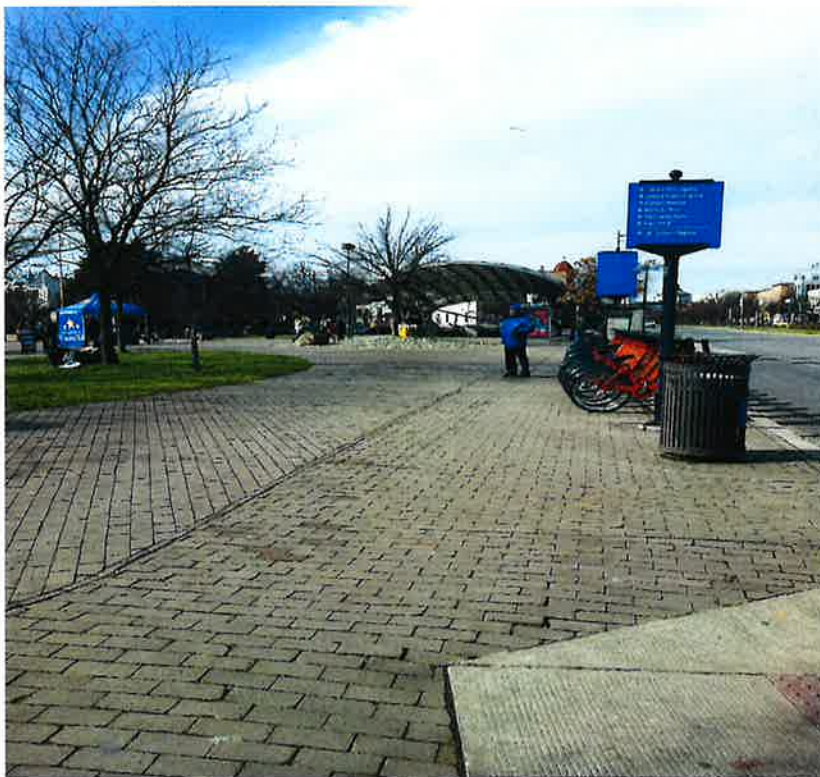
Photo 4b – South Plaza looking west along eastbound lane of Pennsylvania Ave.
Note: Metro entrance is in the background.

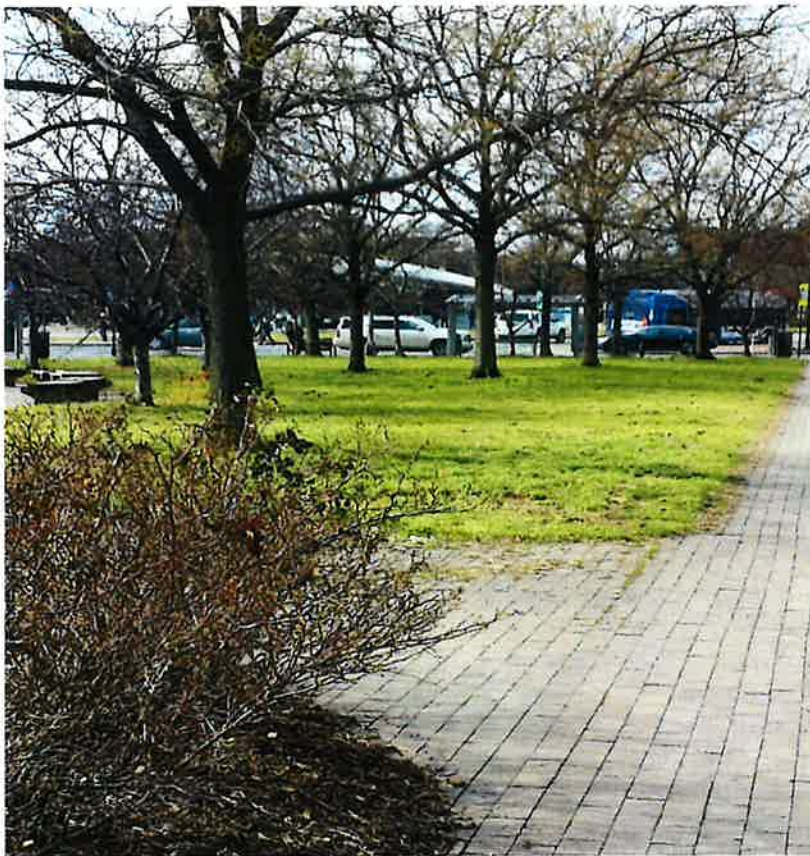
**Photo 5a – North Plaza looking southwest with the Metro entrance in the background.
Note: the playground shown in Photo 5b is to the left.**

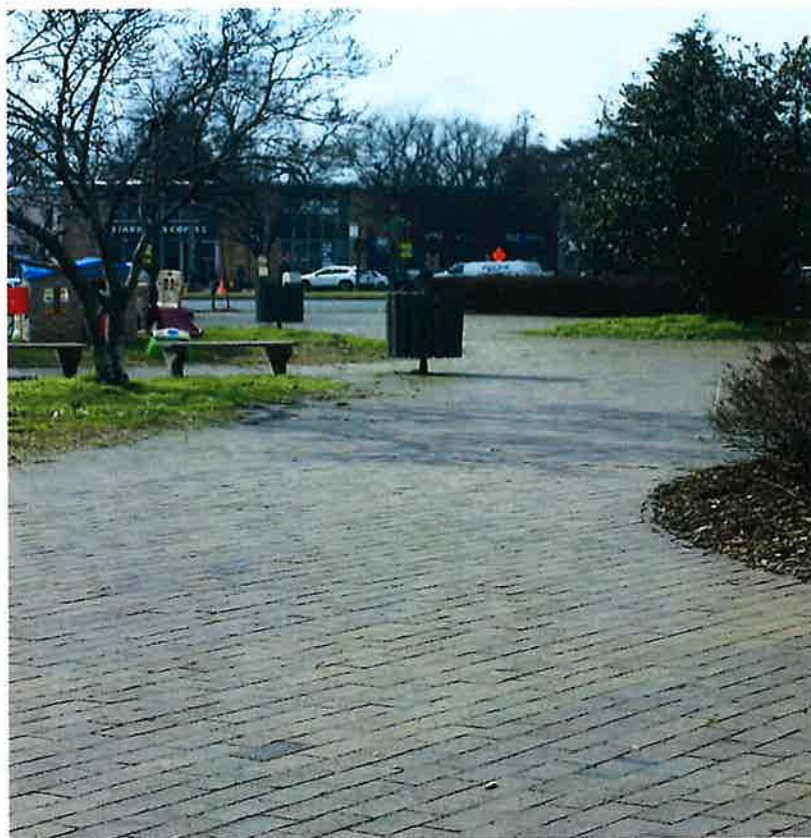
**Photo 5b – North Plaza looking south at the playground.
Note: Starbucks and Long&Foster Realtors are in the background.**

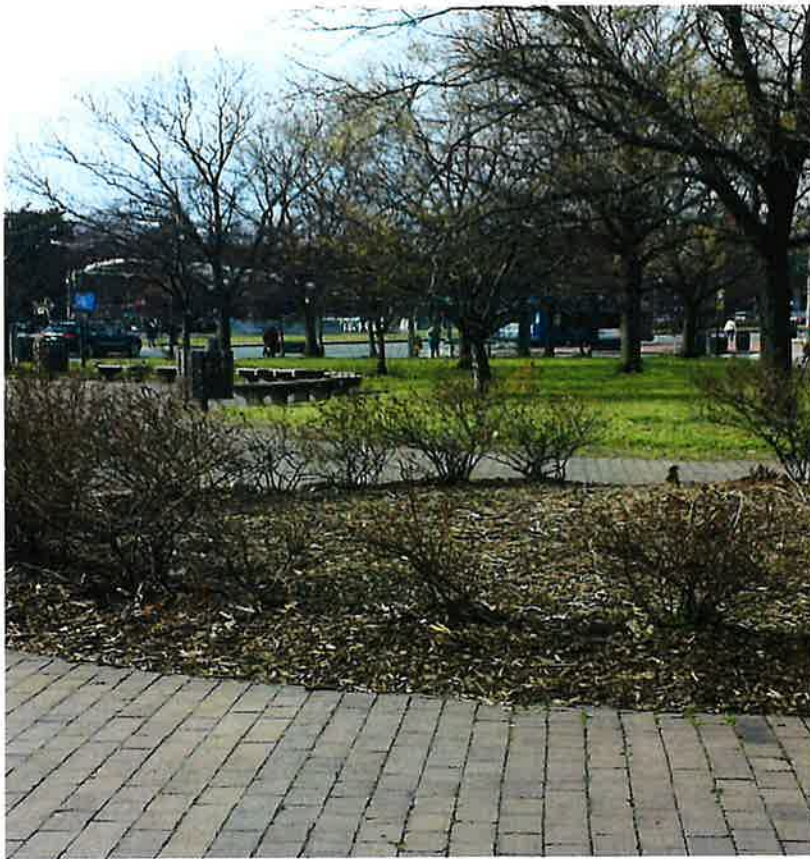
Photo 6a – North Plaza looking southwest with the Metro entrance in the background.

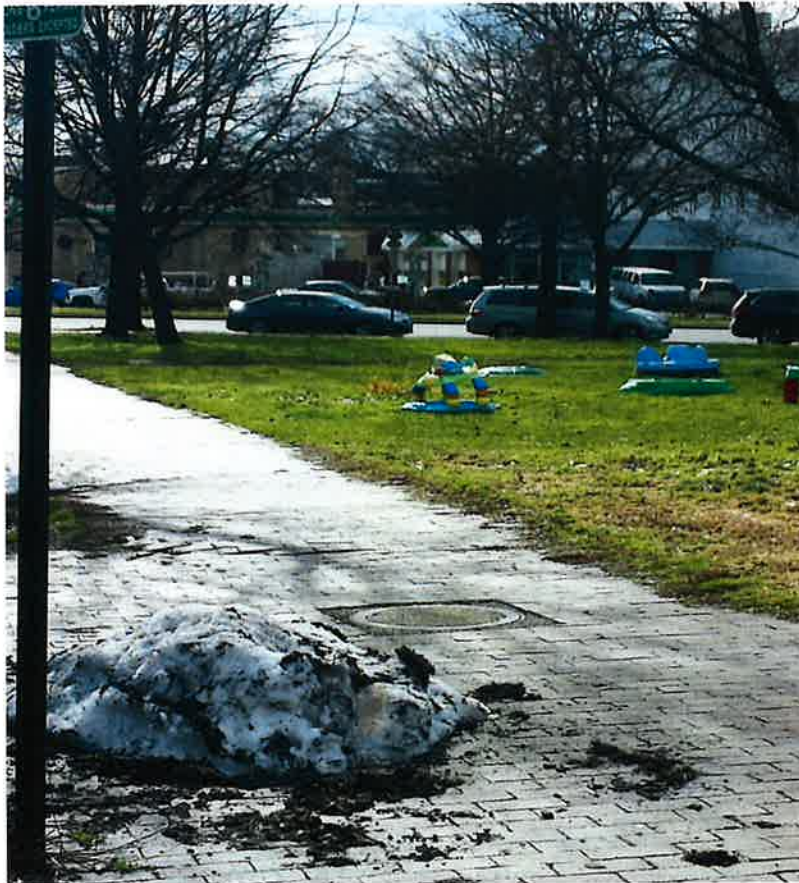
**Photo 6b – North Plaza looking south at the east edge of the plaza.
Note: the playground is shown in Photo 5b and the BP filling station in the background.**

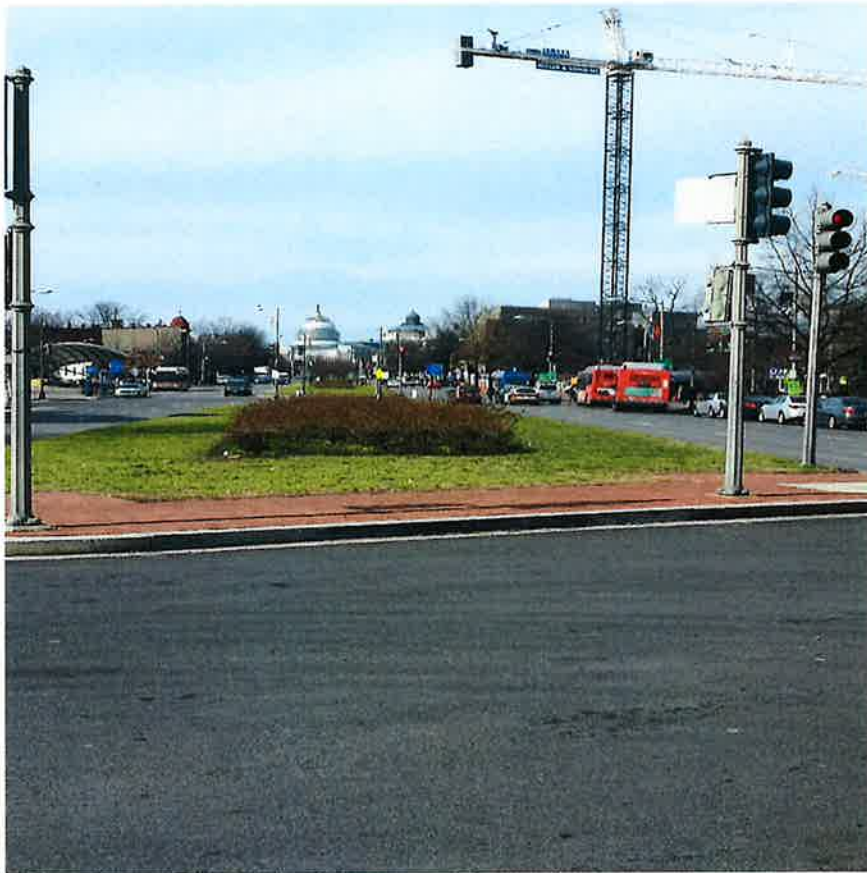
Photo 7a – looking west at the Pennsylvania Ave. median between eastbound (left) and westbound (right) lanes at the 9th St. traffic light. Note: the Metro entrance in the left background.

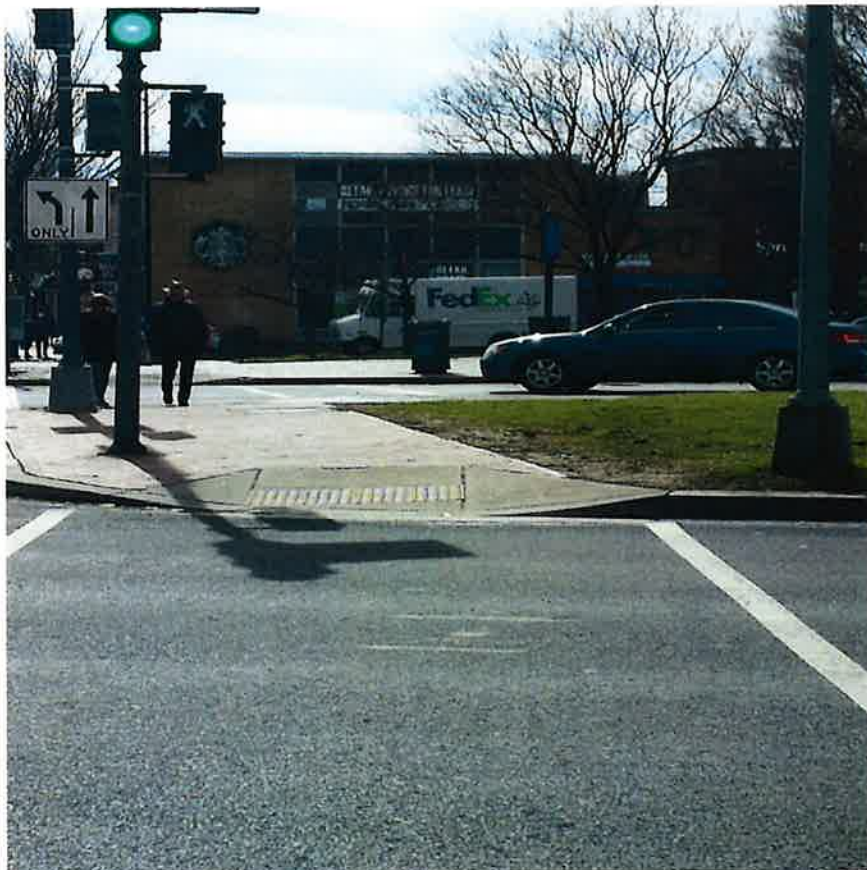
Photo 7b – looking south along 9th St. across the Pennsylvania Ave. median at Starbucks.

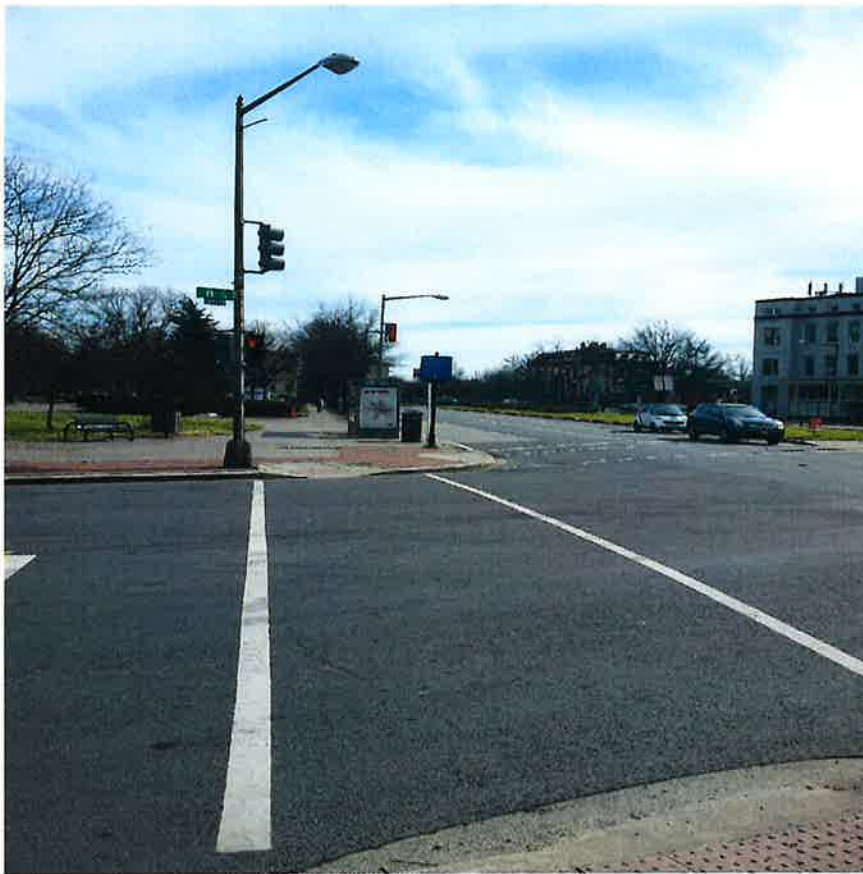
Photo 8a – looking east across 8th St. / Pennsylvania Ave. intersection.
Note: North Plaza is to the left and the white building in the background is the old Haines Store.

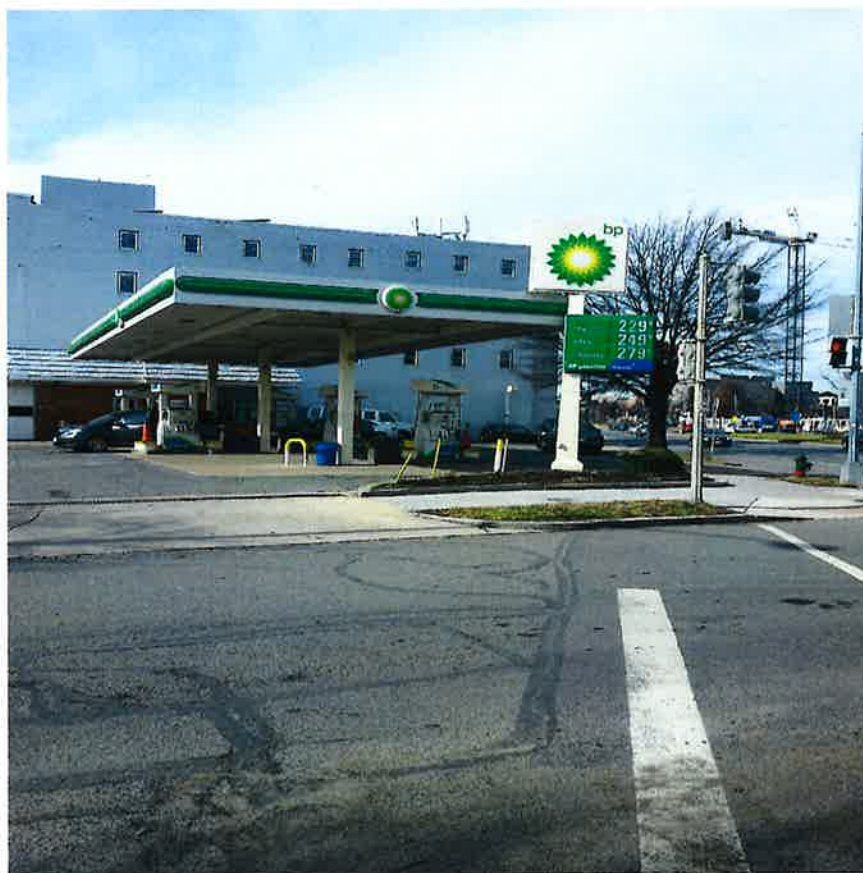
Photo 8b – looking west across 10th St. at the BP filling station.
Note: the white building in the background is the old Haines Store at 901 Pennsylvania Ave.

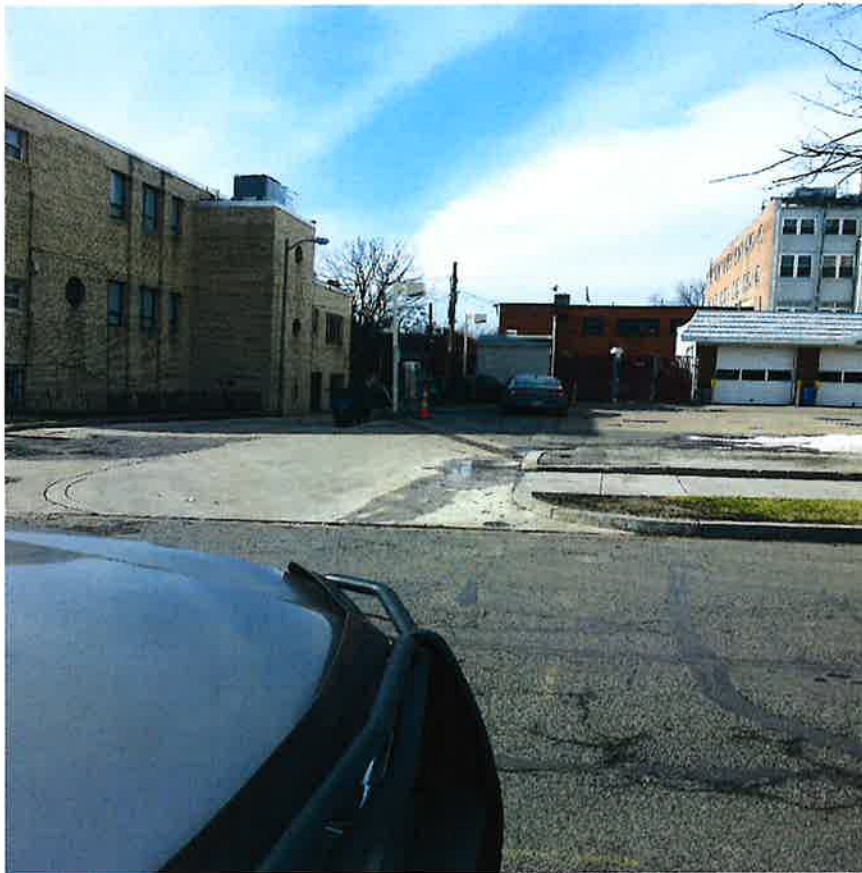
Photo 9a – looking west at the south end of the BP station.

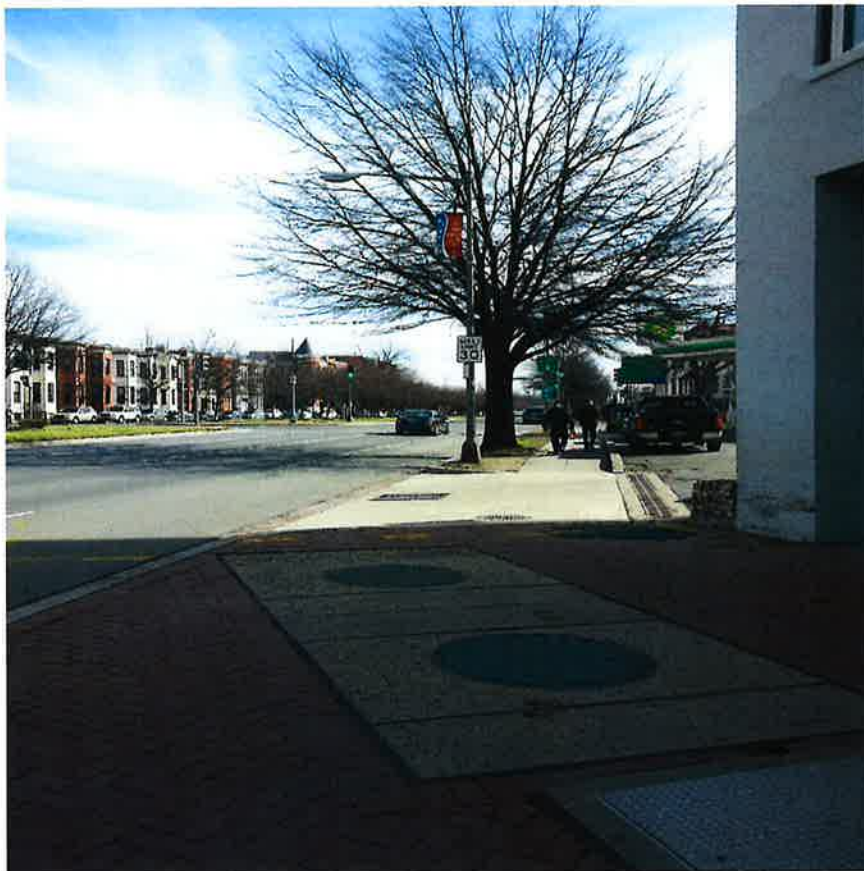
Photo 9b – looking east along eastbound Pennsylvania Ave.

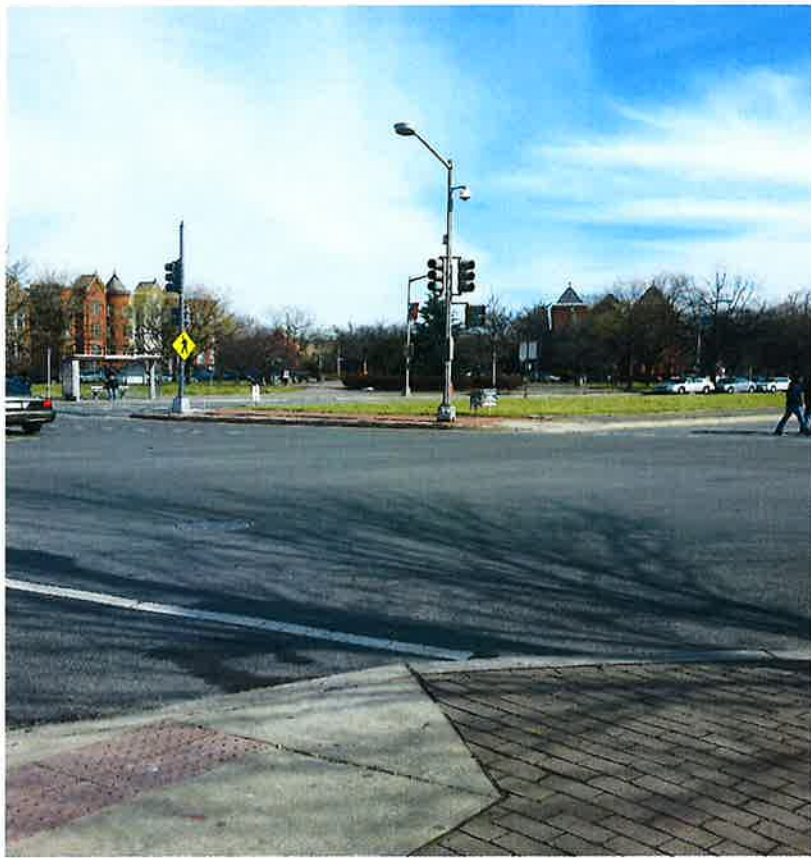
Photo 13a – looking northeast across both lanes of Pennsylvania Ave. from in front of CVS Pharmacy at the southwest corner of the 7th St. / Penn Ave. intersection. Note: the Metro entrance is to the right.

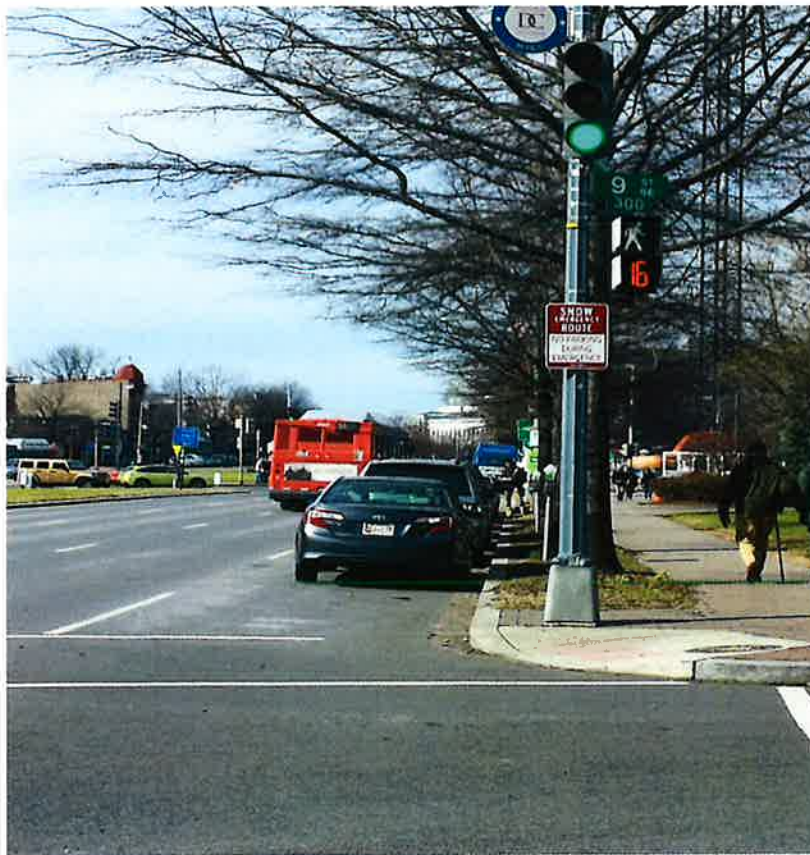
Photo 13b – looking west along westbound lane of Pennsylvania Ave. Note: the south end of the North Plaza is on the right.

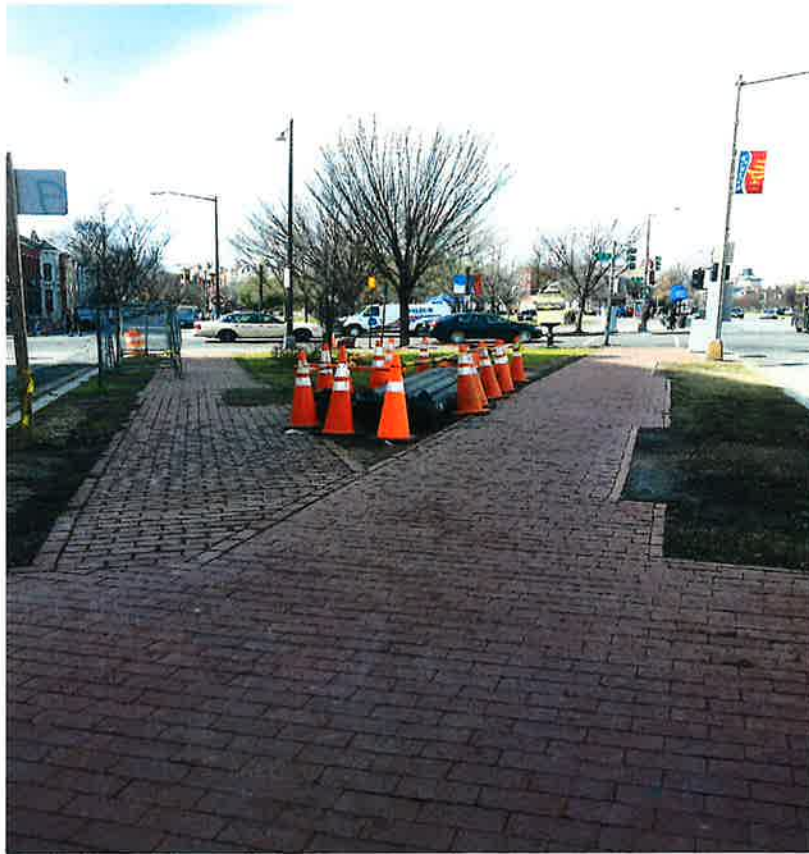
Photo 14a – looking west at the 8th St. / 'D' St. (left) and 9th St. / Pennsylvania Ave. (right) intersections. Note: the white building at 901 Penn. Av. shown in Photos 8b & 9b is out of view to the left.

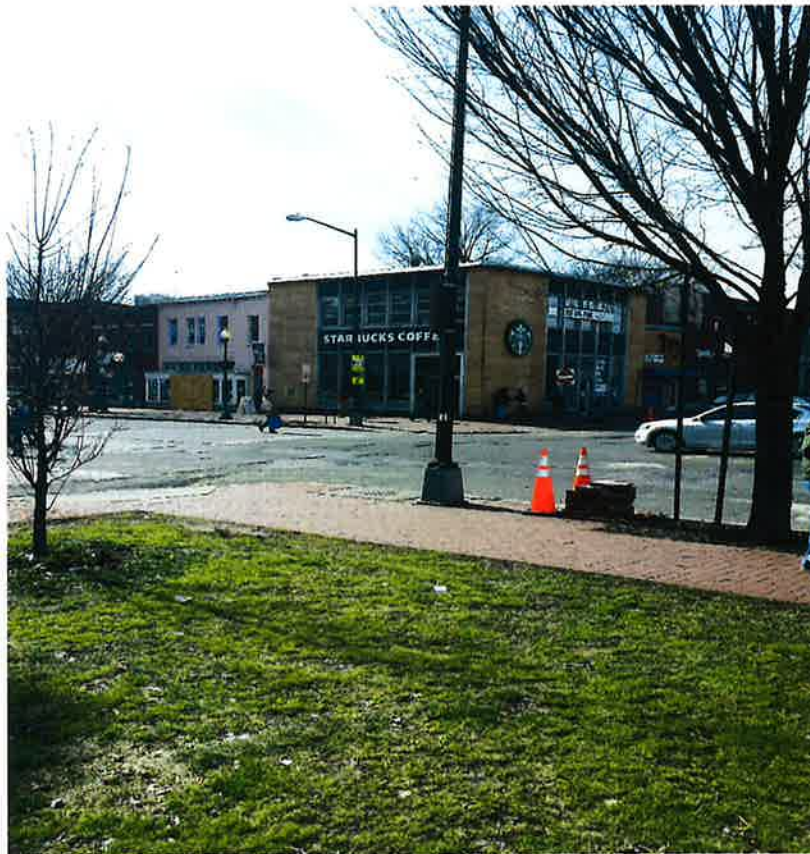
Photo 14b – looking southwest from the extreme eastern portion of the South Plaza at the 8th St. (left) /
