Task 2: Investigation of the Existing Conditions for Compliance

TECHNICAL MEMO 2 - RECOMMENDATIONS

PROJECT: Kalorama Park (Volkert No. 230405.60)

DATE OF REPORT: June 29, 2012

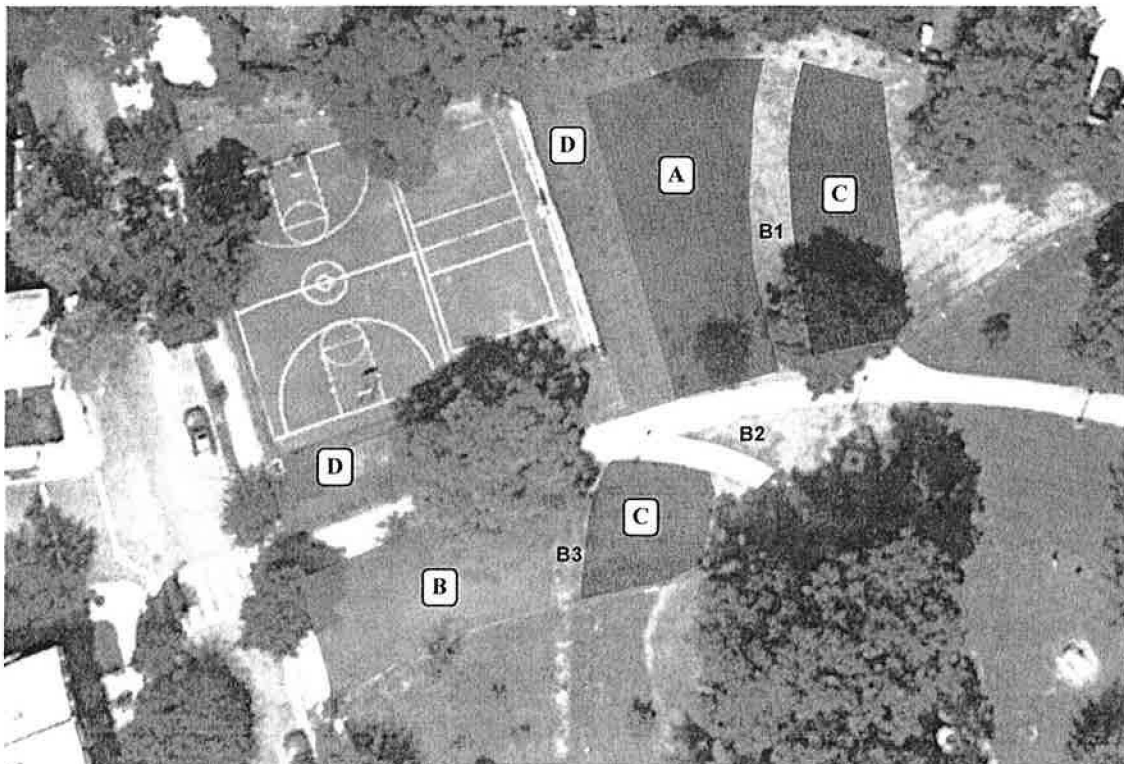
This plan represents the site improvement zones and berms, which are describe in this technical memo. This information will be used to develop biddable plans and specifications for improvements to Kalorama Park.
