# **KALORAMA PARK**

# PHASE I

DATE OF REPORT: June 18, 2012

# **TECHNICAL MEMO 2 - RECOMMENDATIONS**

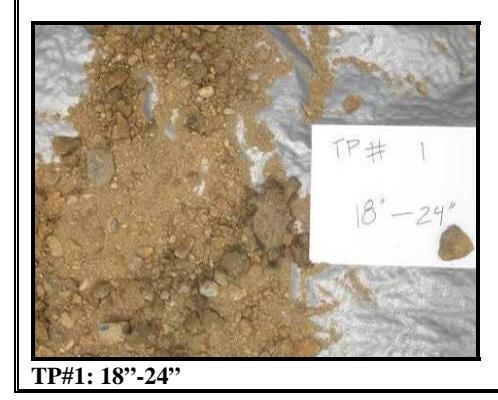
# TP#1: 0"-12"

The top layer of test pit #1 consists of clay like medium that appears to be bonded together. Grass has not established to a satisfactory condition and appears in only small patches. At 6" we encountered a slightly loamy sand mix.

At 12 to 18 inches, we encountered layers of sand and construction debris, such as filter fabric. The filter fabric layer was found at 18" between two layers of sand. The sand layers were 2"-3" thick each.

OBSERVATION	INITIAL RECOMMENDATIONS
See Above.	Remove top 12" of material and provide suitable
	mix.

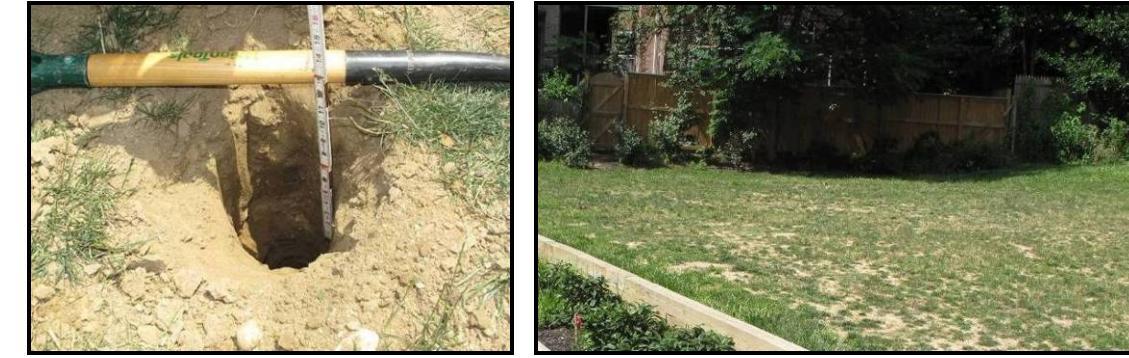
#### TP#2 - Test Pit No. 2:

The top layer of test pit #2 consists of clay like medium that appears to be bonded together. Grass has not established to a satisfactory condition and appears in only small patches. At 6" we encountered a slightly loamy sand mix.

At 12 to 18 inches, we encountered layers of sand and construction debris, such as filter fabric. The filter fabric layer was found at 18" between two

OBSERVATION	INITIAL RECOMMENDATIONS
See Above.	a. Remove top 12" of material and provide
	suitable mix.
	b. Treat with sod or seed.

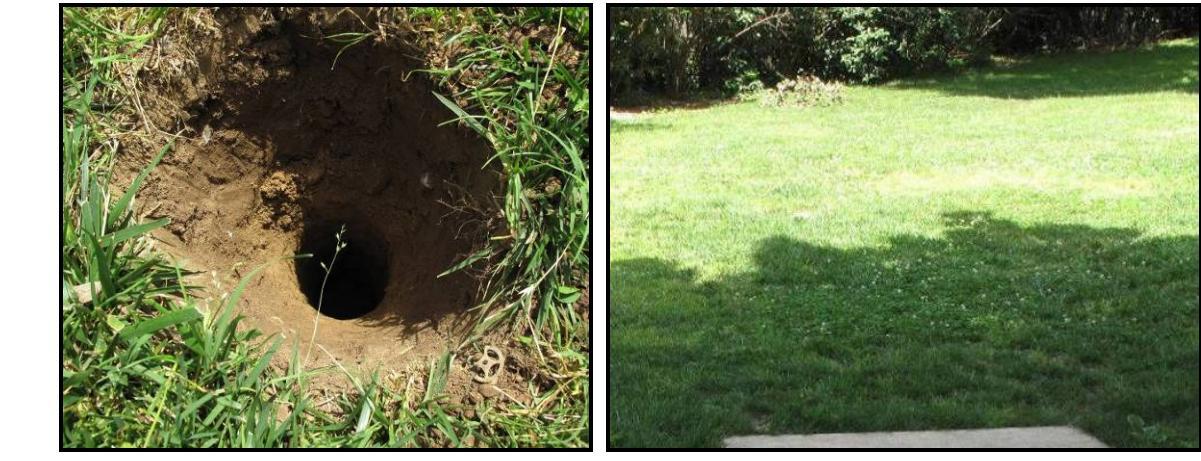
#### TP#3 - Test Pit No. 3:

At 18 to 24 inches we encountered a slightly sandy medium with some small rocks. The soil moisture appeared suitable.

OBSERVATION	INITIAL RECOMMENDATIONS
See Above.	a. Remove top 6" of material and provide
	suitable mix.
	b. Treat with sod or seed.

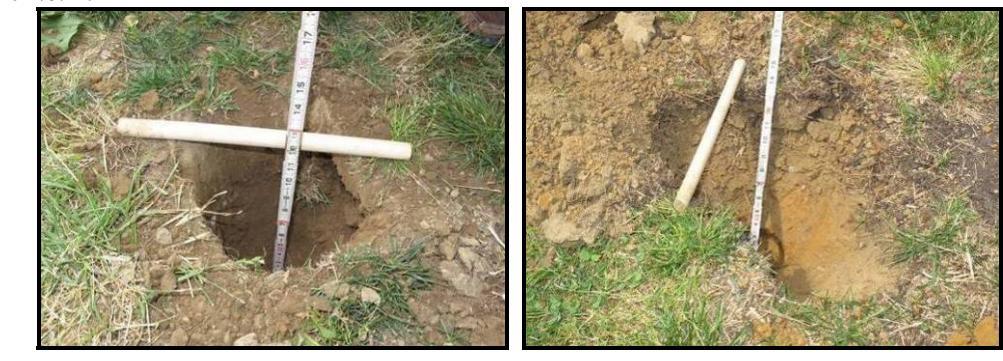
#### TP#4 - Test Pit No. 4:

Review of the construction drawings indicates that this area was a construction entrance during the construction of the site improvements. The stones and the hard subsurface encountered may be the result of improper removal of the construction entrance material.

OBSERVATION	INITIAL RECOMMENDATIONS
See Above.	a. Remove top 36" of material and provide
	suitable mix.
	b. Treat with sod or seed.

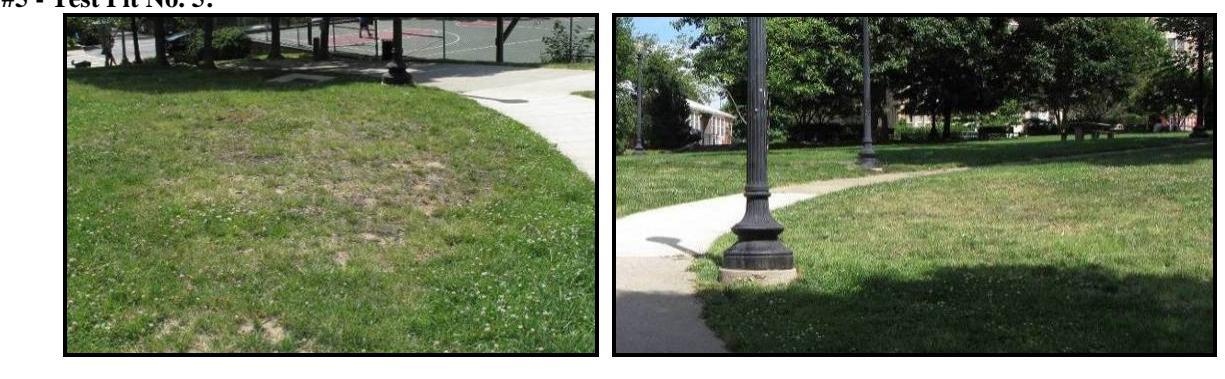
**TP#5: 0"-12"** At 0 to 12 inches we encountered natural soil. Soil appeared to be slightly dryer than expected, but otherwise acceptable.

OBSERVATION	INITIAL RECOMMENDATIONS
See Above.	a. Remove top 6" of material and provide suitable mix

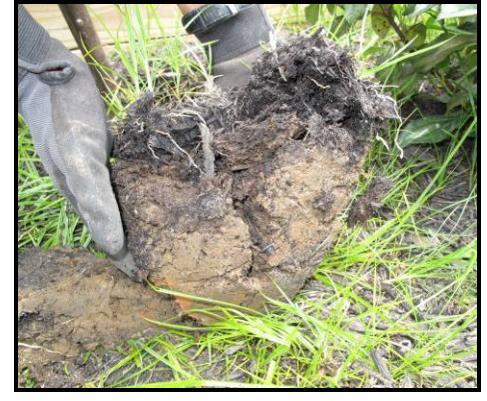
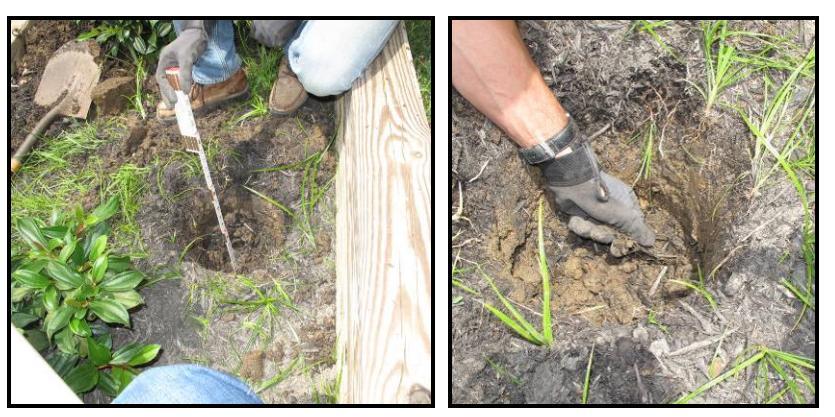
#### **TP#6 - Test Pit at Planting Bed:**

At 0 to 6 inches we encountered a layer of mulch on wet soil. The clay like medium appeared to be inadequate. However, the plants appeared healthy. Roots of shrubs have spread through the planting medium. Weeds are abundant. Roots of weeds remain on the top 1 inch of the planting soil.

At 6 to 12 inches the soil medium was continuously moist with minor construction debris.

OBSERVATION	INITIAL RECOMMENDATIONS
See Above.	Remove weeds (Also see recommendations in
	the Plantings section).

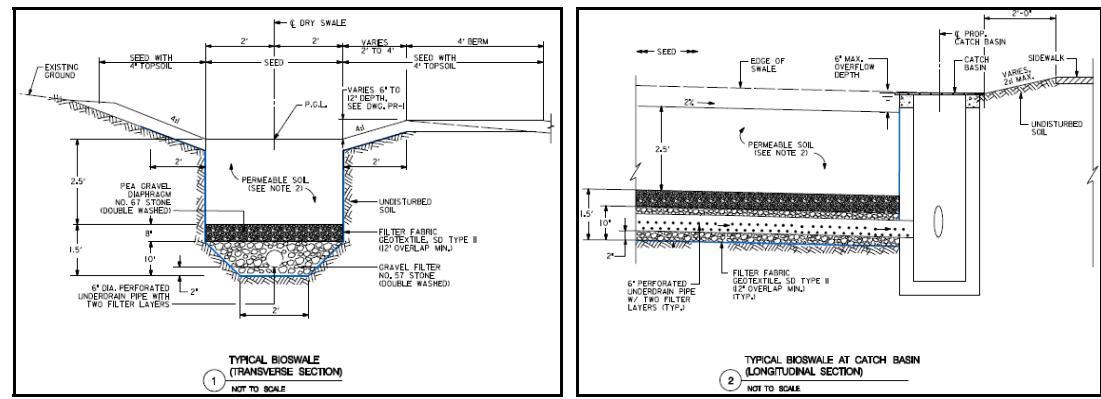
Bioswale details from sheet 8 of the construction drawings, dated 11/6/2009

OBSERVATION	INITIAL RECOMMENDATIONS
• Bioswale appears to be working normally.	a. Prepare bare areas around the catch basin for
• Berm is mostly well covered with lawn. In some area, bare patches	new lawn.
appear.	b. Treat area with seed or sod.
• Soil uphill of the berm appears to be adequate (See TP#3 above).	c. Flush catch basin and cleanout pipes.
• Catch basin at the end of bioswale has standing water. The outfall pipe	
appears to be clogged.

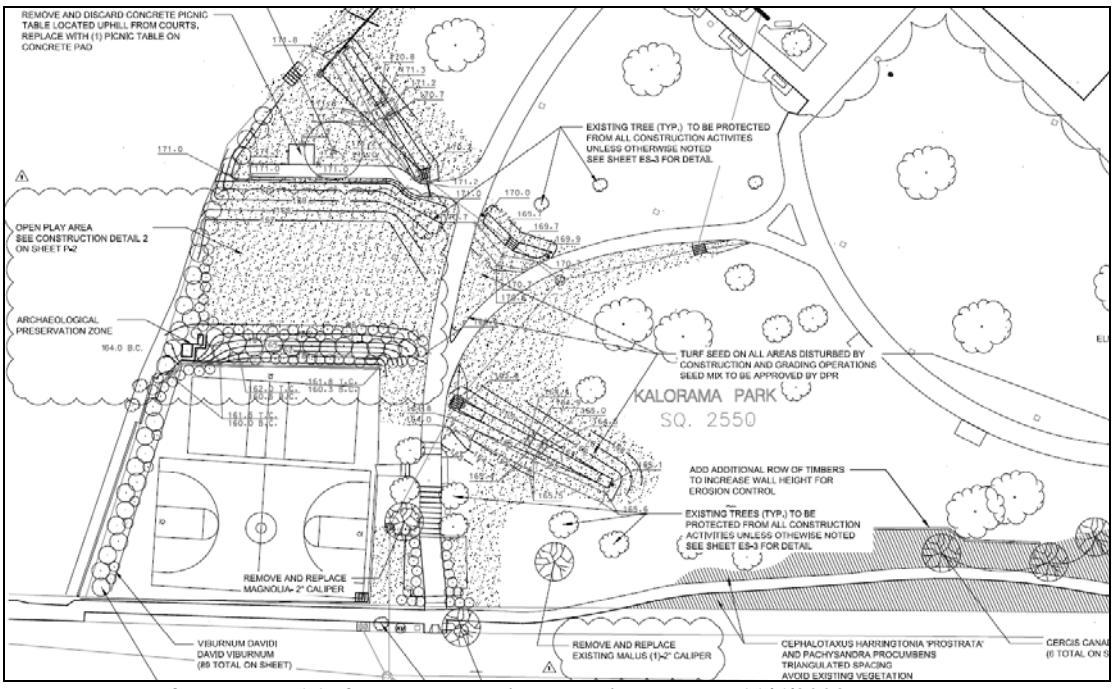
Landscape Plan from sheet 16 of the construction drawings, dated 11/6/2009, Note: Timber retaining wall is not shown

OBSERVATION	INITIAL RECOMMENDATIONS
There are weeds throughout the site.	a. Remove weeds.
