KALORAMA PARK

PHASE I

TECHNICAL MEMO 1 - SITE INVESTIGATION NOTES

TECHNICAL MEMO 2 - RECOMMENDATIONS

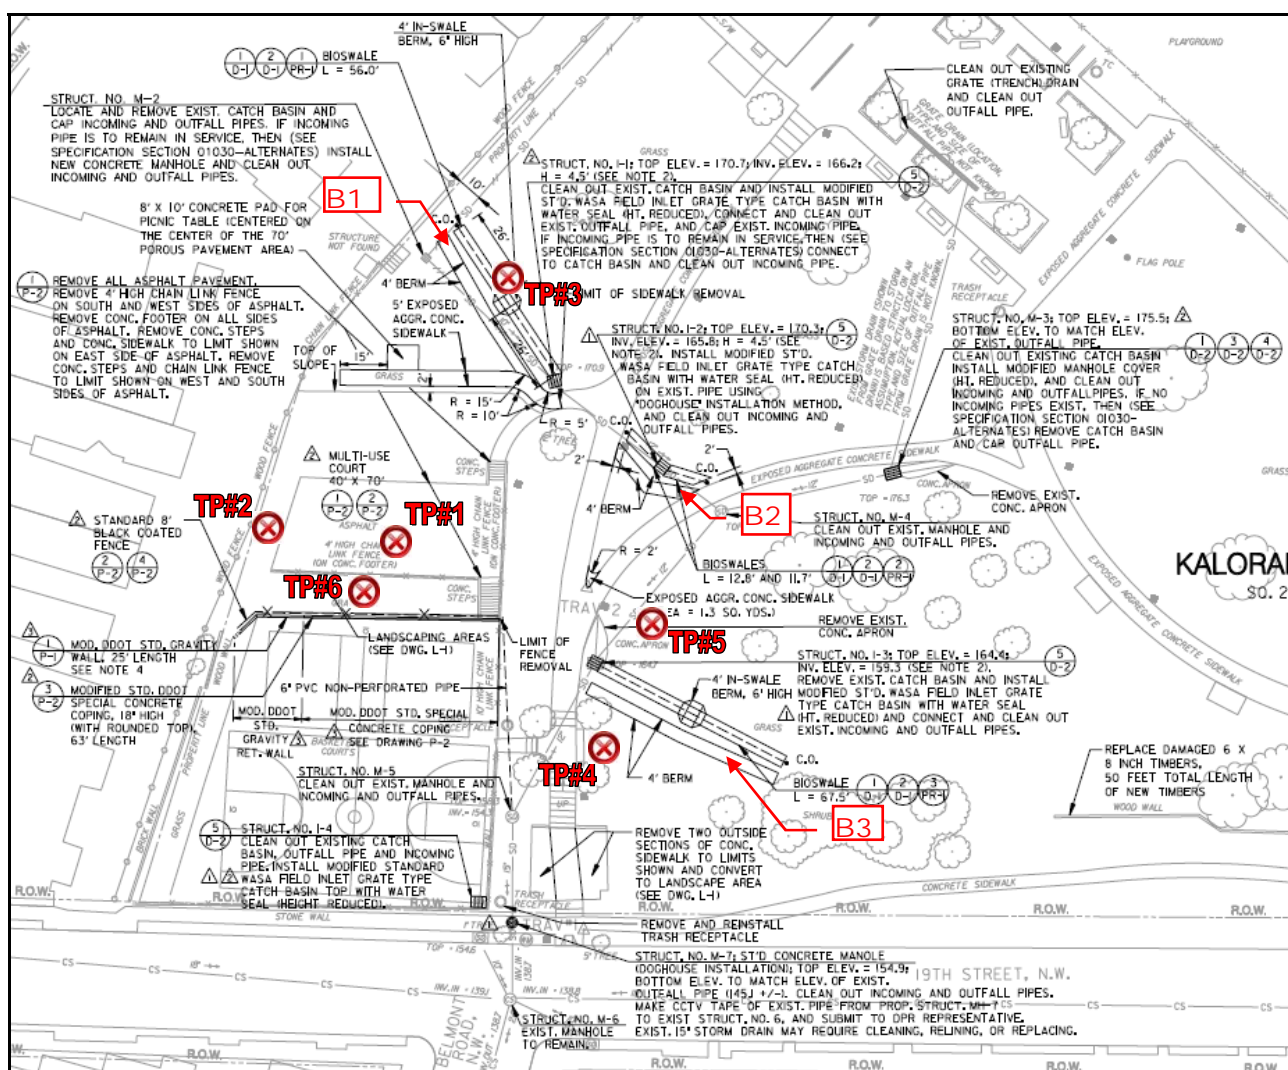
A. Site Plan

Site Plan from sheet 4 of the construction drawings, dated 11/6/2009

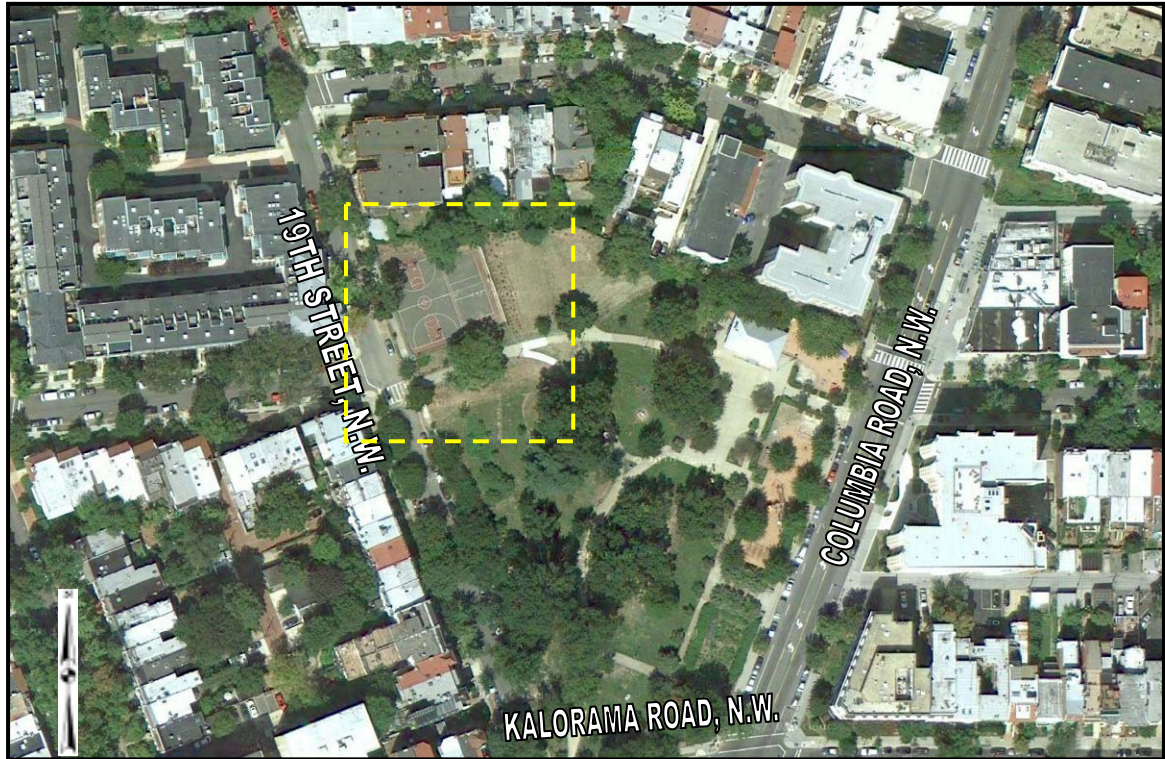
The location for the test pits were determined based on observations during renovation of the park. It is believed that construction procedures used did not comply with the construction drawings, which resulted in construction debris being buried under the lawn areas.

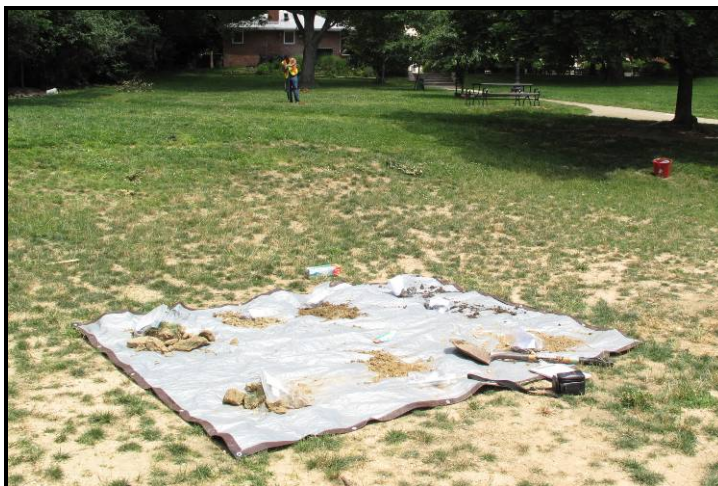
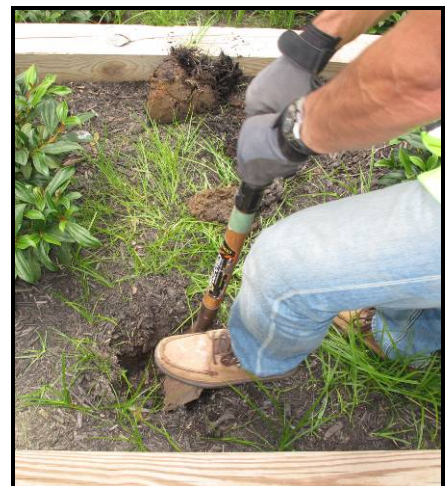
TP#1 - Test Pit No. 1:

The top layer of test pit #1 consists of clay like medium that appears to be bonded together. Grass has not established to a satisfactory condition and appears in only small patches. At 6" we encountered a slightly loamy sand mix.

At 12 to 18 inches, we encountered layers of sand and construction debris, such as filter fabric. The filter fabric layer was found at 18" between two layers of sand. The sand layers were 2"-3" thick each.

OBSERVATION	INITIAL RECOMMENDATIONS
See Above.	Remove top 12" of material and provide suitable mix.

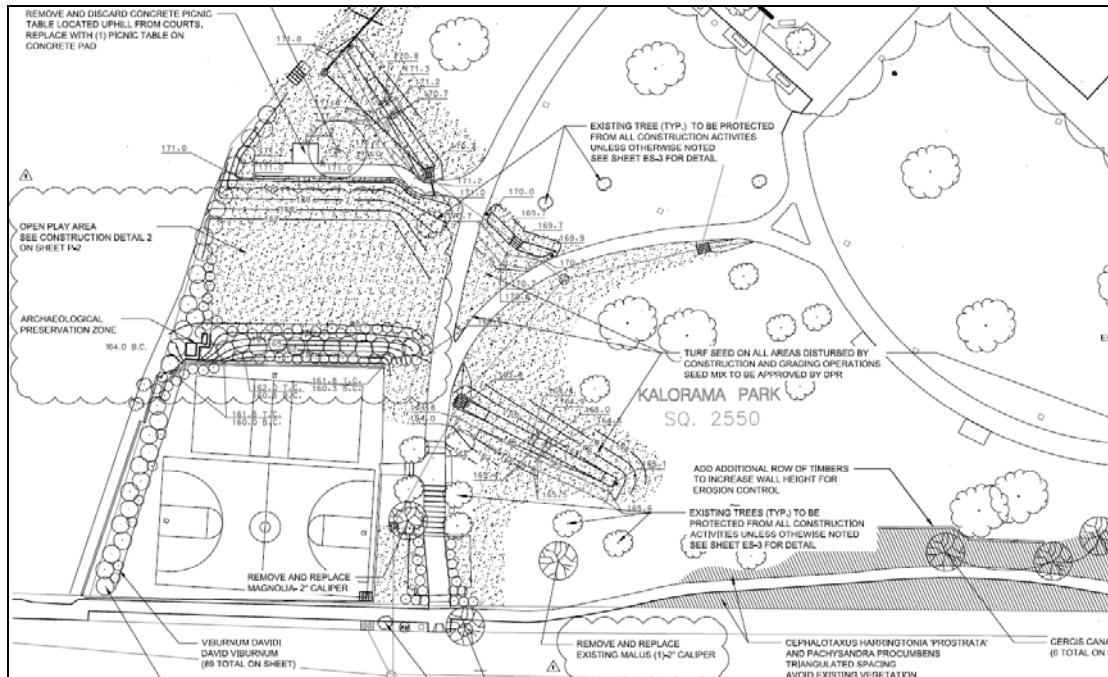
D. Plantings

Landscape Plan from sheet 16 of the construction drawings, dated 11/6/2009,

Note: Timber retaining wall is not shown

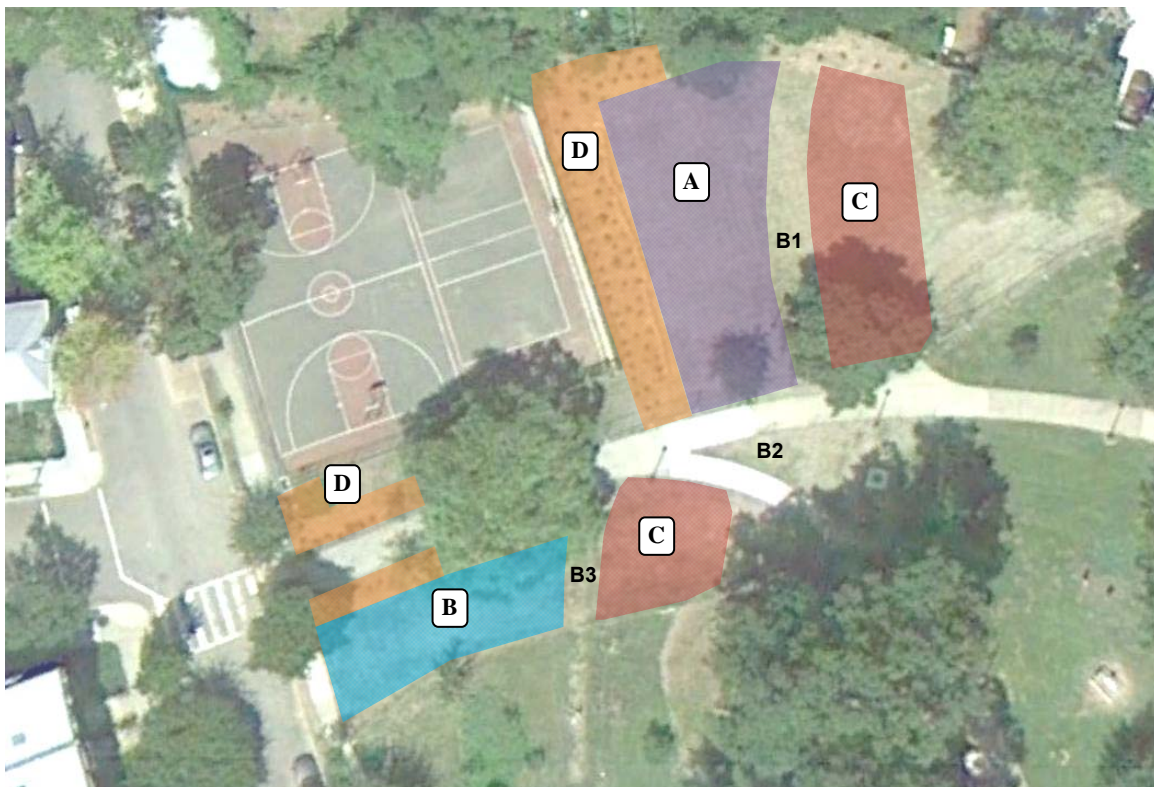
This plan represents the site improvement zones and berms, which are describe in this technical memo. This information will be used to develop biddable plans and specifications for improvements to Kalorama Park.

A. Soil Test Pit Areas 1 and 2 are combined to make up Site Improvements Zone A Test Pit Area #1 (See Technical Memo #1, Site Investigation Notes, For Detailed Information)
