GOVERNMENT OF THE DISTRICT OF COLUMBIA  
DEPARTMENT OF GENERAL SERVICES  
CAPITAL CONSTRUCTION SERVICES

## Earthquake Initiatives – Phase II

### Scope of Work:

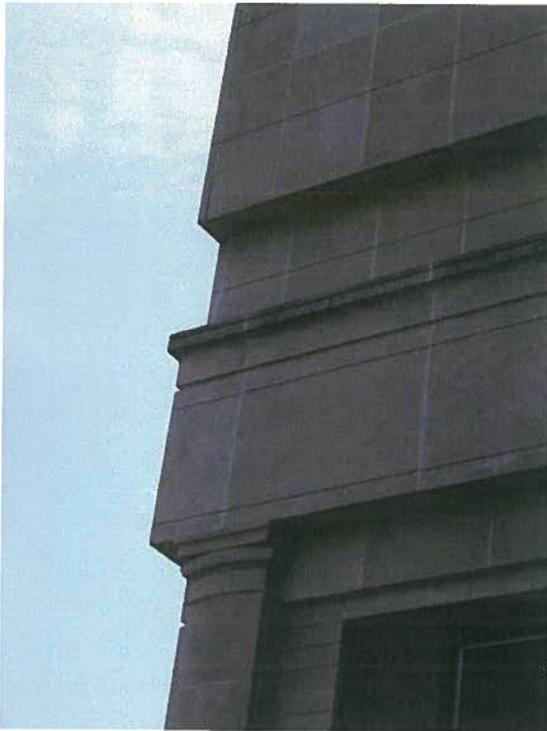
016 item 2.jpg

2. Missing mortar from pre-cast panels of pilaster and damage to edge of pre-cast panel: Re-point with color mortar, scaffolding required for access.

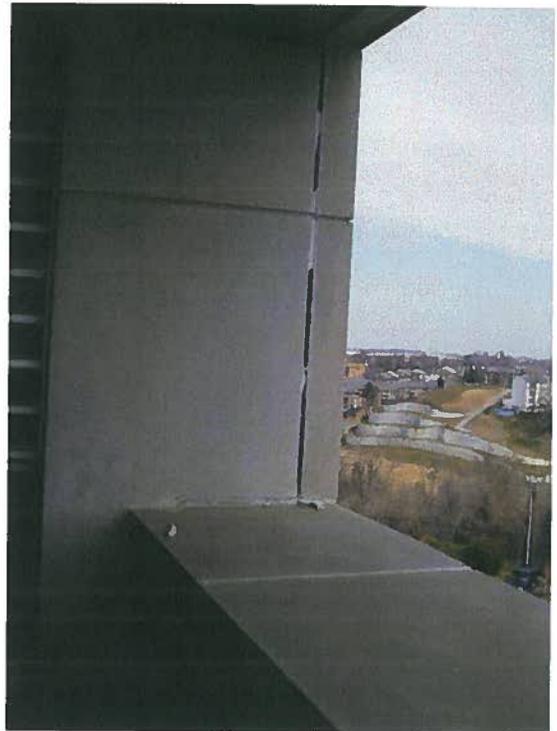
016 item 3.jpg

3. Missing mortar from pre-cast panels of pilaster and at Northeast corner of building: Re-point with color mortar, lift required for access.
4. Missing mortar from pre-cast panels of frieze: Re-point with color mortar, lift required for access.

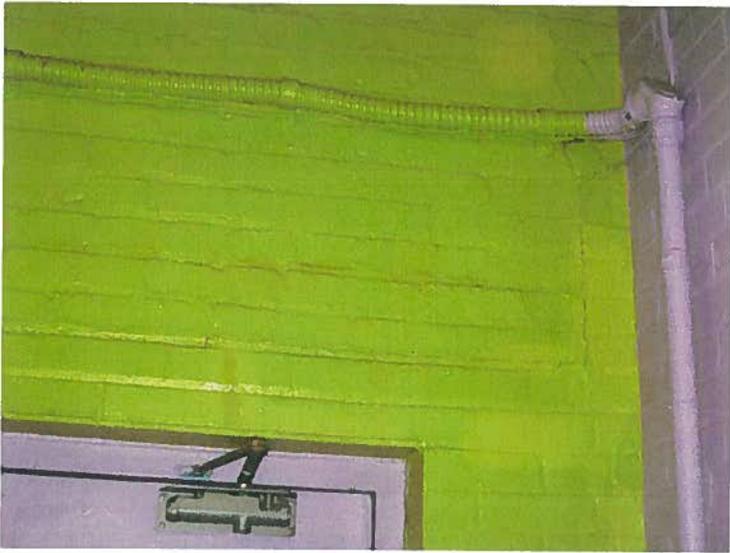
022 Item 2.jpg

1. Cracking at brick mortar joints: Tuck point area.
2. Cracking at brick mortar joints, and displacement: Tuck point area and monitor.

- Item 2: Exterior crack in unpainted brick wall on northeast corner of building. Disturbance of potential hazardous materials not anticipated.
- Item 3: Cracking on interior painted south brick wall in Main Entrance Foyer. Brick wall suspected of being coated with LBP due to construction date (1930s) of building. Extra care during abatement/stabilization may be warranted due to child occupied facility.

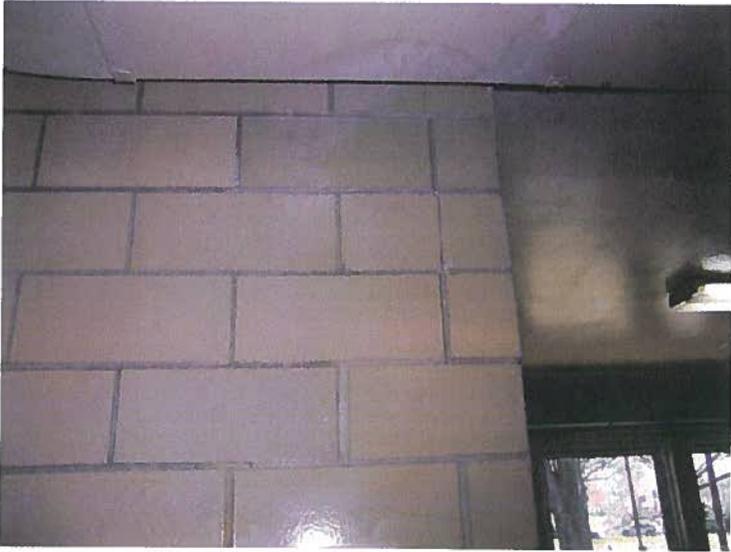
036 item 4.jpg

- Item 4: Cracking of glazed block walls in multiple locations in Main Room. Glazed blocks may be lead-glazed, but no special work practices would be anticipated during repair of cracks.

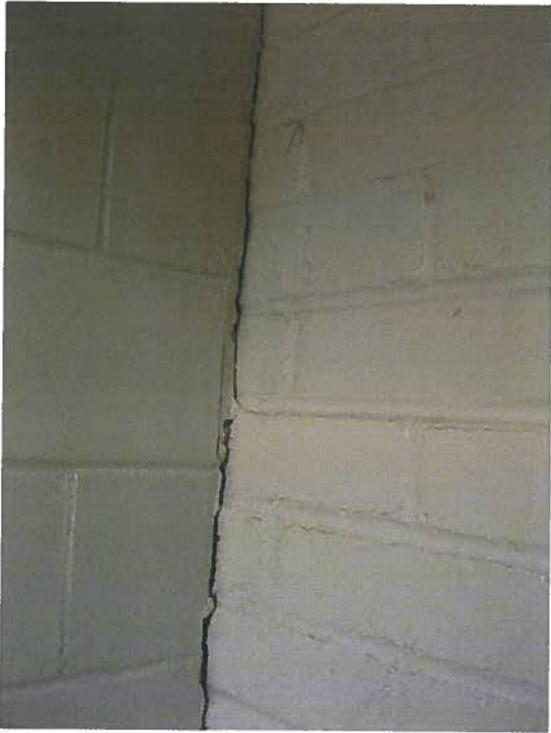
037 - 1.jpg

- Item 1: Separation at painted wall construction joint in Men's Bathroom. Painted walls suspected of being coated with LBP due to estimated construction date (pre-1978) of building. Caulk at construction joint would be presumed to be ACM due to estimated construction date of the building. Uneven settling of ceramic floor also noted. Ceramic floor tiles may be lead-glazed, but no special work practices would be anticipated during repair of floor.
- Item 2: Separation at unpainted brick wall construction joint on exterior of building. Caulk at construction joint would be presumed to be ACM due to estimated construction date of the building.
- Item 3: Stair crack on unpainted, exterior brick wall. No hazardous materials would be anticipated to be disturbed during repair of this item.

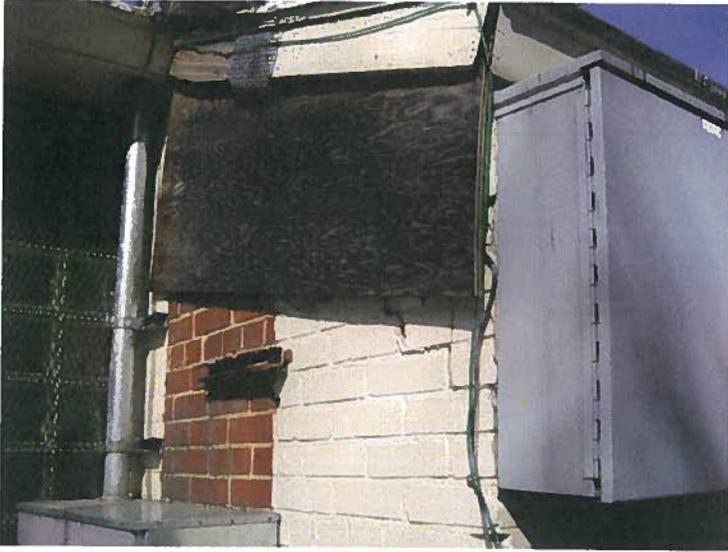
038 - 3.jpg

- Items 1, 2, and 3: Cracking of exterior painted brick walls in multiple areas. Damage is most likely pre-existing/non-EQ. Painted brick walls suspected of being coated with LBP due to estimated construction date (pre-1978) of building.
- Item 4: Separation between painted gypsum wallboards and painted wood panels ceilings. Damage is difficult to observe and may be pre-existing. Painted walls and ceiling suspected of being coated with LBP due to estimated construction date (pre-1978) of building.

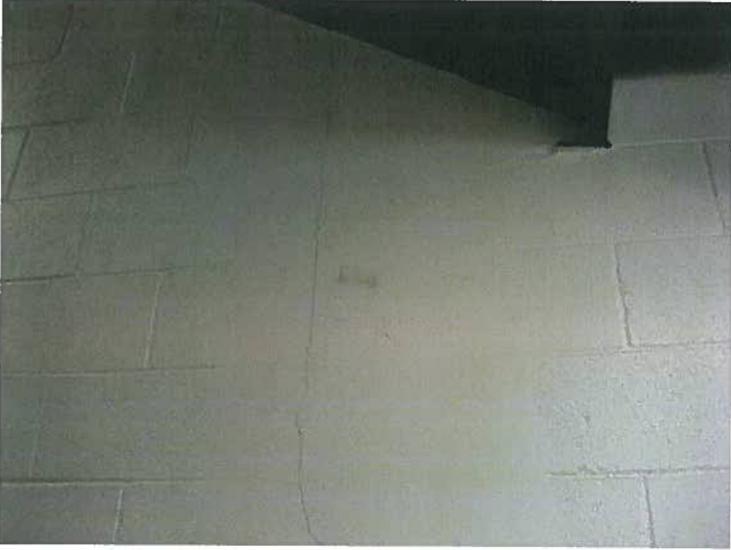
044-1.jpg

- Items 1 through 6: Damage to painted CMU walls in East and South Stairwells. No hazardous materials are anticipated due to recent construction dates (1991, 1996) of building.

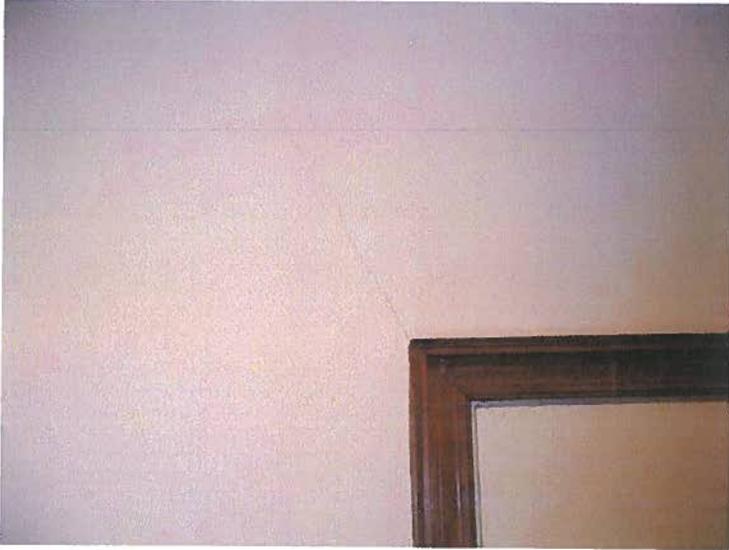
059 item 1.jpg

- Items 1, 2, and 3: Cracking of painted plaster walls/ceiling with separation of painted plaster walls and painted wood window casings in select areas. Some EQ damages have already been repaired by DGS. Painted surfaces likely coated with LBP due to construction date (1938) of building.
- Item 4: Severe deterioration of painted surfaces observed in Room NB-3C Sprinkler Room in Basement Level Payroll Office. No EQ damage noted. LBP likely present and should be stabilized and delaminated paint should be cleaned up.
- Items 5 and 6: Exterior cracking on unpainted bricks on east façade of building. LBP likely present on window exteriors, but is not anticipated to be disturbed during repairs.

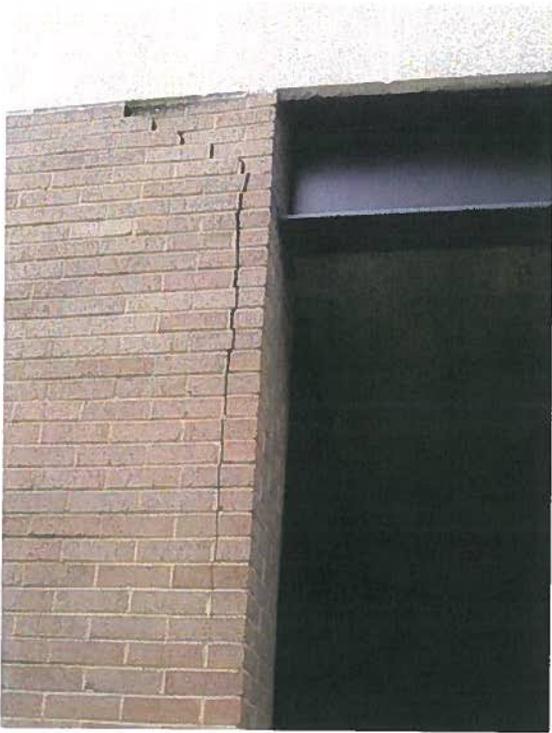
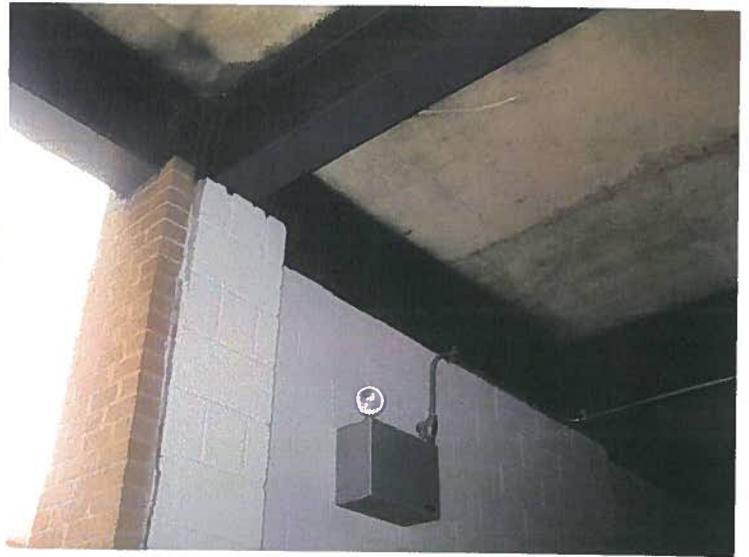
- Item 1: Cracking in exterior, unpainted brick on parking garage column. No hazardous materials anticipated to be disturbed by repairs.

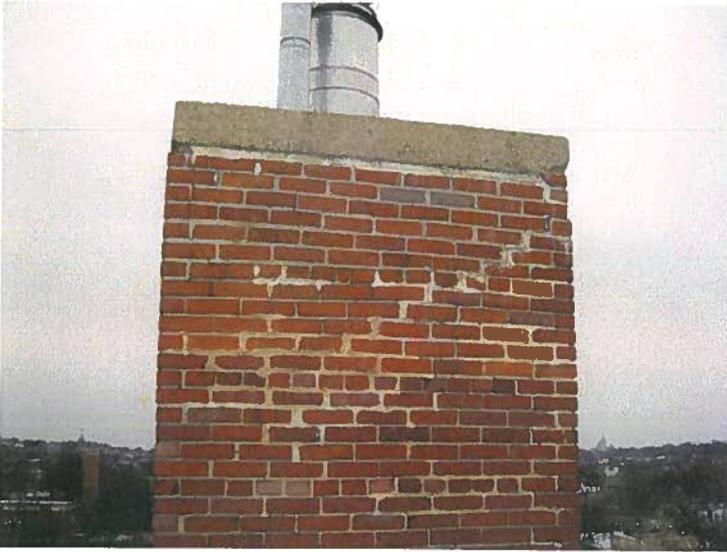
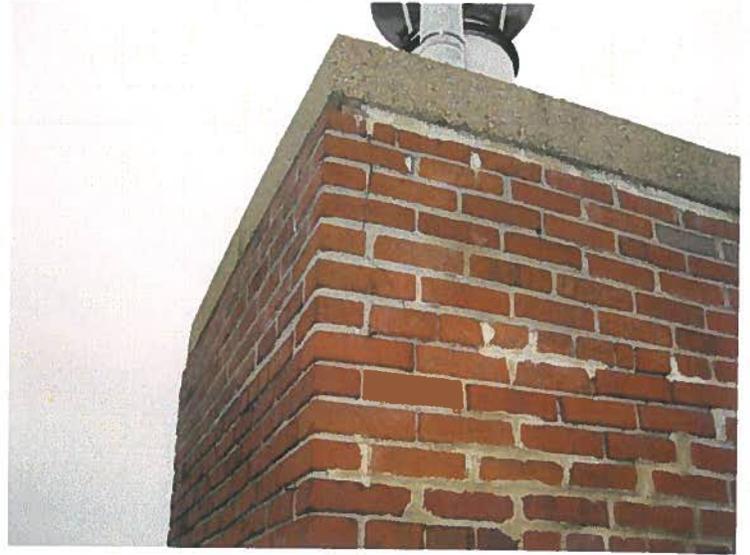
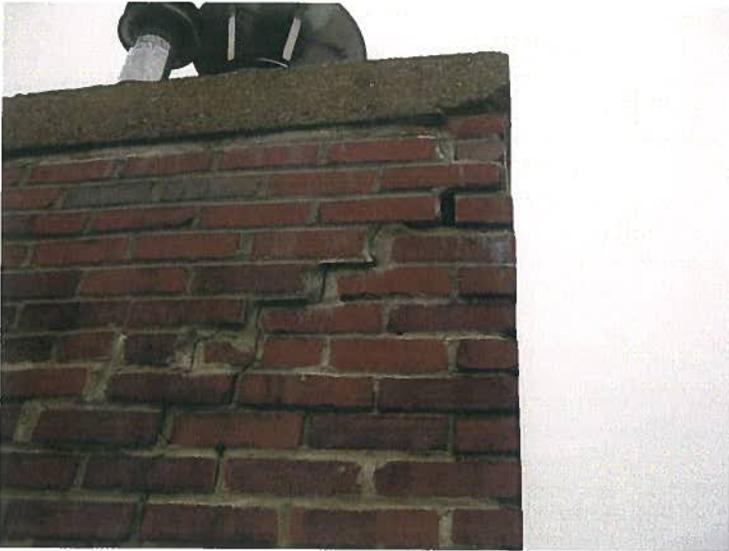
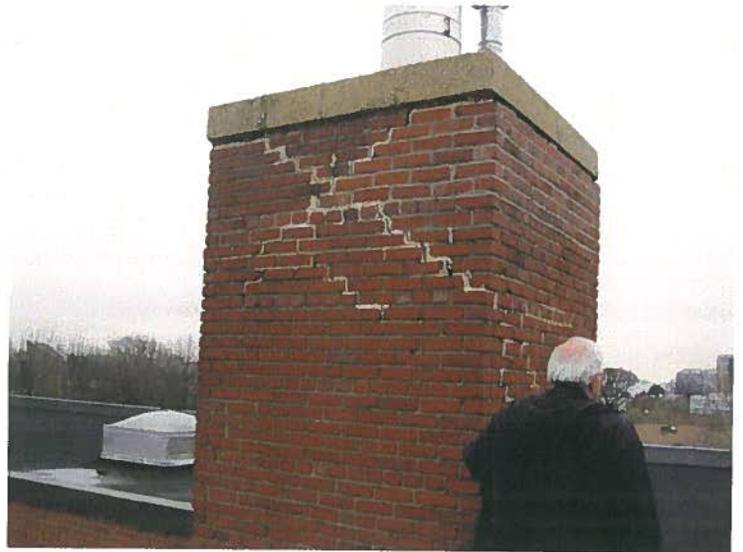
- Item 1: Cracked, unpainted brick on rooftop. Likely pre-existing condition worsened by EG. No hazardous materials anticipated to be disturbed during repairs.
- Item 2: Repairs to exterior fence on 2<sup>nd</sup> floor rooftop have been completed. No hazardous materials anticipated to be disturbed.

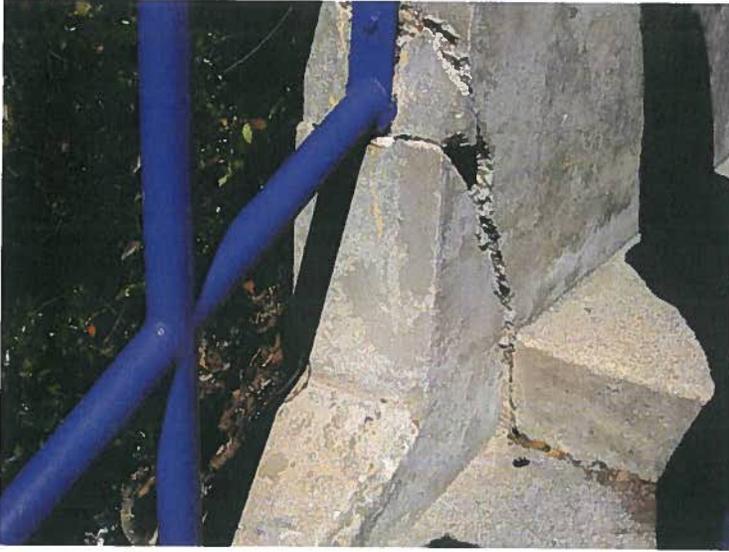
071-a.JPG

1. Cracks and spalls: Non-structural patching needed.

- Item 1: Damage to exterior concrete stairs. No hazardous materials anticipated to be disturbed. LBP is presumed to be on painted metal railings, but is not anticipated to be disturbed during repairs.
- MPD ERT is also located at this address, but no damage was reported and building was not inspected.

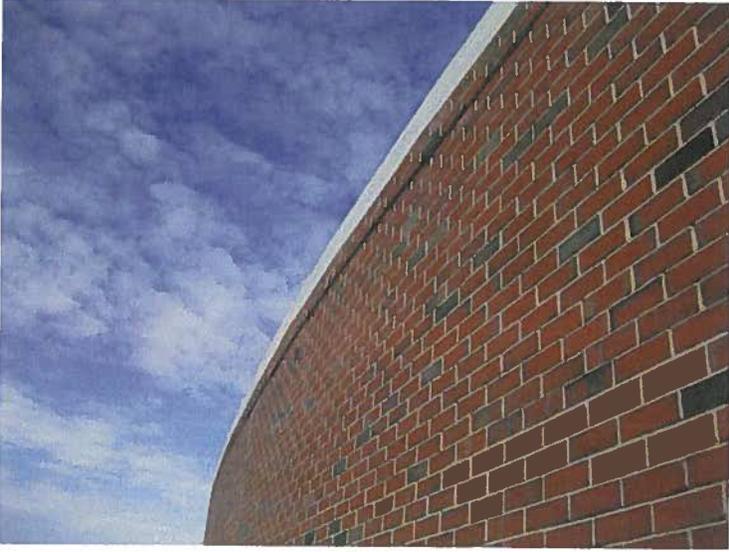
072 item 1.JPG

1. The top two courses of brick and the cast stone coping have, in two locations, shifted westward a maximum of a half inch. The shift accurately follows the mortar joint below the two top brick courses. There are weep holes immediately above the shift line, but the shift line is a solid mortar joint, not a flashed joint, as would be anticipated below weep holes. Investigation is advised and as-built drawings would be helpful. It is not clear what extent of repair is warranted.

- Item 1: Damage to unpainted brick, exterior parapet wall. No hazardous materials were observed during this site visit, nor would not be anticipated due to recent construction date (2008) of building.

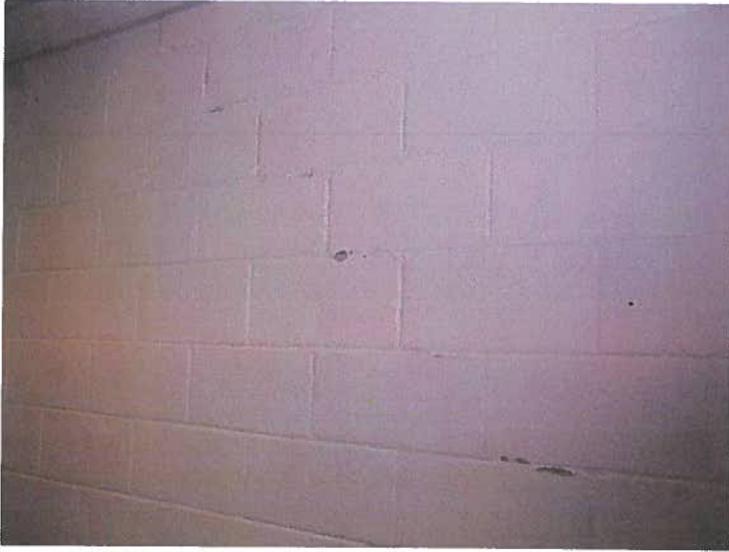
073 item 1.jpg

1. Step crack in CMU wall outside Dance Room and vertical crack in west CMU wall, potential for LBP and ACM see HAZMAT: Tuck point, caulk and re-paint.

- Items 1 through 5: Cracking of painted CMU walls and separation of painted CMU wall construction joints at multiple interior building locations. Painted CMU walls suspected of being coated with LBP and caulk at construction joints are presumed ACMs due to construction date (1969) of building.

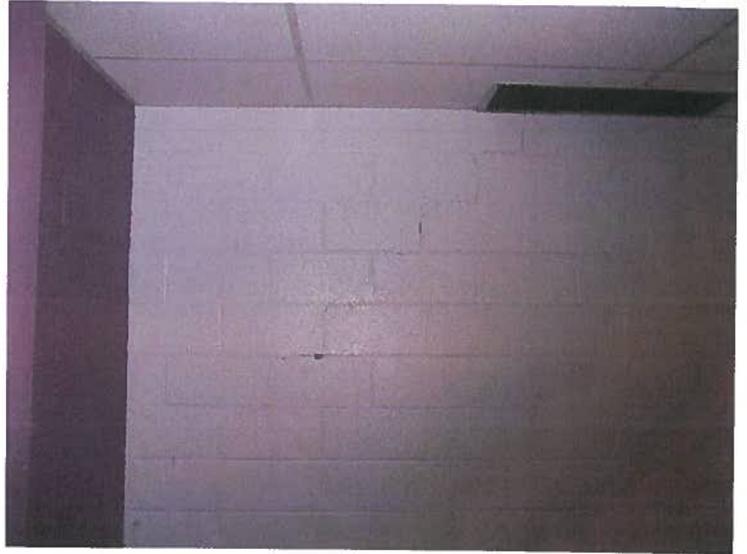
073 item 2.jpg

2. Step crack in west CMU wall potential for LBP see HAZMAT: Tuck point and re-paint.

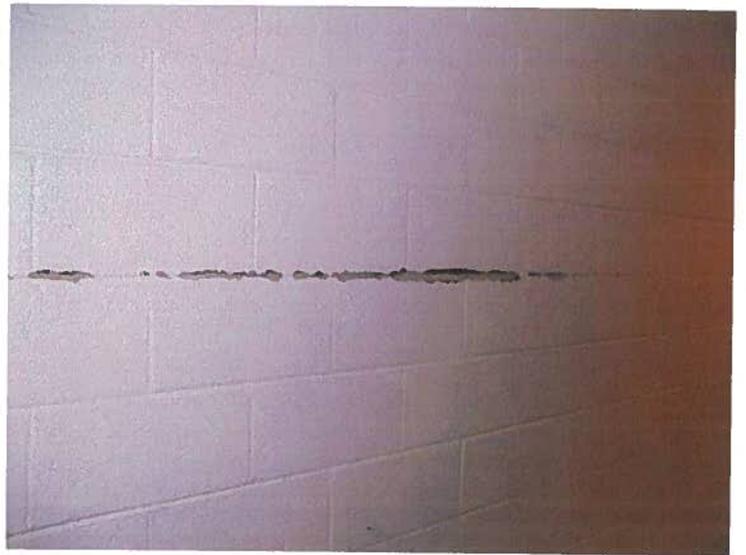
073 item 3.jpg

3. Horizontal crack in east CMU wall and vertical crack in east CMU wall at water fountain, potential for LBP and ACM see HAZMAT: Tuck point, caulk & re-paint

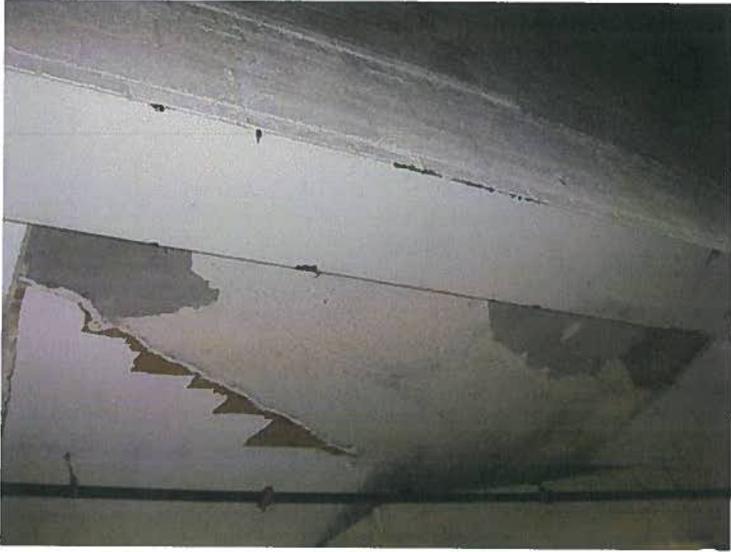
074-3.JPG

1. Crack in drywall: Patch & re-paint.
2. Crack in Drywall: Patch & re-paint.
3. Portion of drywall ceiling detached / missing: Repair and re-paint.

- Items 1 and 2: Cracks on painted drywall wall in 1<sup>st</sup> Floor Hallway, between Room 117/Men's locker Room and Room 120/Blood Drying Room. Age of building is unknown, but was reportedly renovated in 2001. LBP not anticipated being present due to recent renovation.
- Item 3: Damage to unpainted drywall panel attached to concrete slab substrate ceiling at entryway to Garage. No suspect hazardous materials associated with drywall panel was noted, however, paint/coating was observed below drywall on concrete slab. If this paint/coating is paint it would be suspect LBP, or if this is a coating/mastic it would be a suspect ACM.

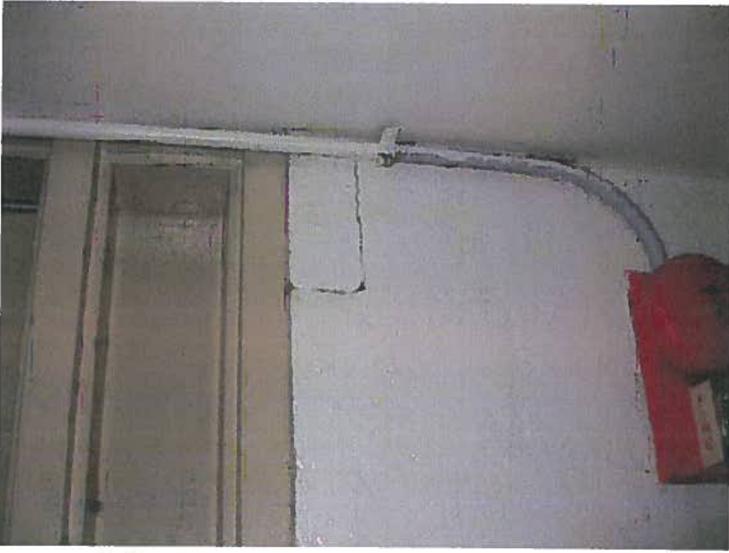
075 item 1.jpg

- Item 1: Separation at interior and exterior door frame and wall interfaces on Main Entrance door. Painted interior and exterior walls, as well as painted door components, suspected of being coated with LBP due to estimated construction date (pre-1978) of building. Caulk at interior and exterior interfaces would be presumed to be ACM due to estimated construction date of the building. VFT/mastic (presumed ACMs) and vinyl cove base/mastic (presumed ACMs) were observed in interior of building, but are not anticipated to be disturbed during repairs.

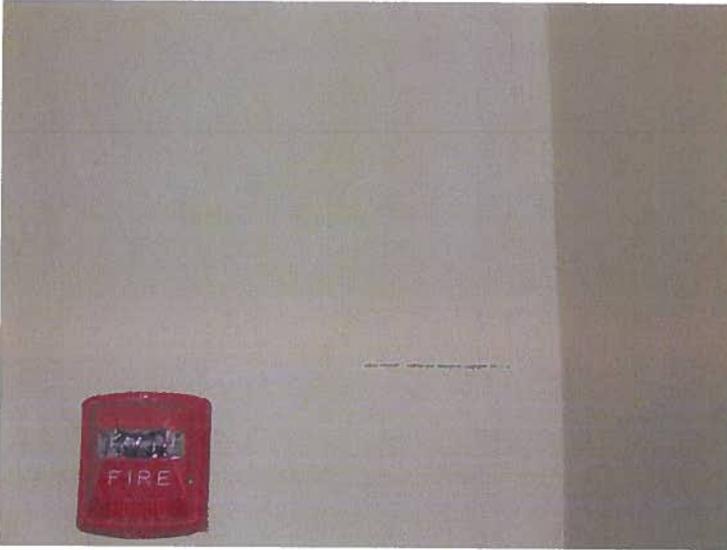
077 item 1.jpg

| 3 <sup>rd</sup> Floor Conference Room | 1. Southeast & southwest wall cracks & ceiling crack: Spackle & re-paint. |

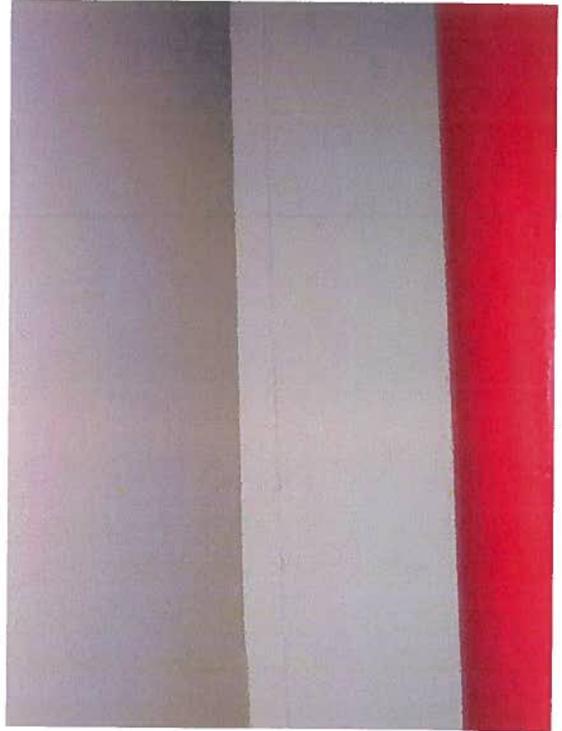
077 item 2.jpg

| North Stair, 3 <sup>rd</sup> floor, north wall | 2. West corner: crack: Spackle & re-paint. |

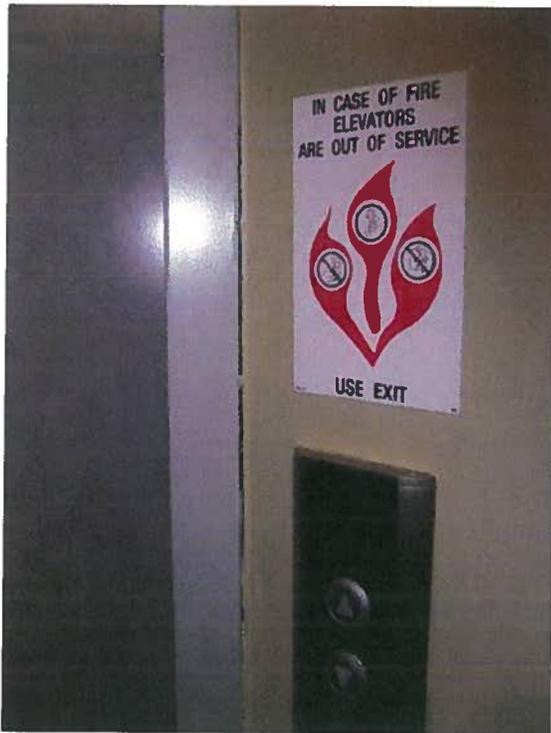
077 item 5.jpg

| 2 <sup>nd</sup> Floor Corridor | 5. Elevator door jamb: Caulk & re-paint separation between frame & wall. Door to Room 201: Crack above frame: Spackle & re-paint. |

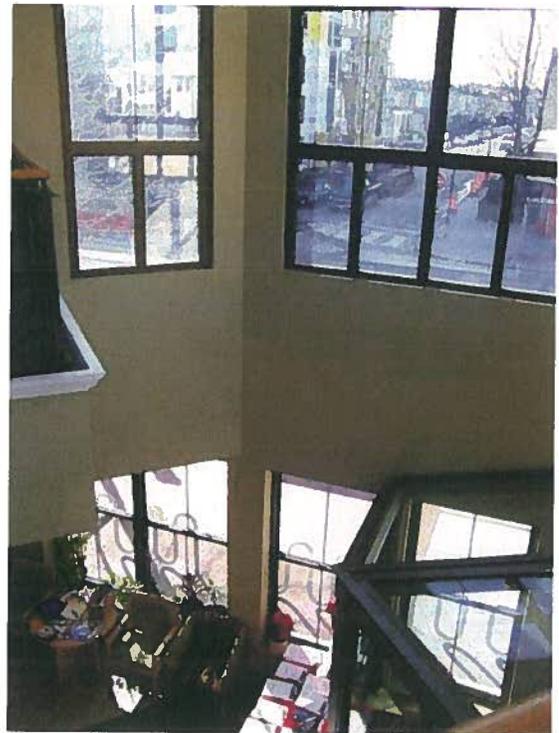
077 item 4.jpg

| 2 <sup>nd</sup> Floor Atrium | 4. Cracks: Between bases of windows (north & west) and at southeast wall: Spackle & re-paint, scaffolding required for access. |

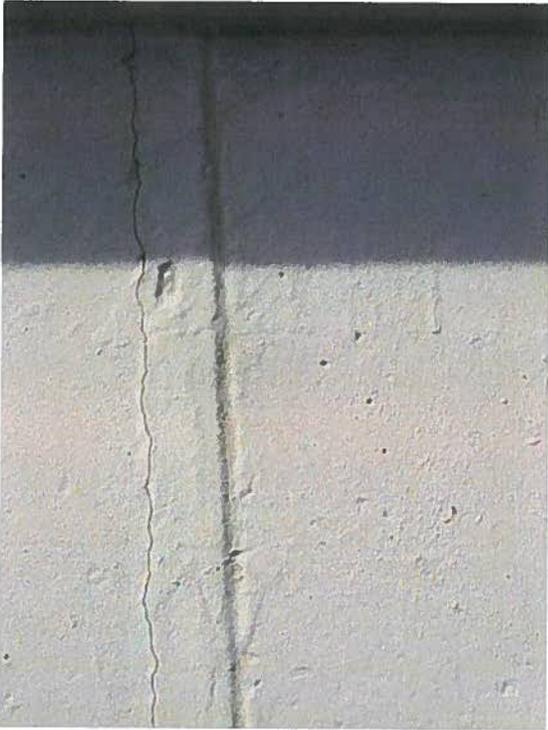
079 item 1.jpg

1. Vertical cracking at CMU corner and at joint between concrete and CMU, potential for LBP see HAZMAT: Grind and install flexible sealant.

- Items 1, 2, 3, and 4: Exterior cracking on painted CMU and concrete walls. Walls suspected of being coated with LBP due to construction date (1967) of building. It should be noted that suspected asbestos-containing Transite boards were observed along roof edge/soffit. This material was observed to be damaged in a few locations, but is not anticipated to be disturbed during exterior EQ repairs.
- Item 5: Separation of vertical seams along metal door frames/casings and brick walls throughout interior of building. Metal door frames/casings are coated with suspect LBP, but are not anticipated to be disturbed during repairs (i.e. expanding foam and caulk.)
- Item 6: Cracking along joint compound seam on plywood ceiling seams not likely EQ damage. JC associated with plywood ceiling seams is suspect ACM.

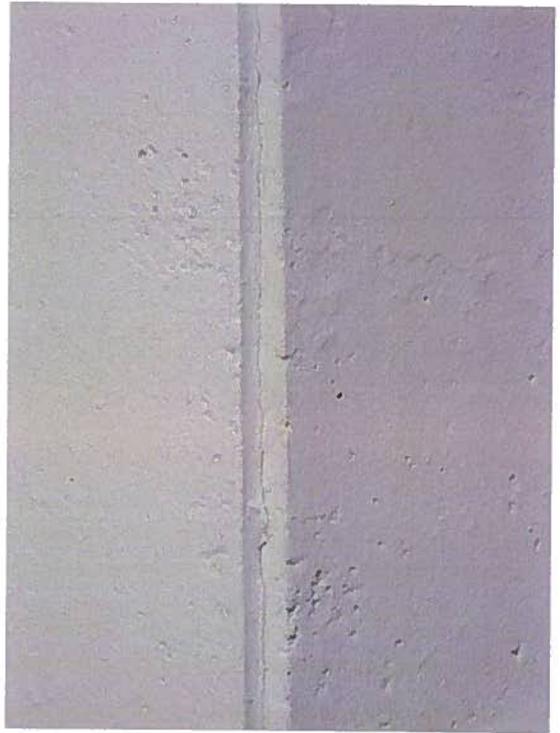
079 item 3.jpg

3. Vertical cracking at CMU, corner potential for LBP see HAZMAT: Grind and install flexible sealant, re-paint.

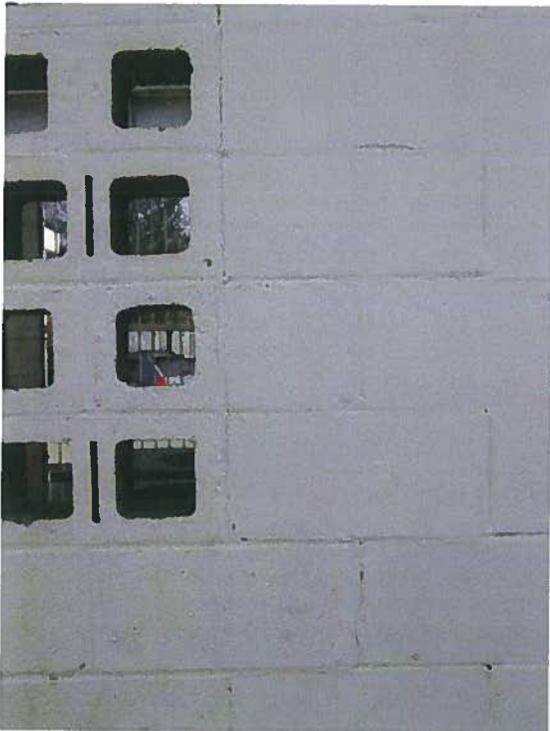
079 item 2.jpg

2. Cracking at mortar joints of CMU, potential for LBP see HAZMAT: Tuck point and paint.

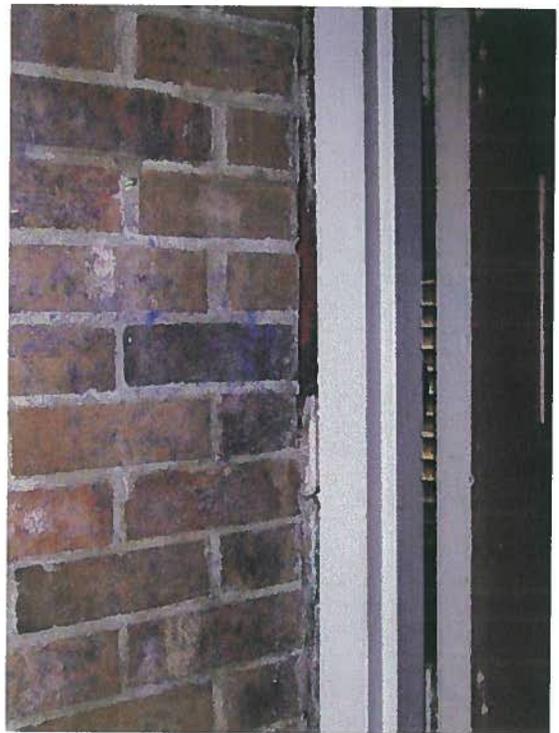
079 item 5.jpg

5. Mortar between brick and metal door frame is missing, determined to not be earthquake related. Potential for LBP adjacent to work area, see HAZMAT: Remove loose material, install expanding foam to provide backing, and install caulking.

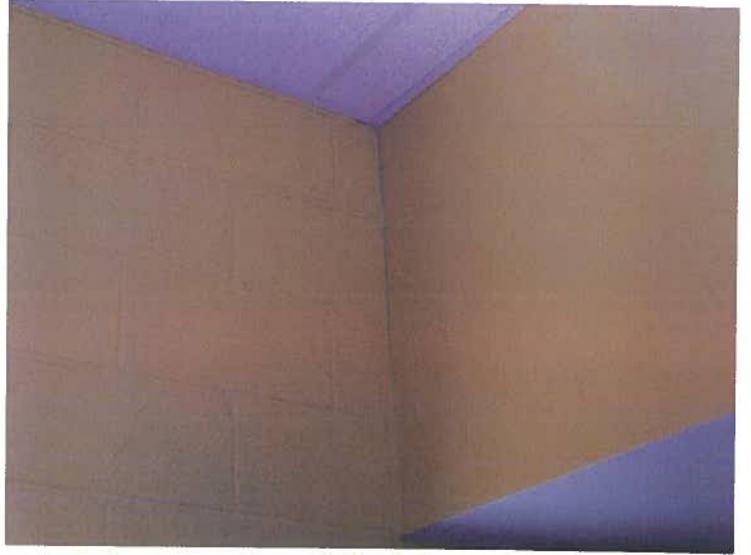
083 item 2.jpg

2. Gaps between gypsum fascia and south CMU wall: Caulk & re-paint. Cracks in gypsum soffits: Spackle & re-paint.

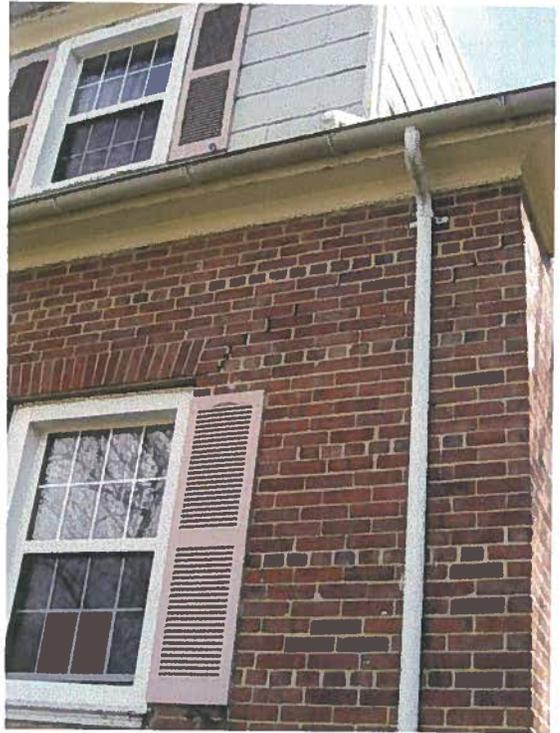
086-12.JPG

- Item 12: Damage to unpainted brick on SW and SE exterior of building. Suspect LBP on windows and suspect ACM shingles observed on 2<sup>nd</sup> Floor SW corner bump out. These materials are not anticipated to be disturbed by exterior repairs.

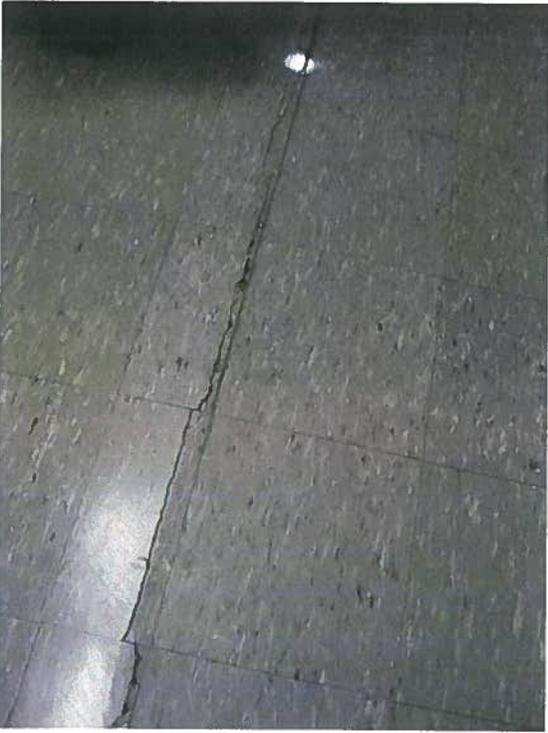
087-1.JPG

- Item 1: Damage to floor in 5<sup>th</sup> Floor/Attic Level Elevator Lobby. Pre-existing condition possibly worsened by EQ. Cracked/delaminated VFT and associated mastic is presumed ACM.
