MASTER PLAN: CONCEPT SUBMISSION ONE

EASTERN MARKET METRO PARK WASHINGTON, D.C. - EXISTING CONDITIONS ANALYSIS

PN 2018043 | 11.20.2018 | DEPARTMENT OF GENERAL SERVICES + DEPARTMENT OF PARKS AND RECREATION

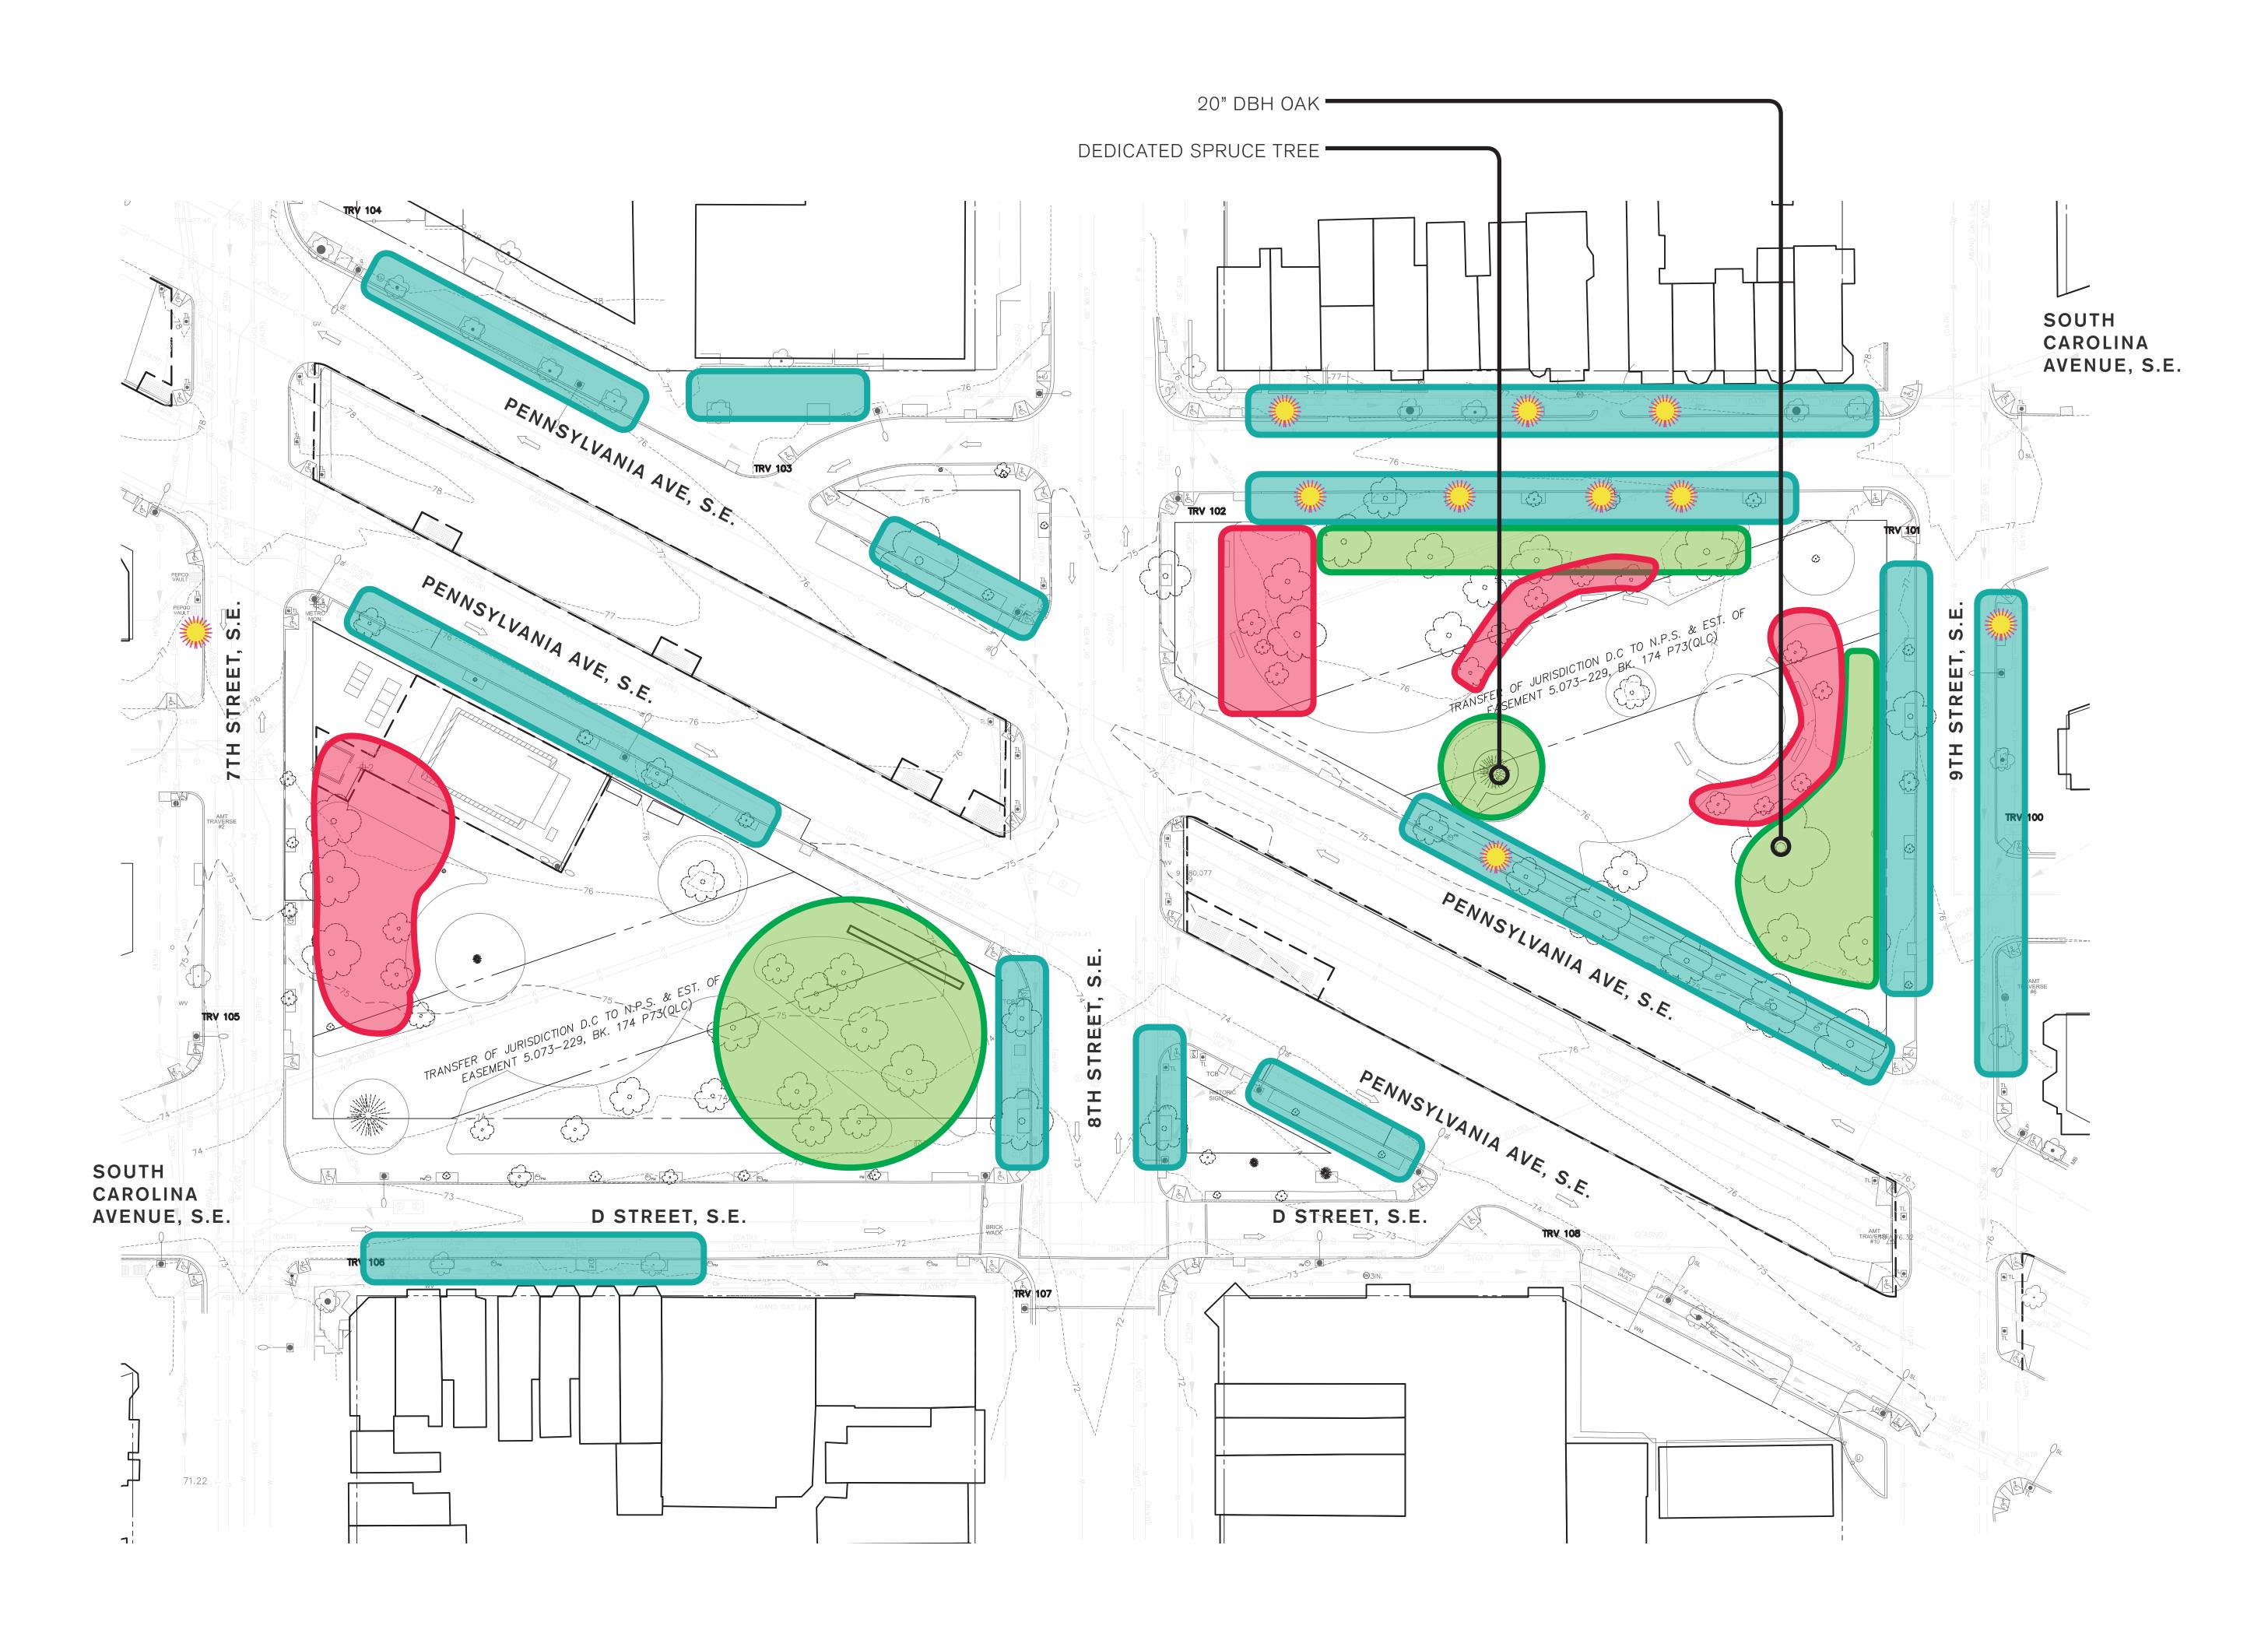
TREES + CANOPY

The park's streetscape trees provide good edges to the spaces and with a few exceptions should be saved where in good health. Consideration should be given to opening the view to the Library for a stronger connection. Ornamental trees interior to the site, predominately crab apples, are less desirable as they block visibility through the space. However, several other interior trees including shade trees and an evergreen tree dedicated to the founding president of the Capitol Hill BID, may be saved.

Potential Tree Saves

Existing Street Trees Create Significant Edges

Street Tree Planting Opportunity

Low Branching Ornamental Trees Create Visual Barrier

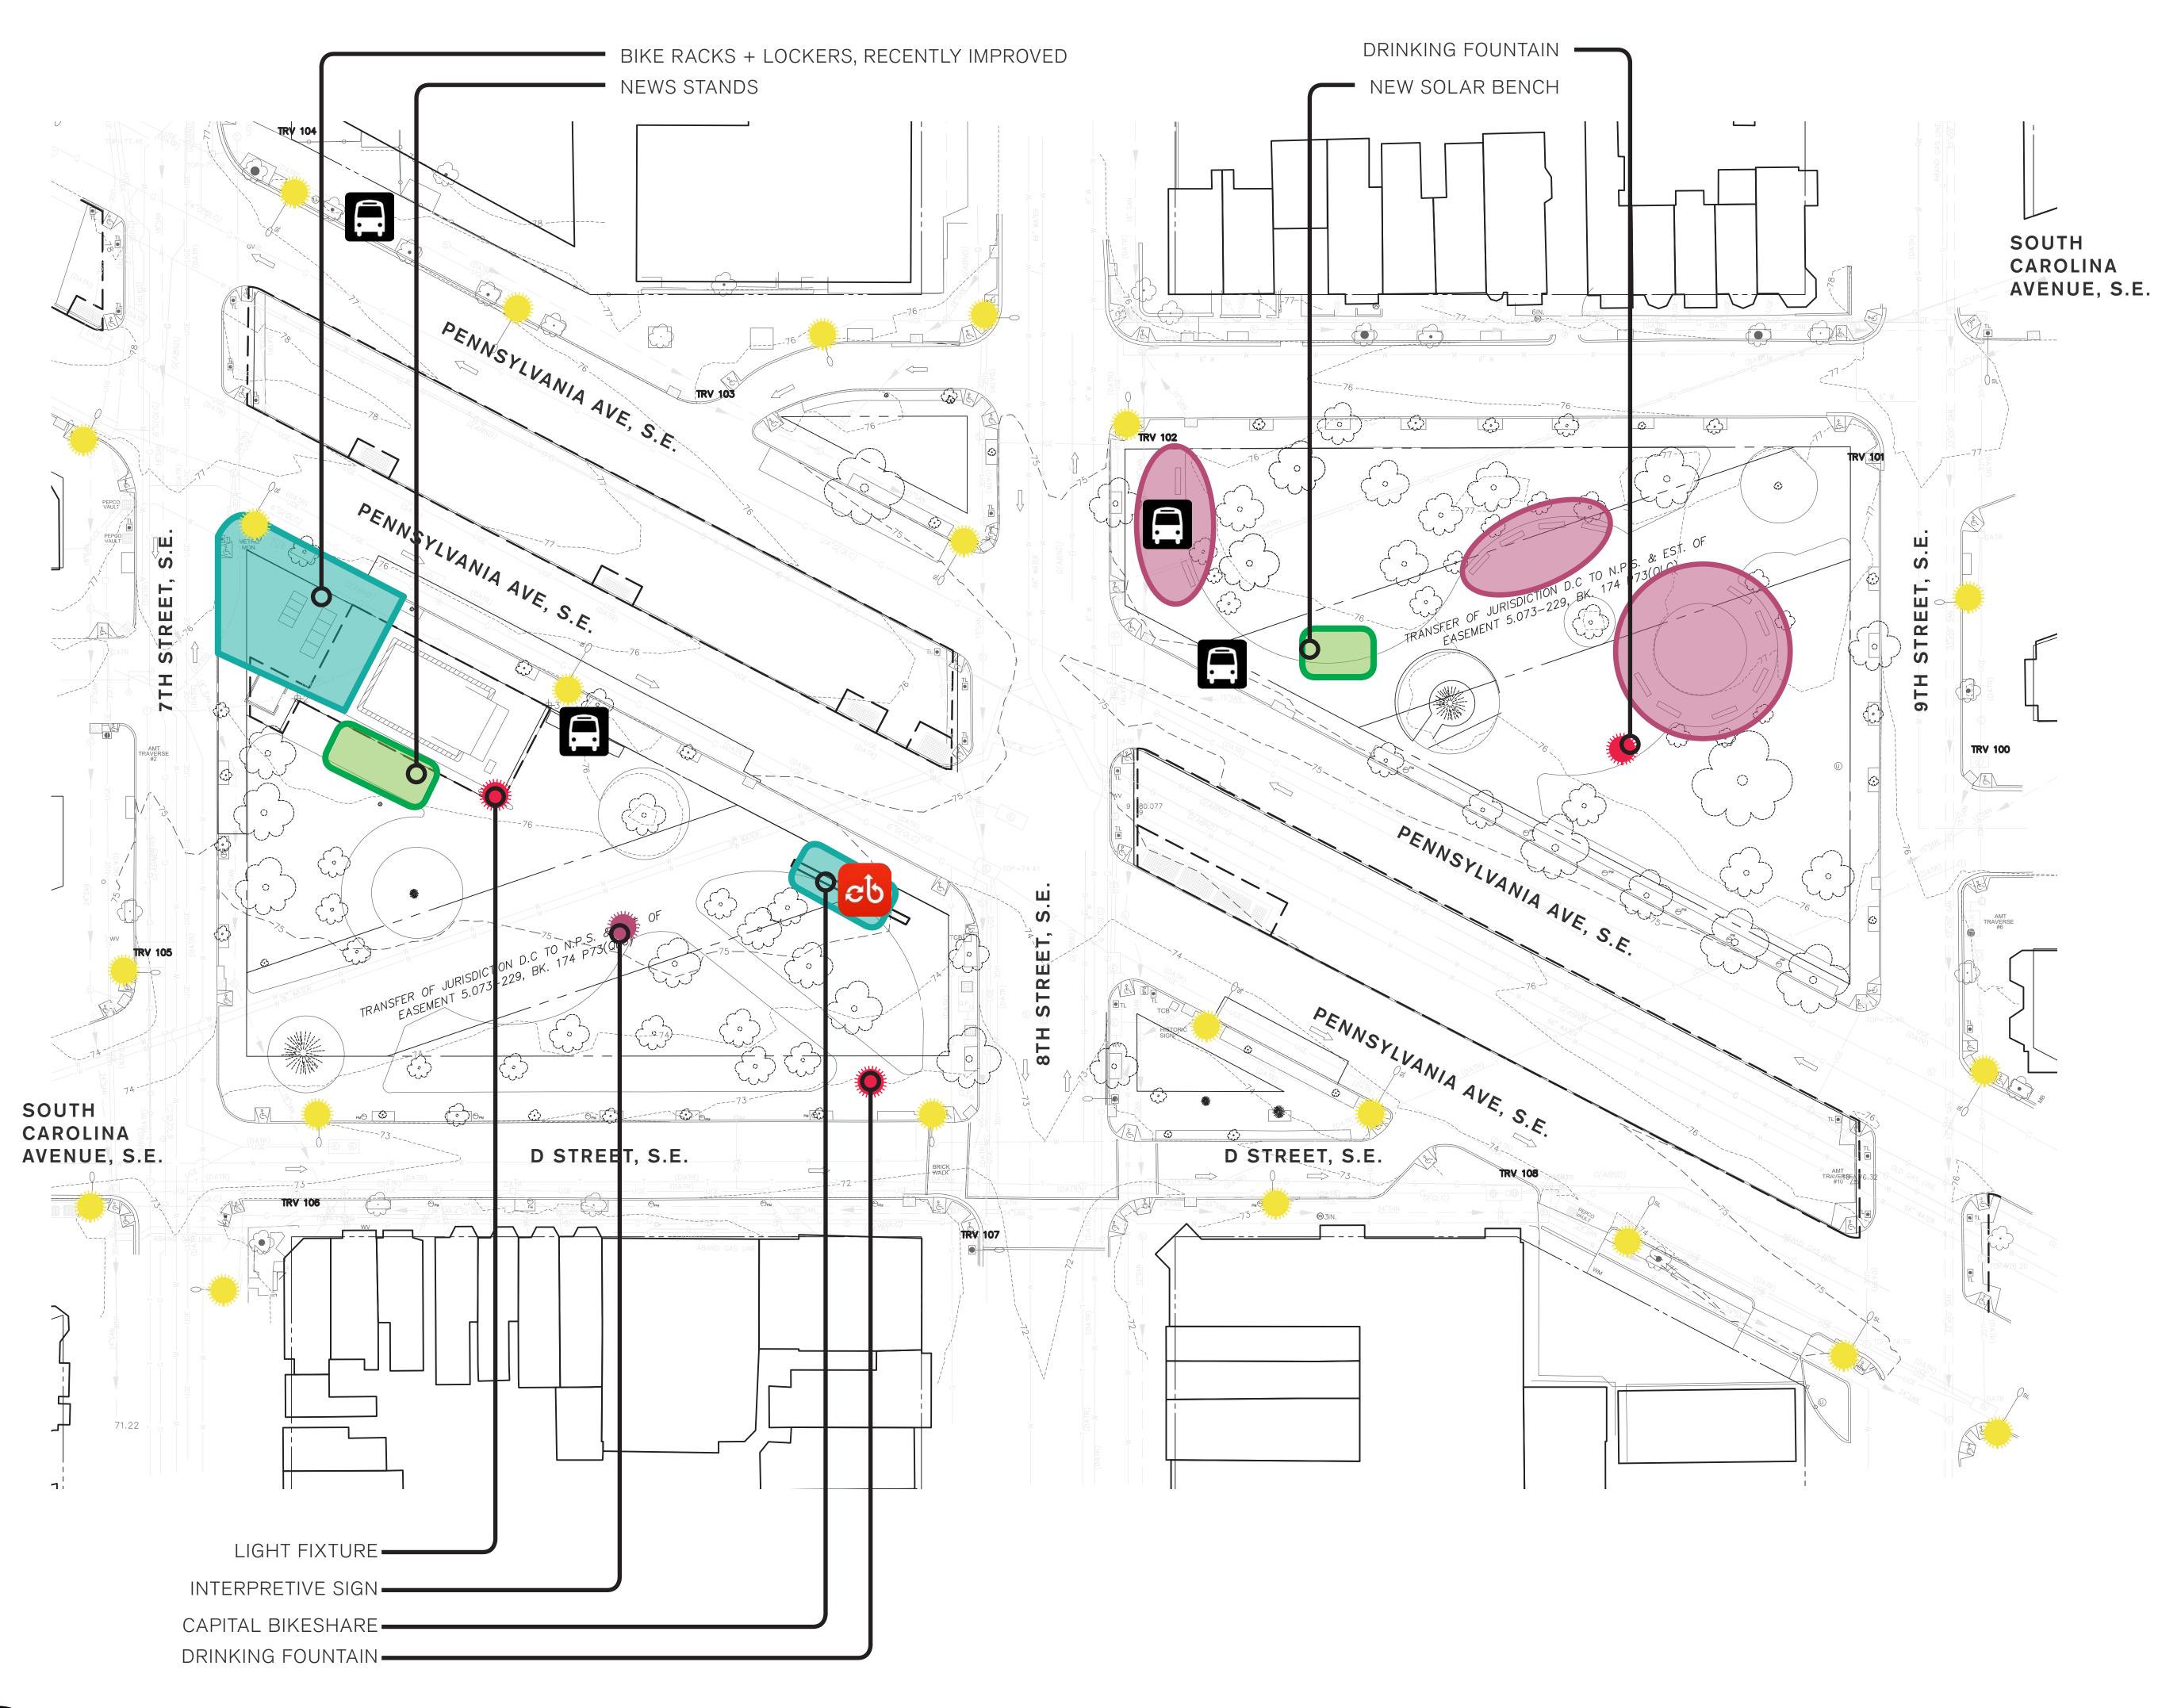
SITE FURNITURE

Very little site furniture exists within the park today, and some of what does remain is in poor condition or inappropriate arrangements. While Parcel 1 does have a number of benches, most of these are deteriorated and the linear layouts are not conducive to social engagement. A new solar bench near the corner could be relocated and replicated in the new plan. Parcel 4 lacks benches altogether. The existing bus shelters on Parcel 4 are placed very close to the Metro entrance and should be considered for relocation several feet further away for improved circulation. There are two existing water fountains that are out of service.

Furniture To Be Relocated

Benches Do Not Encourage Conversation Or Relaxation

Failing Infrastructure

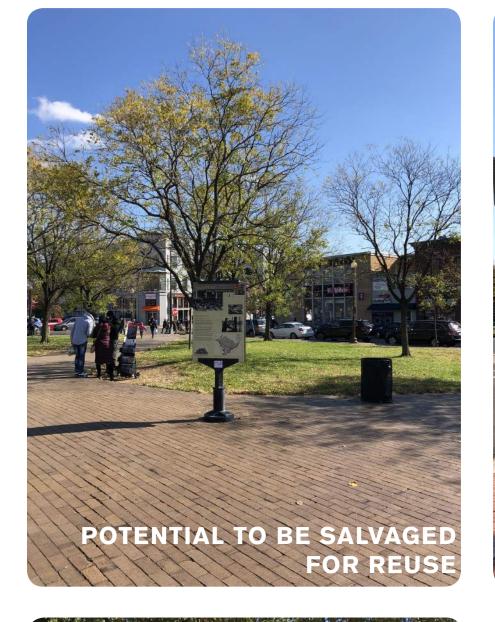
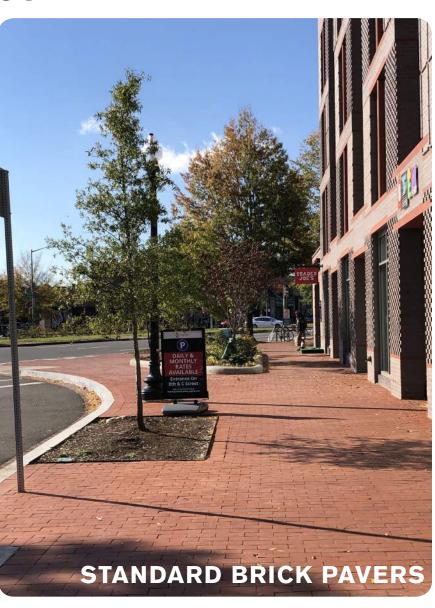
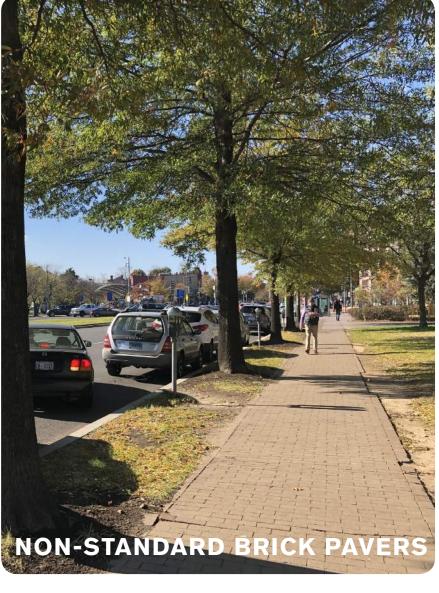
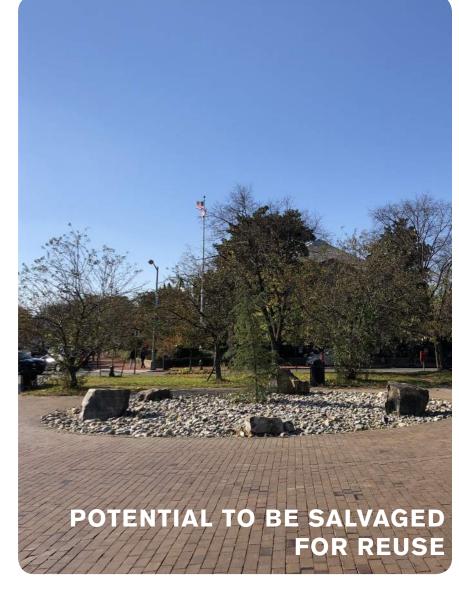
EXISTING CONDITIONS PHOTOS

The site area contains a mix of pavement types which include the standard red brick, a non-standard darker brick, and concrete. There is potential to salvage the non-standard darker brick for reuse as a specialty paver to accent specific areas of the new plan. The concrete pavement around the Metro entrance is under WMATA jurisdiction and will not be altered. Many curb ramps that were recommended for replacement in the 2015 Master Plan have already been reconstructed and now comply with ADA guidelines.

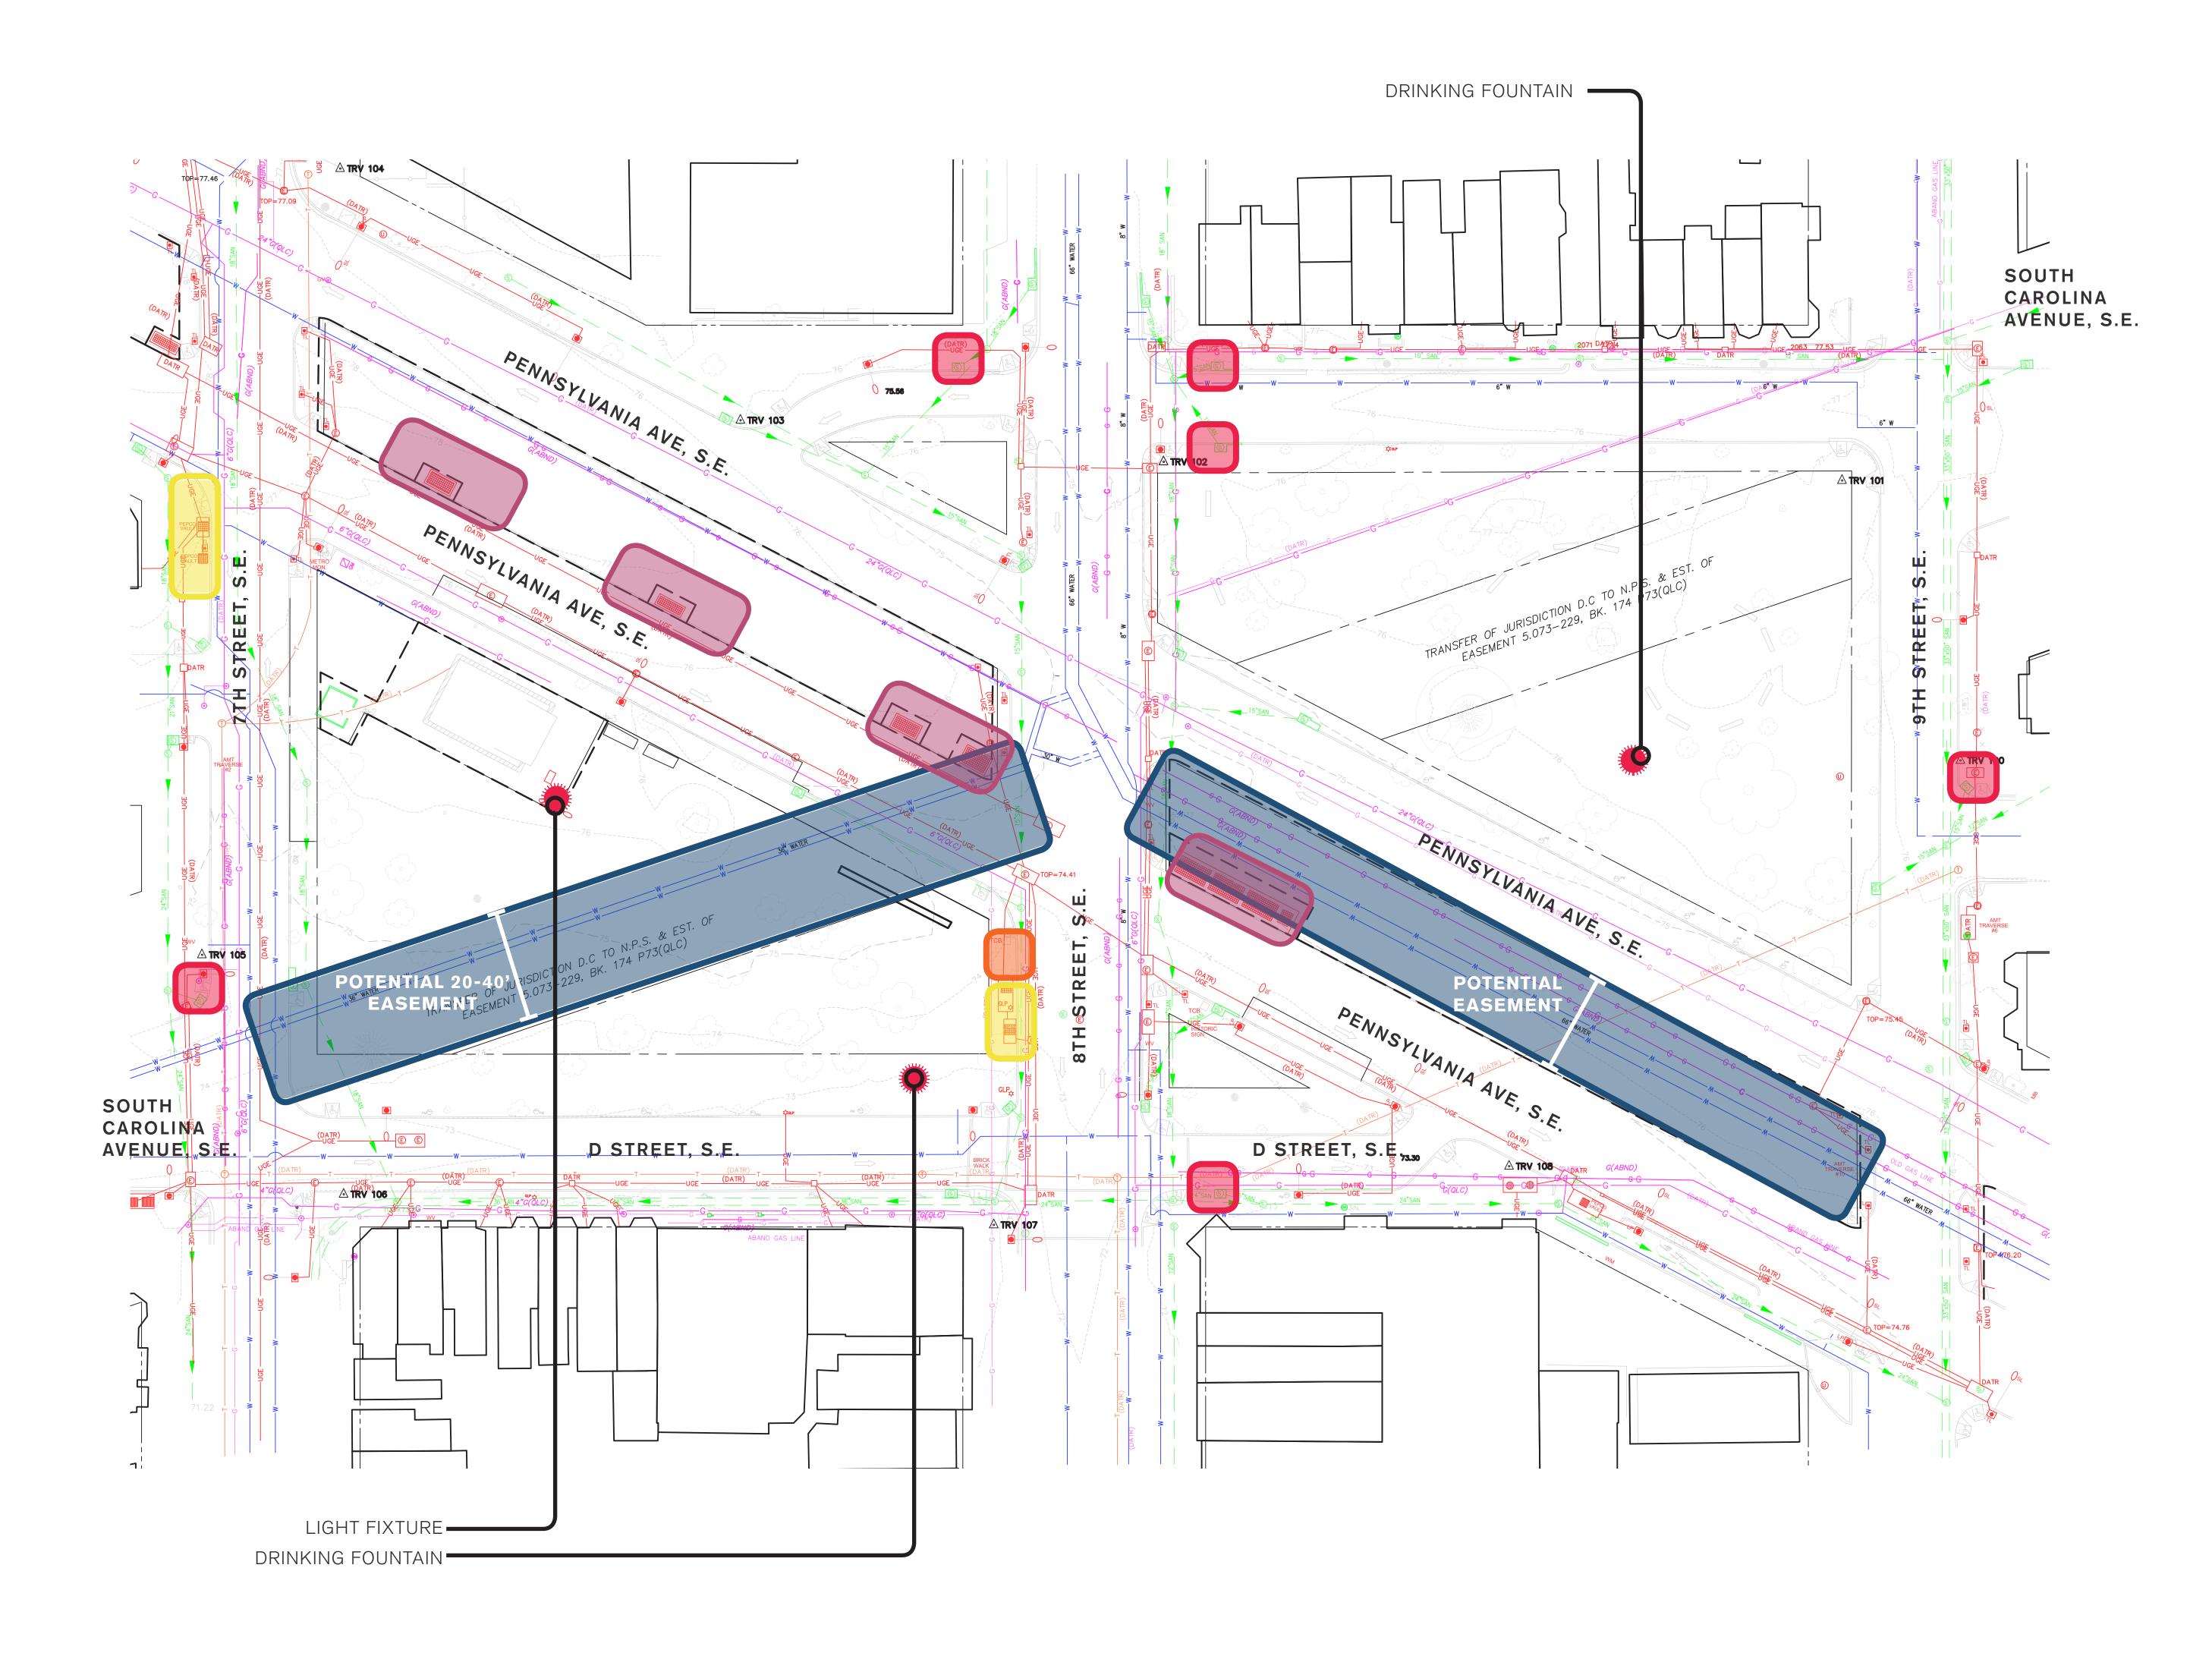
UTILITIES

The majority of the area's utilities are located at the edges of the Parcels. However, a few key utilities do pass through them in critical locations. These primarily include WMATA's tunnel facility and significant pipes belonging to DC Water. Additional refinement to the Master Plan may be required as the implications of these become fully understood through further discussions.

SWM Inlet In Conflict With Potential Curb Alignment

WMATA Structure

Above Ground Utility Structure

Below Ground Utility Structure Potential 40' Water Easement

- Stormwater management inlet conflicts with proposed curb alignments add significant cost impact
- Recommendation: Include space for civic and neighborhood events

- Splash pad location conflicts with DC Water Line
- Recommendation: Consider alternate locations and options for agreements with DC Water for locating within easement

- Trees in Pennsylvania medians conflict with utilities and WMATA
- Recommendation: provide shrubs, perennials, and groundcovers only in median
- · South Carolina median additions increase speeds and potential accident risk

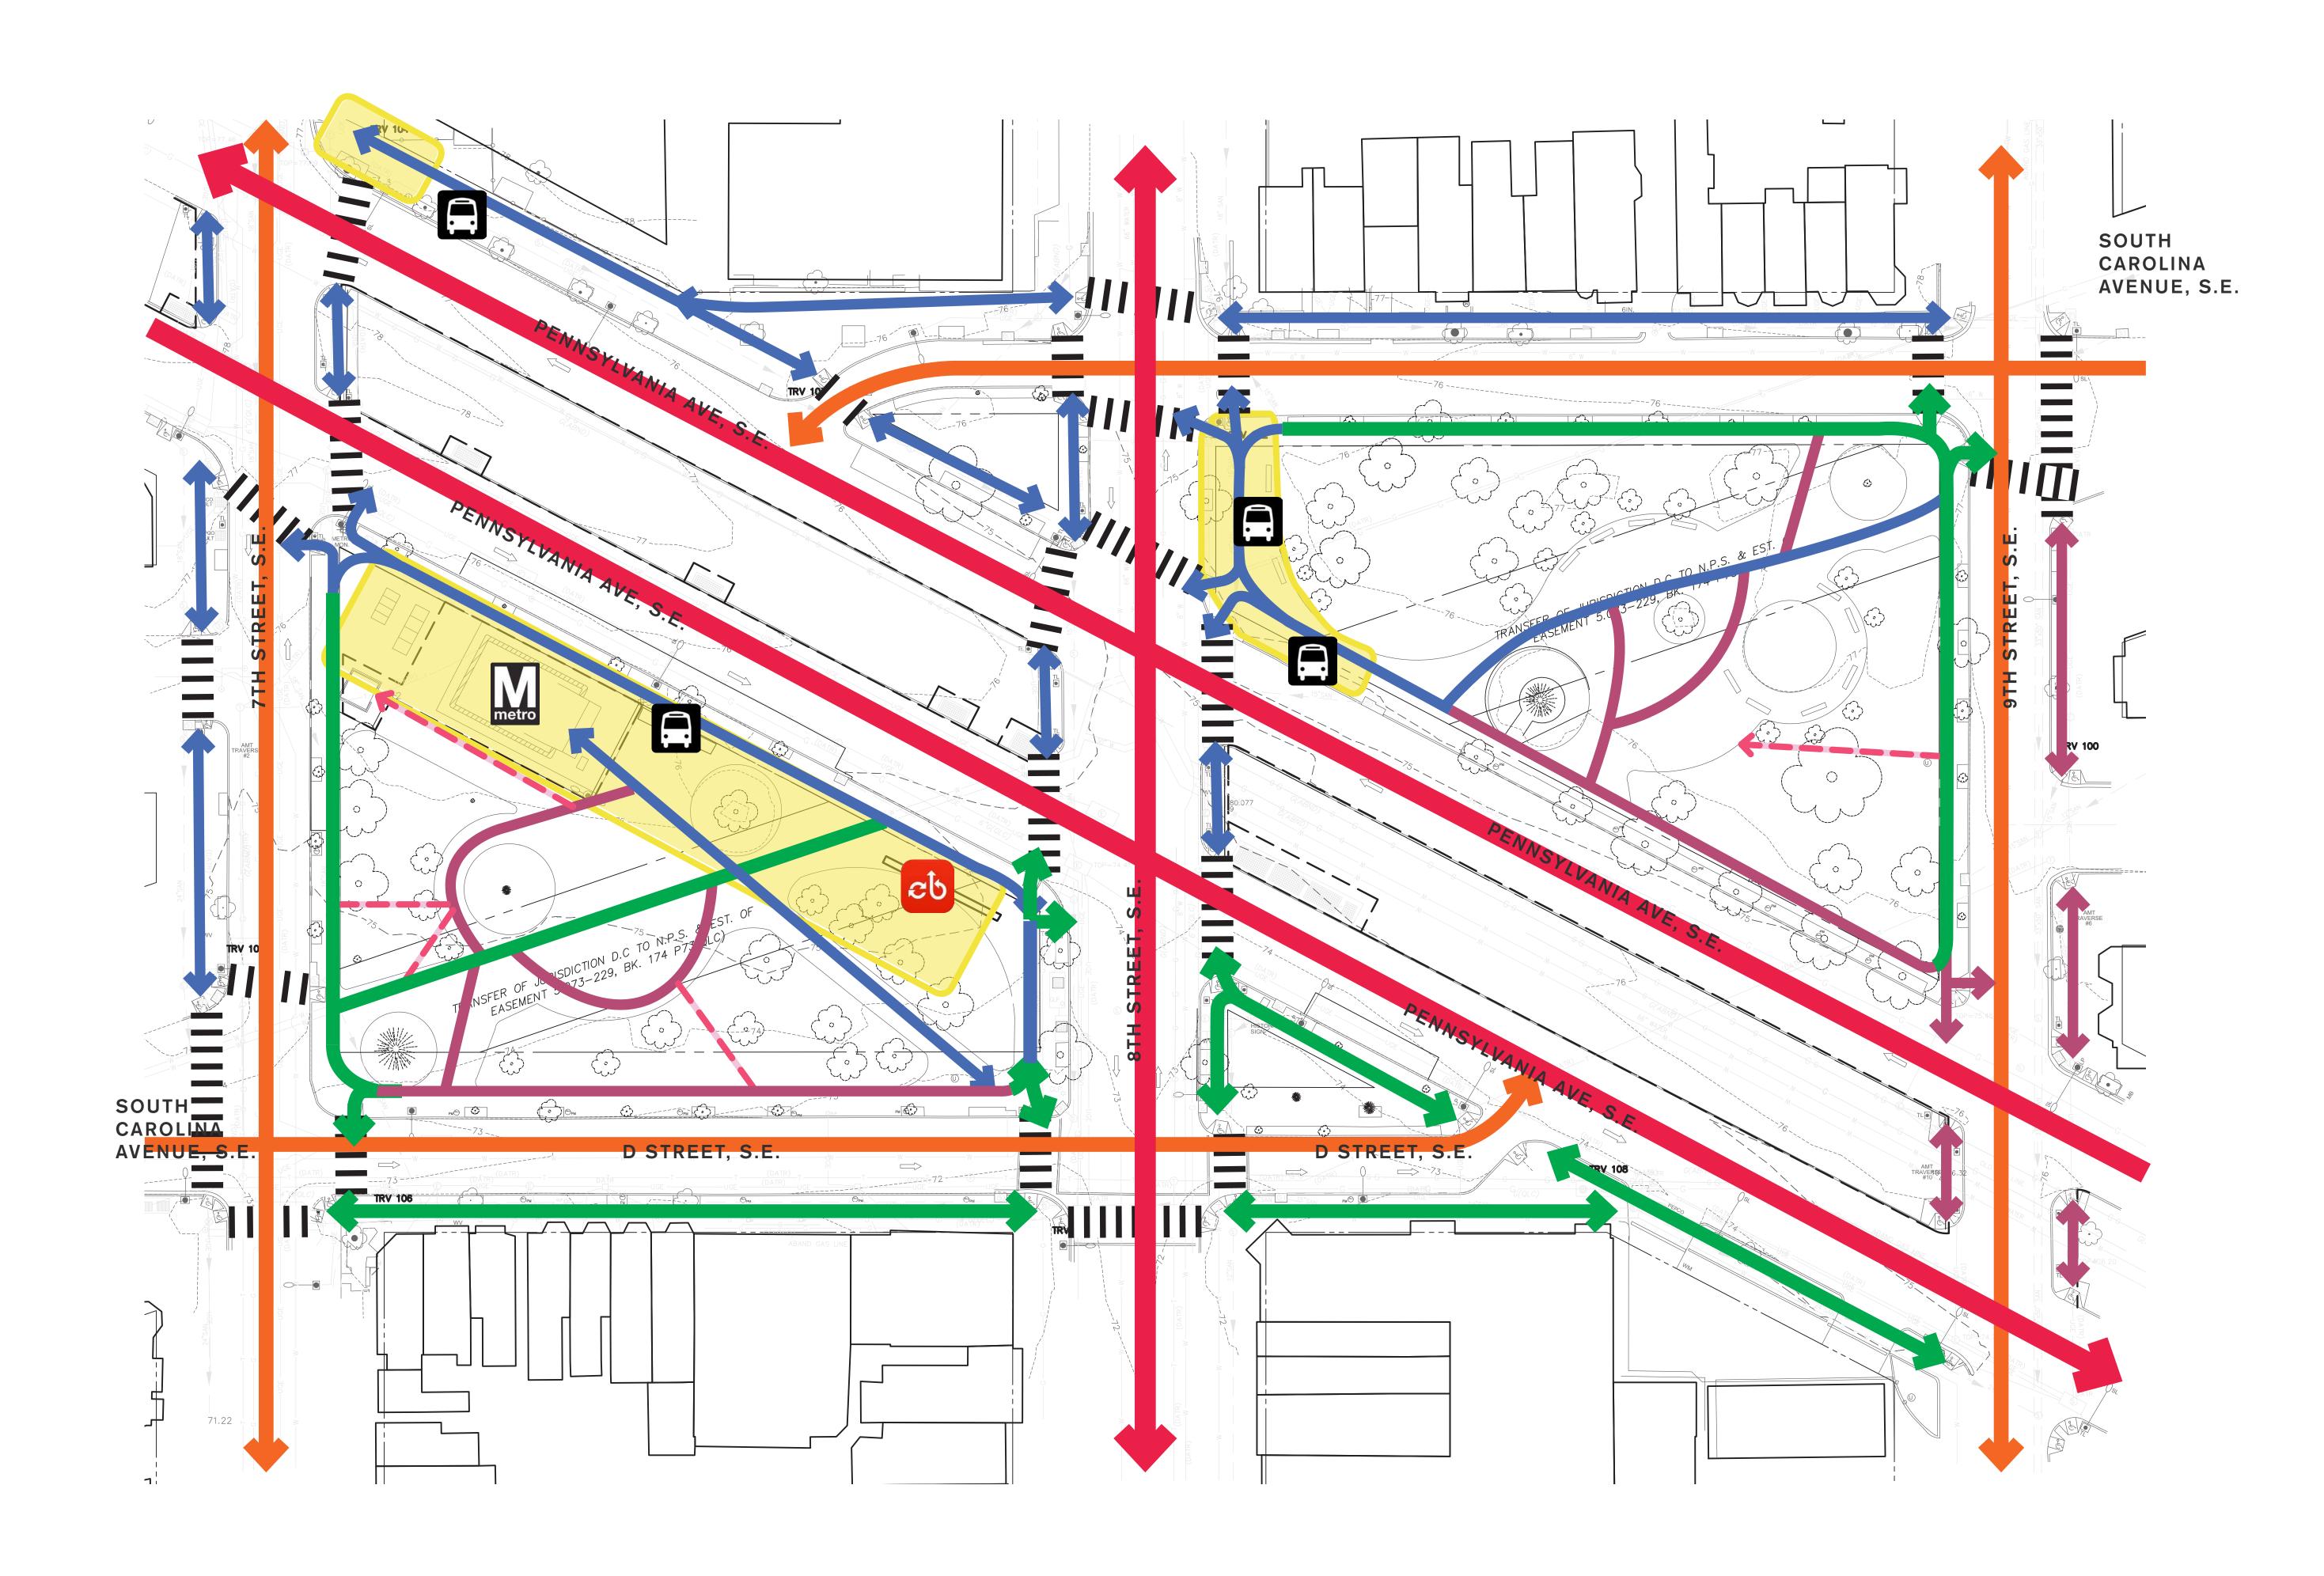
TRANSPORTATION + CIRCULATION

Site observations indicate a number of vehicular and pedestrian circulation patterns, as well as areas of high pedestrian traffic which should be considered when planning pavement areas and widths. A traffic analysis is being performed and will provide additional clarity and information for vehicular, pedestrian, and bicycle, at which time this graphic will be updated.

Primary Pedestrian Circulation

Secondary Pedestrian Circulation

Tertiary Pedestrian Circulation

Pedestrian "Cow Path"
