# G-MAX TEST REPORT

Date 06-18-2019

Project Name – Jelleff Recreation Center

Test Type - Onsite G-max Test - 10 Locations

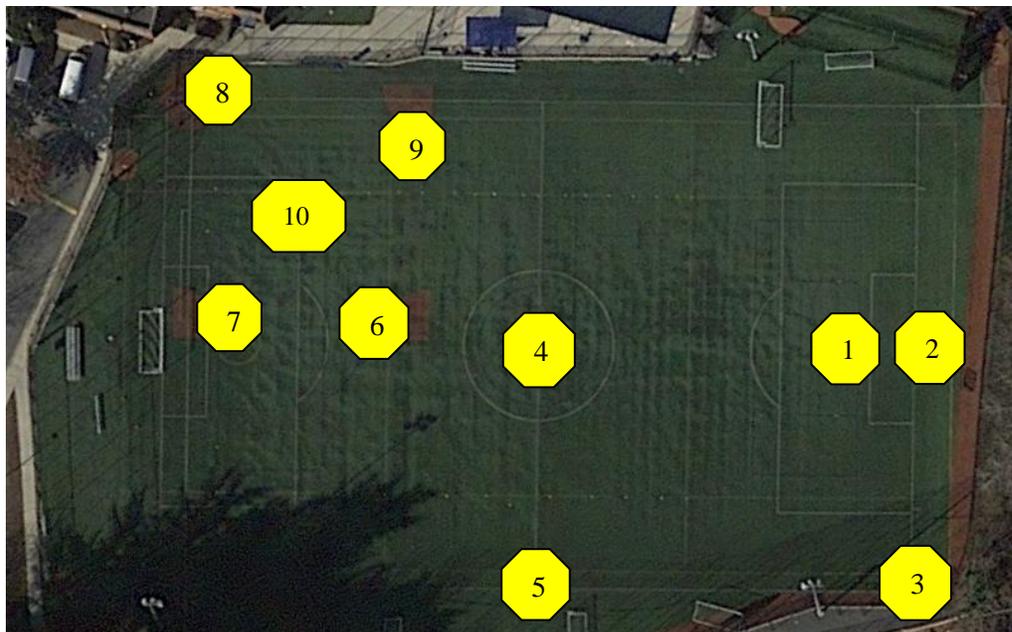
Location	Specific Location Description
1	East Penalty Kick Area at Center of Field
2	East Goal Area at Center of Field
3	SE Corner Kick Area
4	Center Field
5	South Midfield Sideline
6	2nd Base Area 3ft off towards 1st base
7	1st Base Area 3ft off towards 2nd base
8	Home Plate Left Handed Batters Box
9	3rd Base Area 3ft off towards 2nd Base
10	Center of Pitchers Mound
