# LANDSCAPE 1 - OVERALL SITE DESIGN

# LANDSCAPE 2 - ENLARGED PLAN NEAR PROPOSED BUILDING

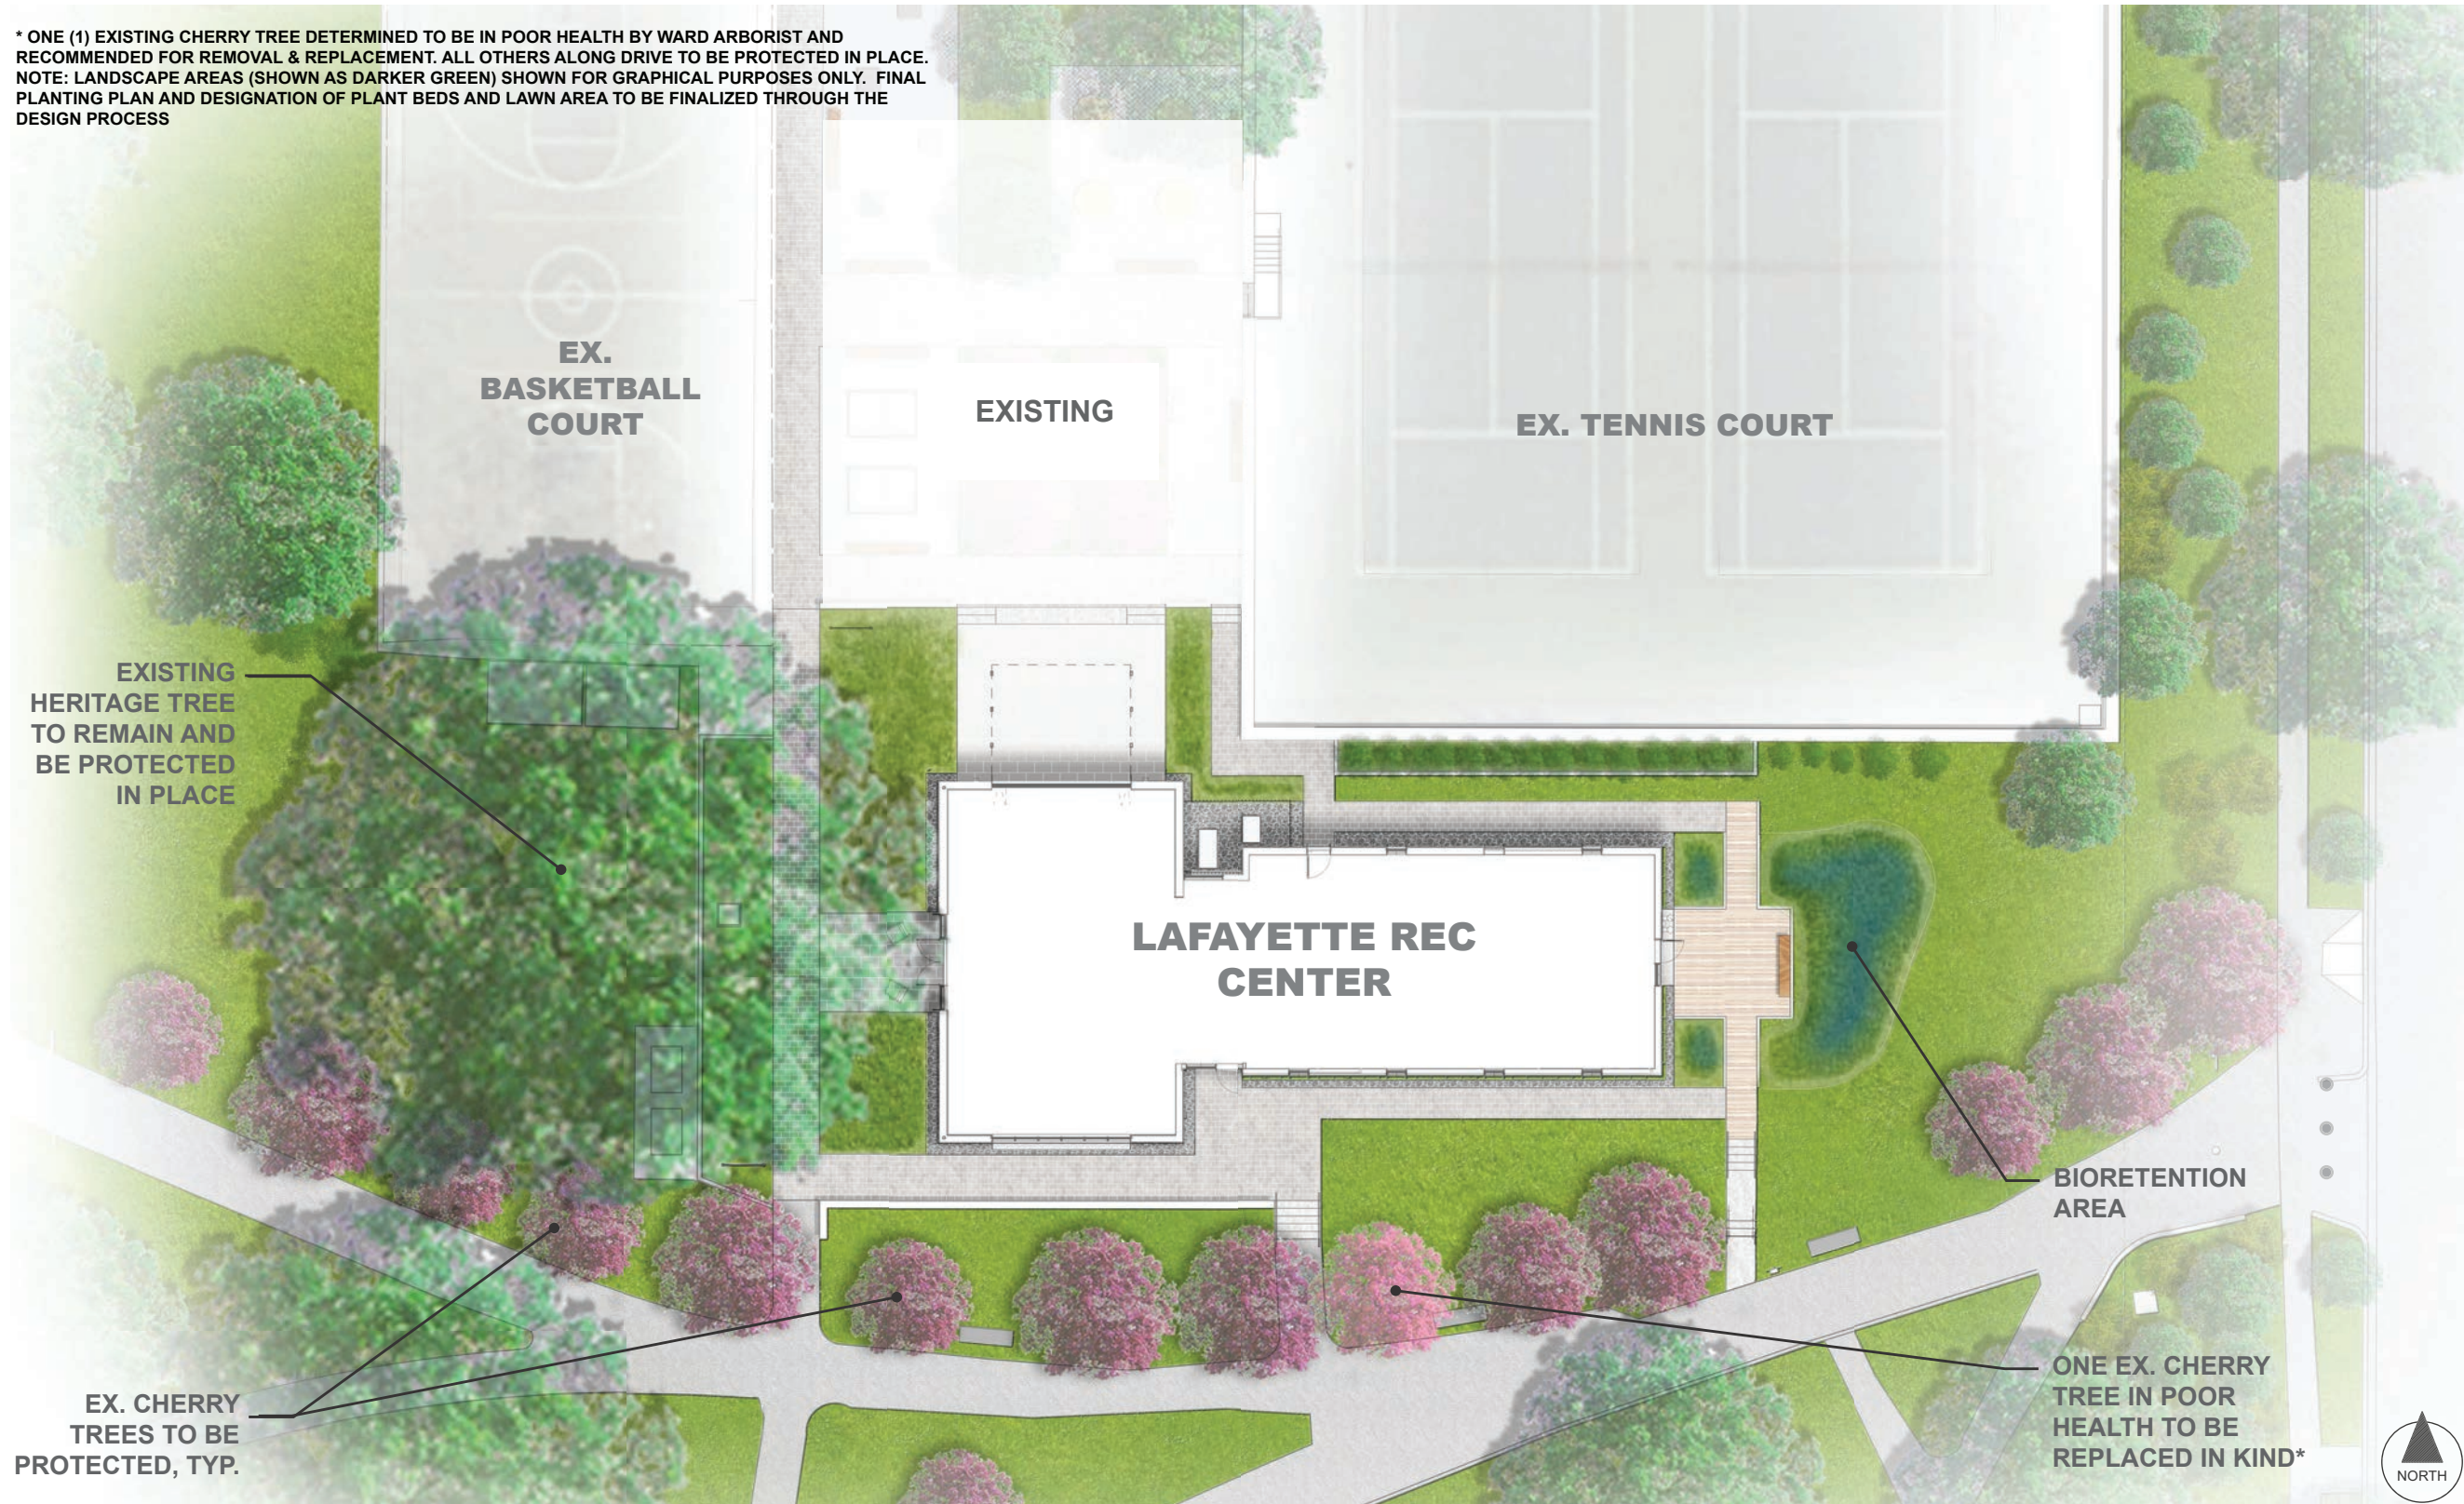
\* ONE (1) EXISTING CHERRY TREE DETERMINED TO BE IN POOR HEALTH BY WARD ARBORIST AND RECOMMENDED FOR REMOVAL & REPLACEMENT. ALL OTHERS ALONG DRIVE TO BE PROTECTED IN PLACE. NOTE: LANDSCAPE AREAS (SHOWN AS DARKER GREEN) SHOWN FOR GRAPHICAL PURPOSES ONLY. FINAL PLANTING PLAN AND DESIGNATION OF PLANT BEDS AND LAWN AREA TO BE FINALIZED THROUGH THE DESIGN PROCESS

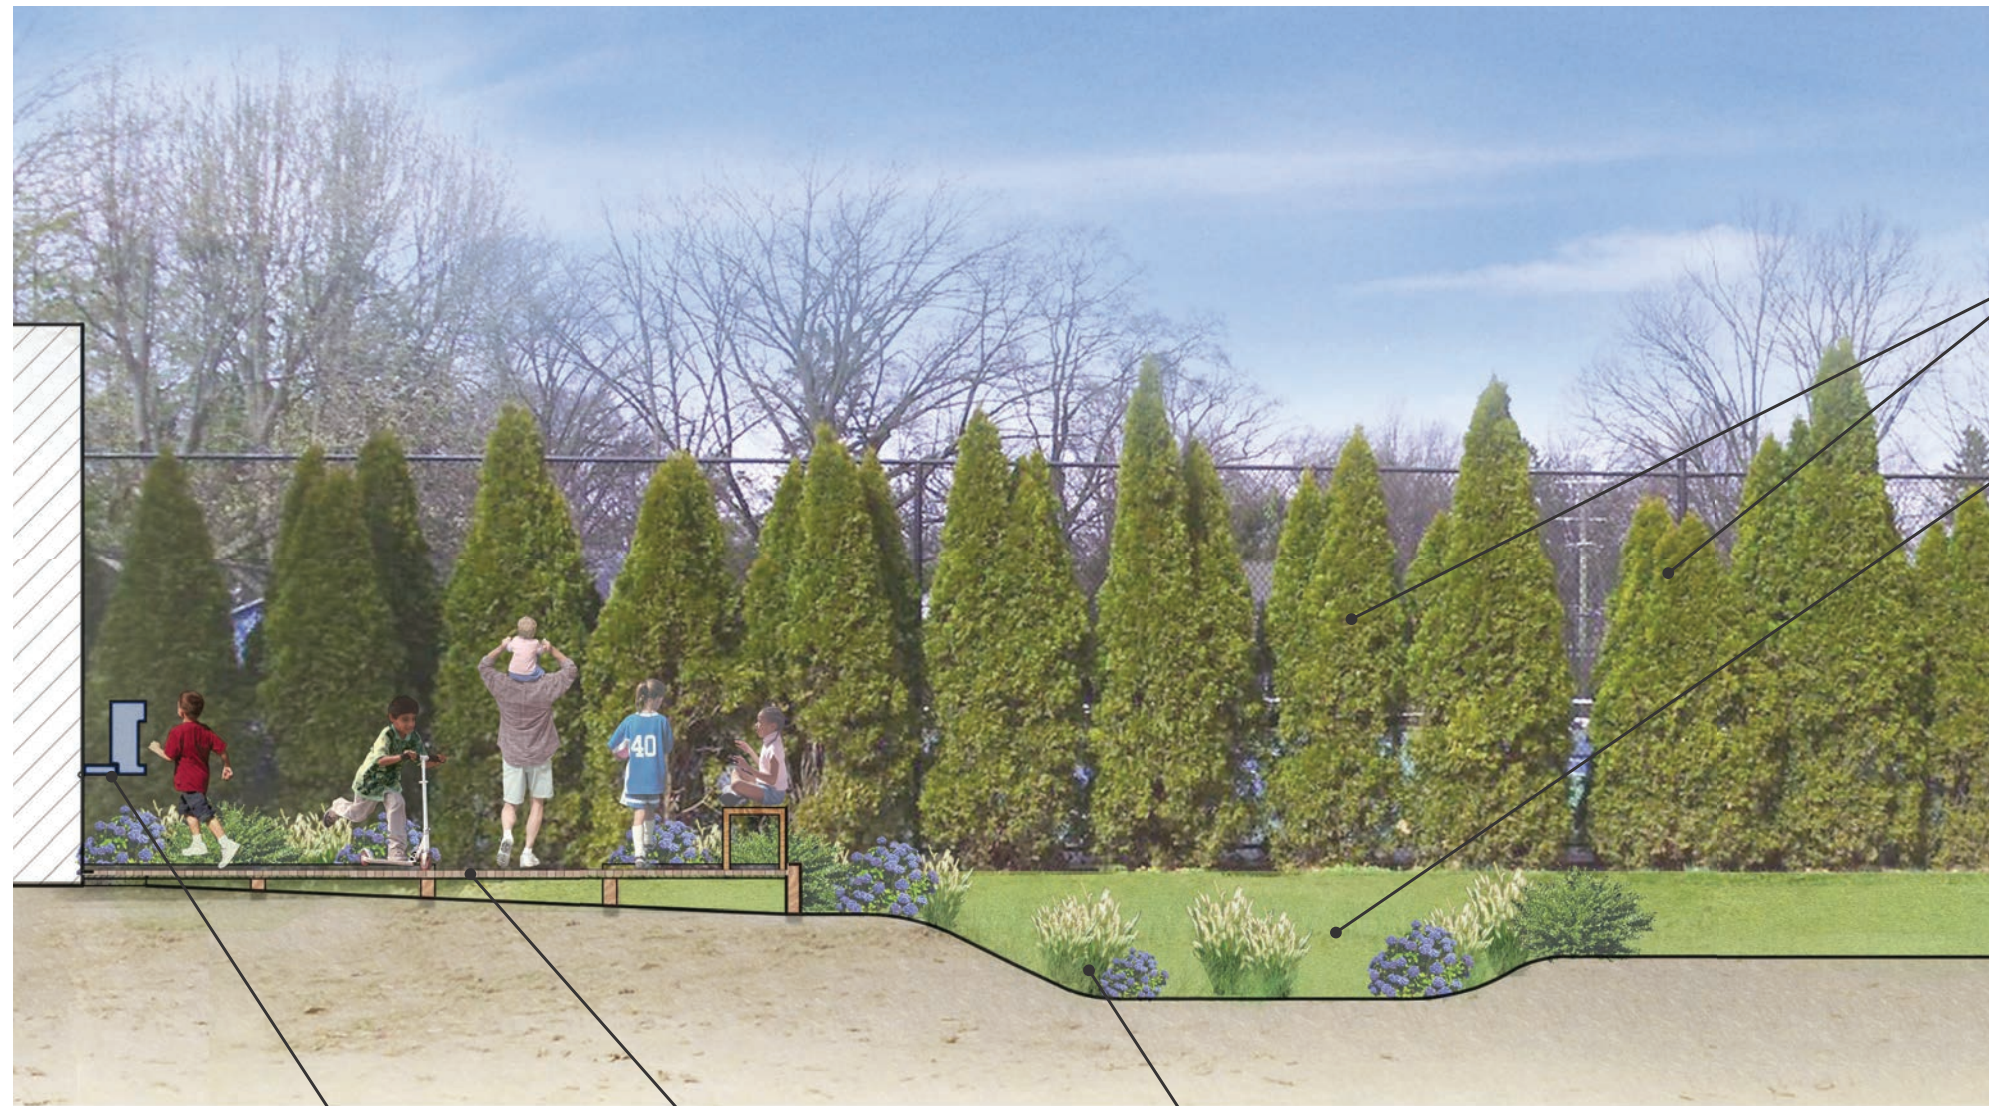
# LANDSCAPE 2 - SECTION THRU BIORETENTION AREA

EXISTING  
EVERGREENS TO  
REMAIN

BIORETENTION  
AREA

WATER FOUNTAIN  
& BOTTLE-FILLING  
STATION

BOARDWALK

BIORETENTION  
PLANTINGS, TYP.
