Engine House 23 Renovation

ATTACHMENT J.1.13

Engine 23 - FY19  
2119 G St NW  
Washington, DC 20037

***Inspection Date:*** Friday, December 7, 2018

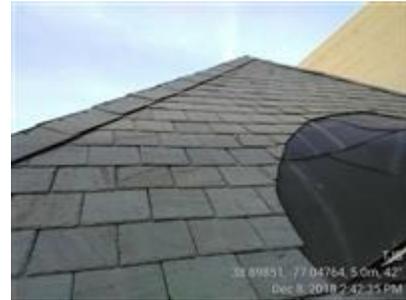
**Section ID:** A - A (Photo #2)

**Roof Condition Score:** 78 (Degraded)

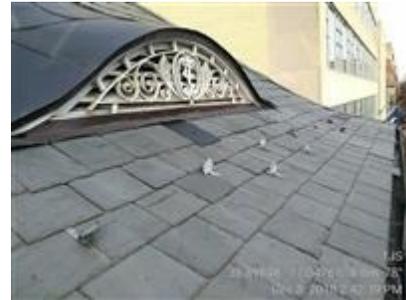
**Section ID:** A - A (Photo #3)

**Roof Condition Score:** 78 (Degraded)

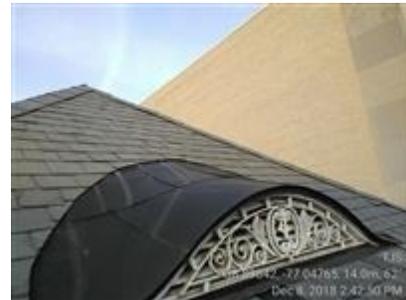
**Section ID:** A - A (Photo #4)

**Roof Condition Score:** 78 (Degraded)

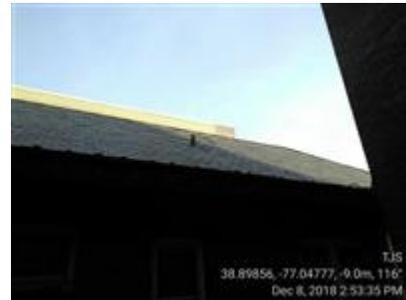
**Section ID:** A - A (Photo #5)

**Roof Condition Score:** 78 (Degraded)

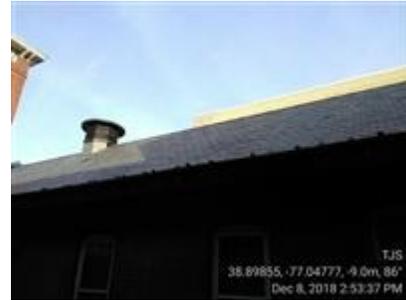
**Section ID:** A - A (Photo #6)

**Roof Condition Score:** 78 (Degraded)

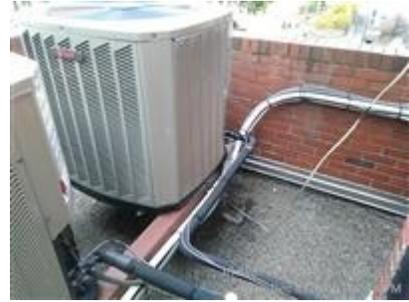
**Section ID:** R-C - R-C (Photo #3)

**Roof Condition Score:** 56 (Unsatisfactory)

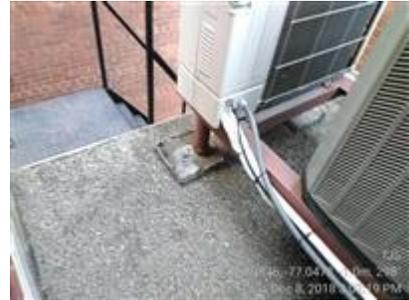
**Section ID:** R-C - R-C (Photo #4)

**Roof Condition Score:** 56 (Unsatisfactory)

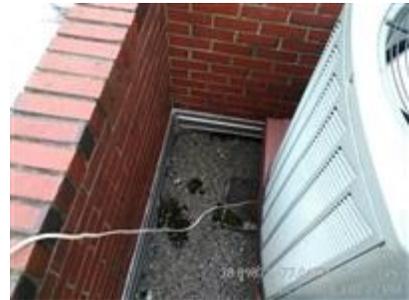
**Section ID:** R-C - R-C (Photo #5)

**Roof Condition Score:** 56 (Unsatisfactory)

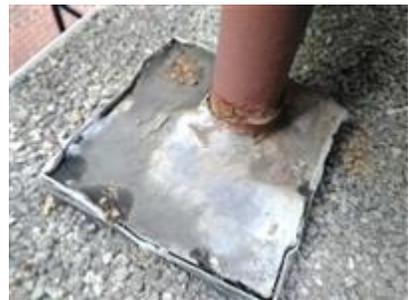
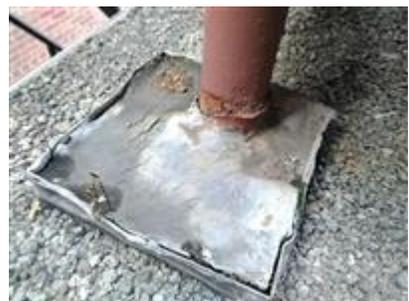
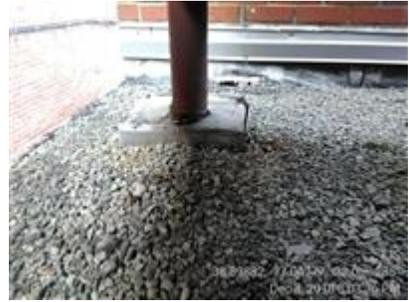
**Pitch pan**

**Defect:** Pitch pan defect.  
**Severity:** Pitch pan sealer is cracked or separated from the pan or penetration.  
**Status:** Repaired

**Recommendation:** Add pourable sealant and crown for positive drainage. Typical of 4.

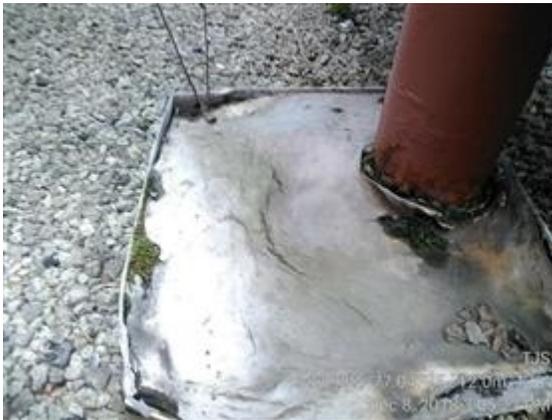
Defect #1: Pitch pan defect

## Defect Summary – Section R-C

### Defect #1 - Field defect

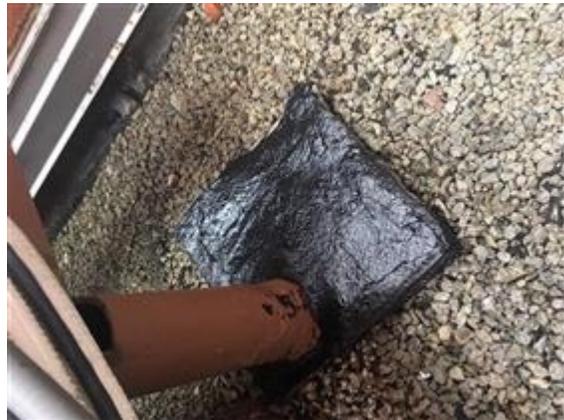
Defect #1: Pitch pan defect

### Defect #1 - Field defect (Continued)

**Defect:** Pitch pan defect.  
**Severity:** Pitch pan sealer is cracked or separated from the pan or penetration.  
**Status:** Repaired

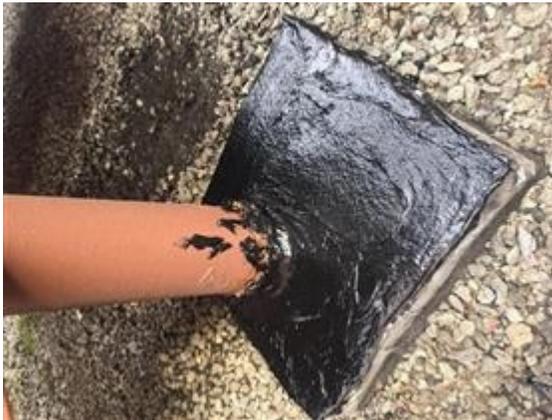
Defect #1: Pitch pan defect

**Defect #1 - Field defect  
(Continued)**

**Defect:** Pitch pan defect.  
**Severity:** Pitch pan sealer is cracked or separated from the pan or penetration.  
**Status:** Repaired
