**Addendum No. 5**

**Architectural/Engineering Services for the MPD 7th District Headquarters  
New Facility and New Parking Structure**

# COMPREHENSIVE FACILITIES CONDITION ASSESSMENT & SPACE UTILIZATION SURVEY

DISTRICT OF COLUMBIA METROPOLITAN POLICE DEPARTMENT  
7TH DISTRICT HEADQUARTERS  
2455 ALABAMA AVENUE, SE  
WASHINGTON, D.C 20020

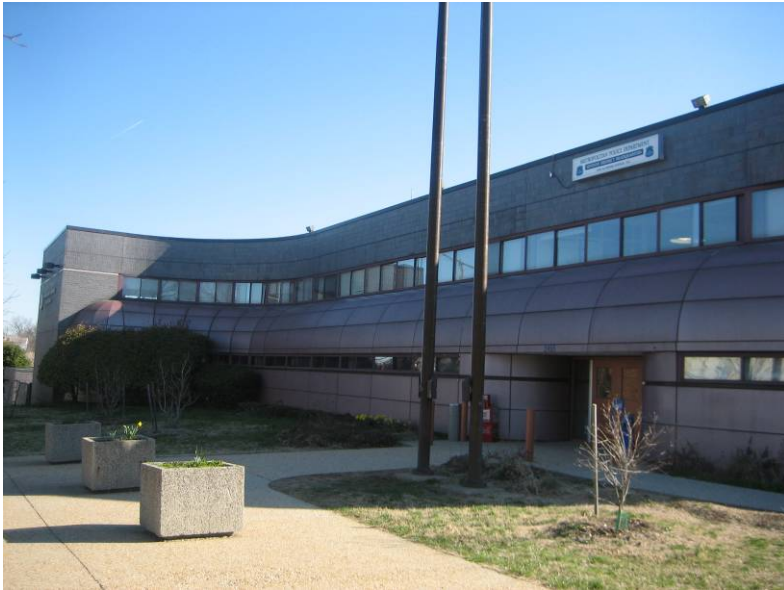
Photograph No. 1

Front Elevation – Main Building

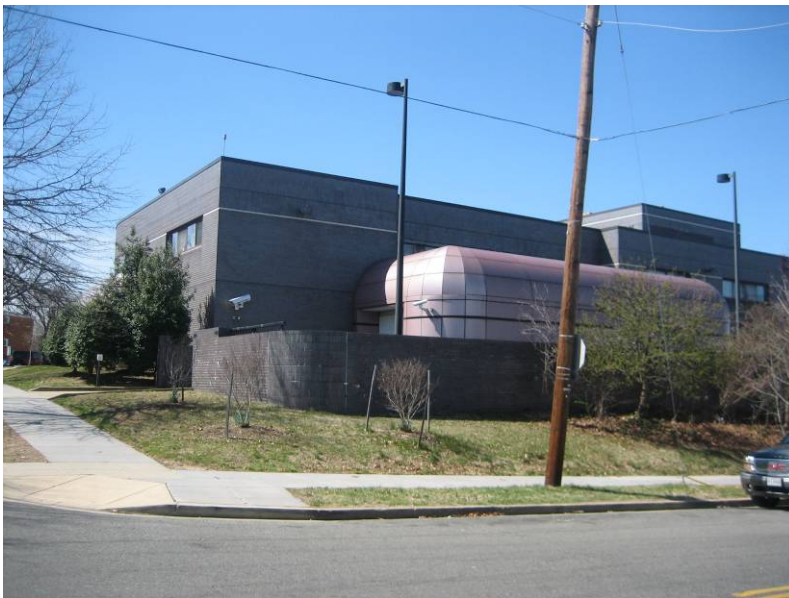
Photograph No. 2

Rear Elevation – Main Building

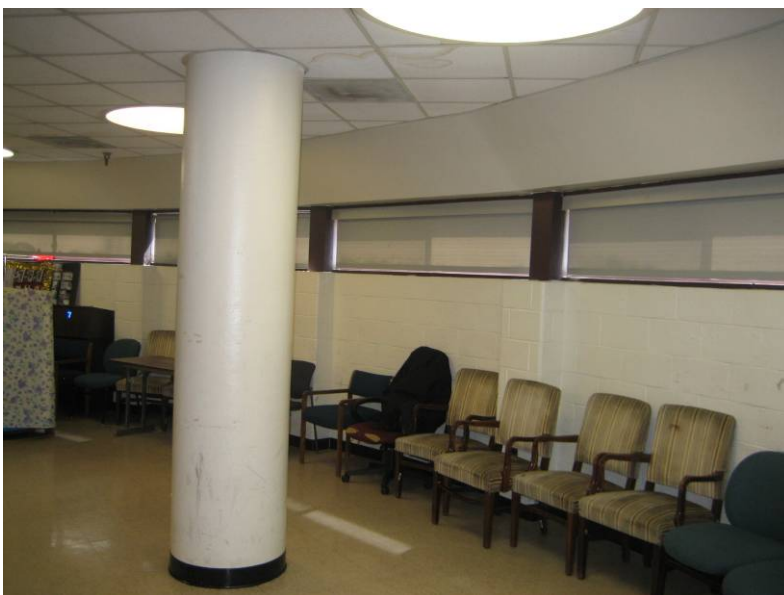
Photograph No. 3

Structural Concrete Column

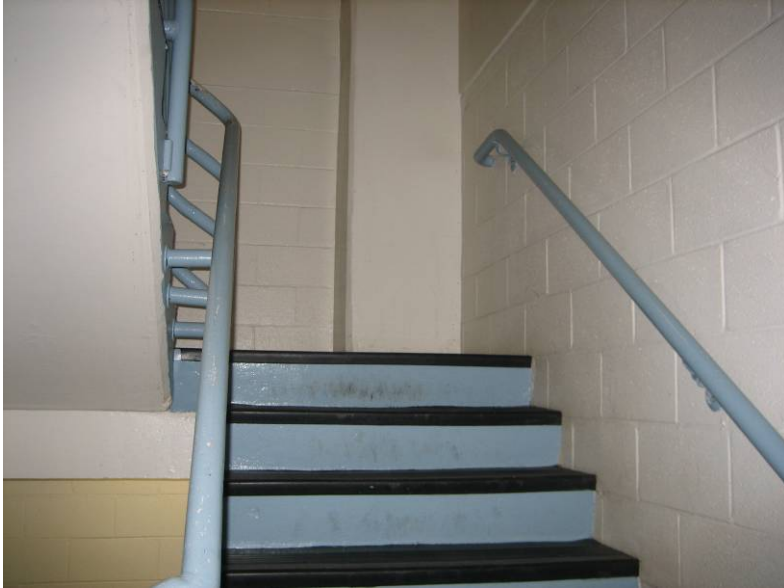
Photograph No. 4

Concrete Staircase

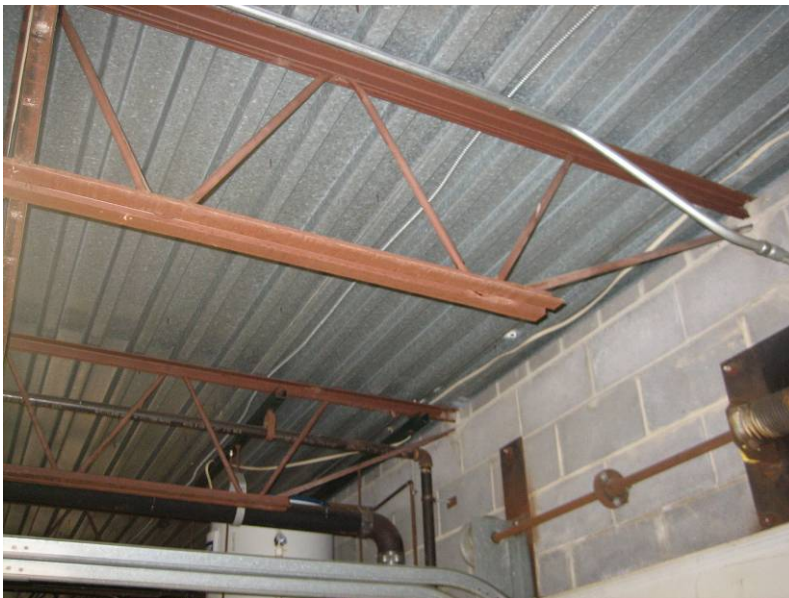
Photograph No. 5

Roof Structure at Vehicle Maintenance Building

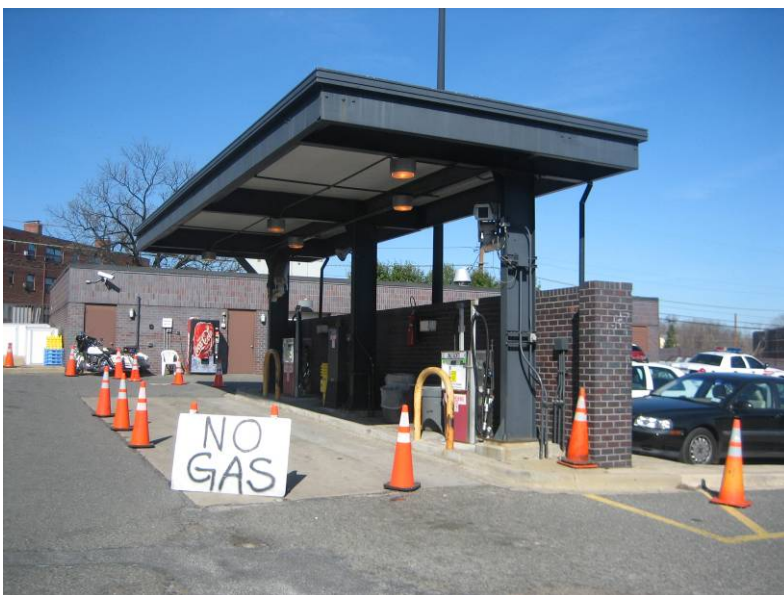
Photograph No. 6

Vehicle Fueling Station

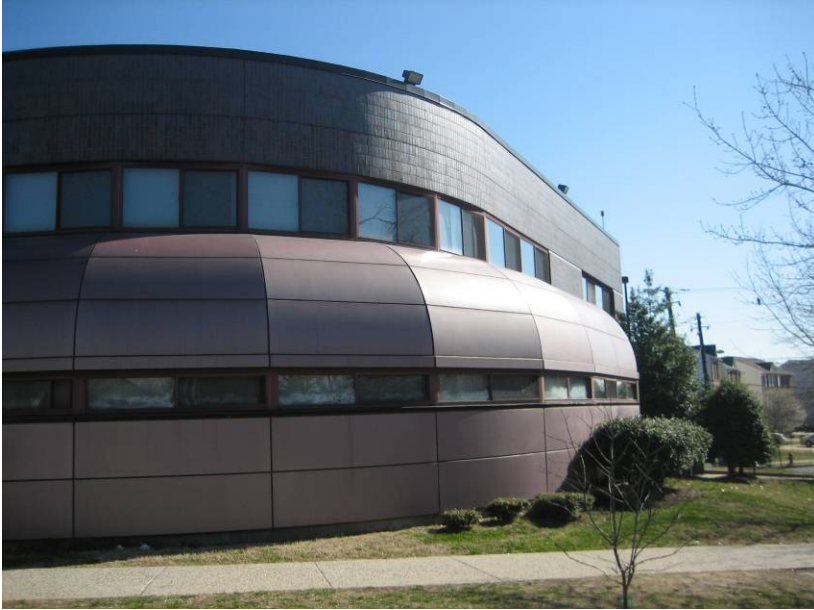
Photograph No. 7

Exterior Wall Panel System at Main Building

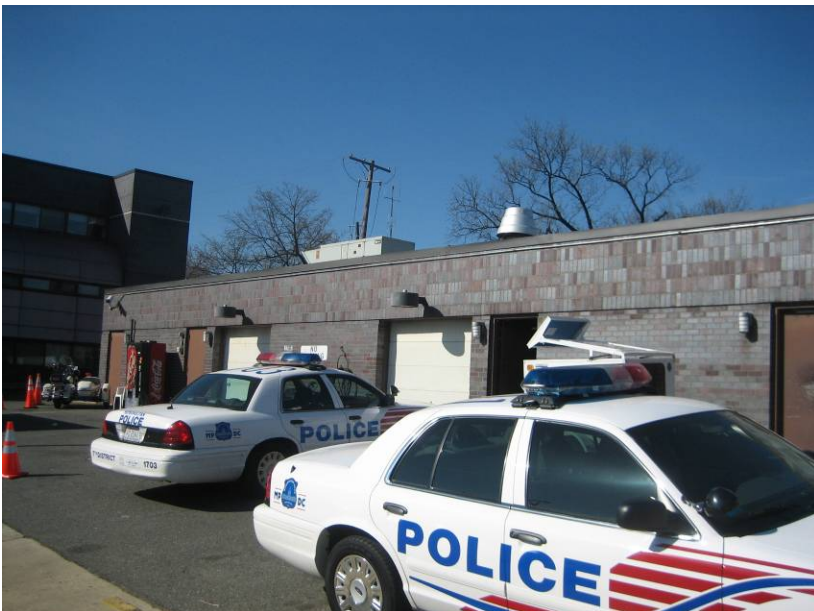
Photograph No. 8

Vehicle Maintenance Building

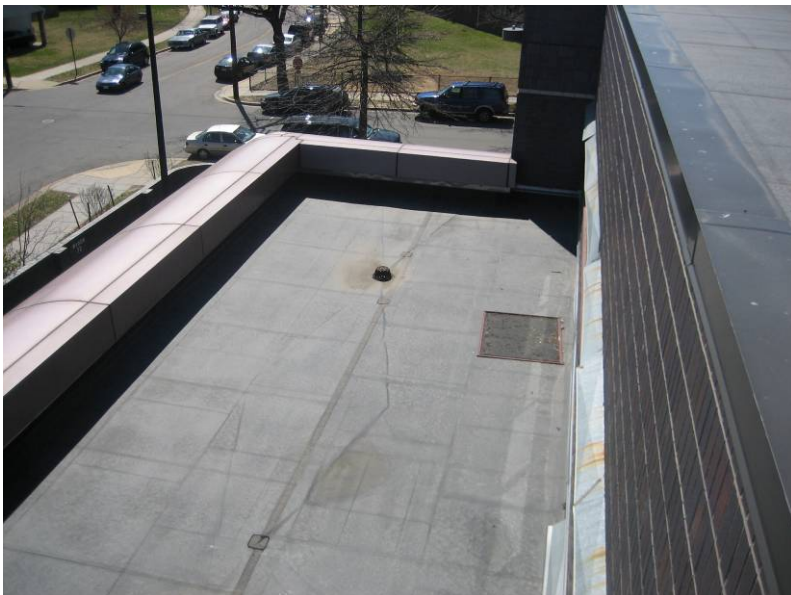
Photograph No. 13

The Property contains four primary roofing systems. The roofs consist of the main low-slope roof area over the main building, the adjoining single-story garage building, the detached vehicle maintenance building, and the vehicle fueling station (reference Photographs 11 through 13 in Appendix C).

Low Slope Roof at Vehicle Maintenance Building

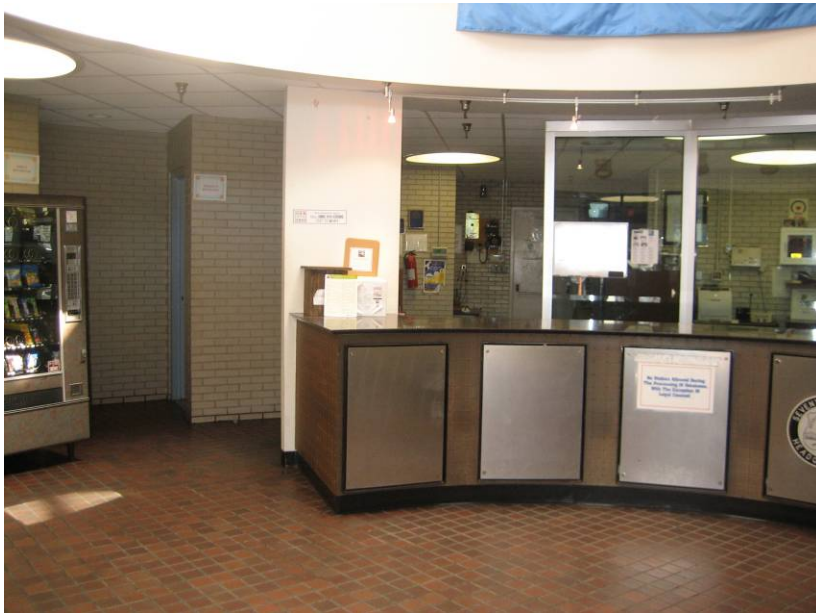
Photograph No. 17

Interior areas include the lobby and reception area, corridors, offices, restrooms, meeting rooms, holding cells, locker rooms, shower facilities, and mechanical spaces, (reference Photographs 17 through 20 in Appendix C). Variable size administrative offices are provided at the outer perimeter of each corridor with demising walls between the rooms constructed of painted gypsum board on metal studs, painted cementitious screeds or CMU.

Reception Area

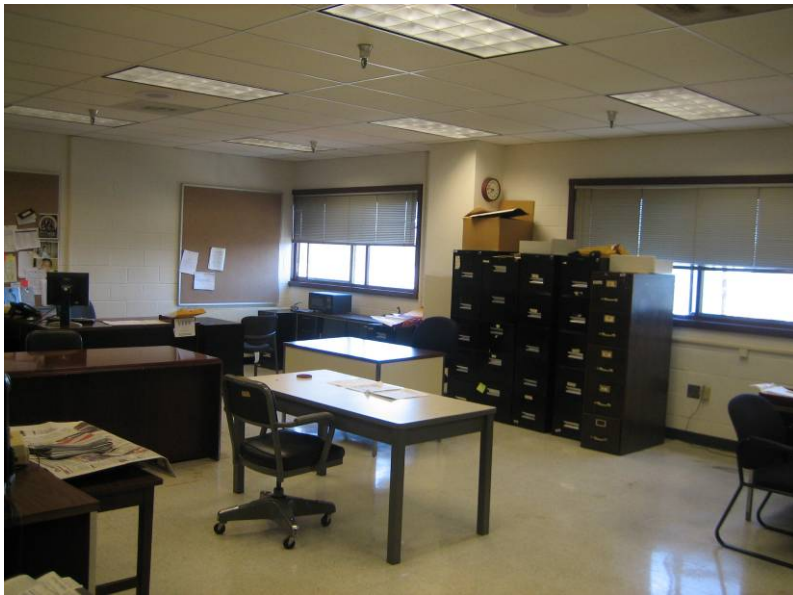
Photograph No. 19

Office Space

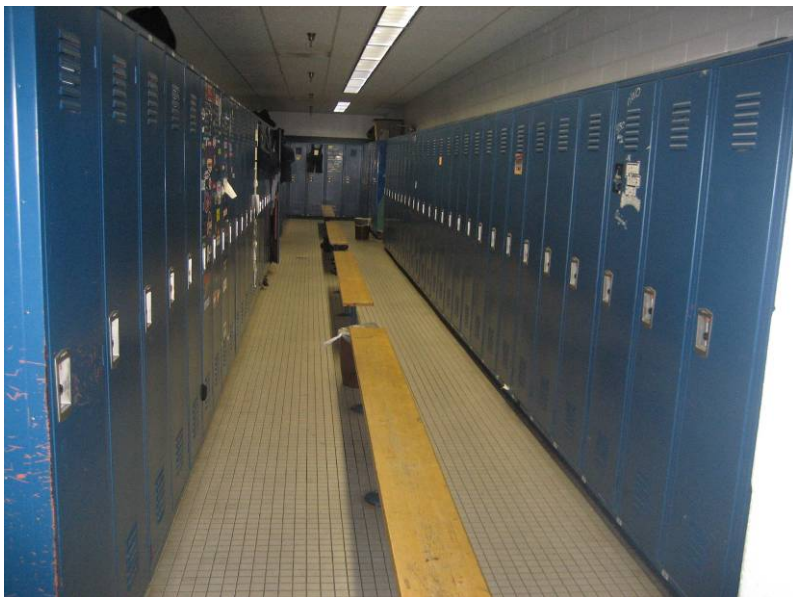
Photograph No. 20

Locker Room

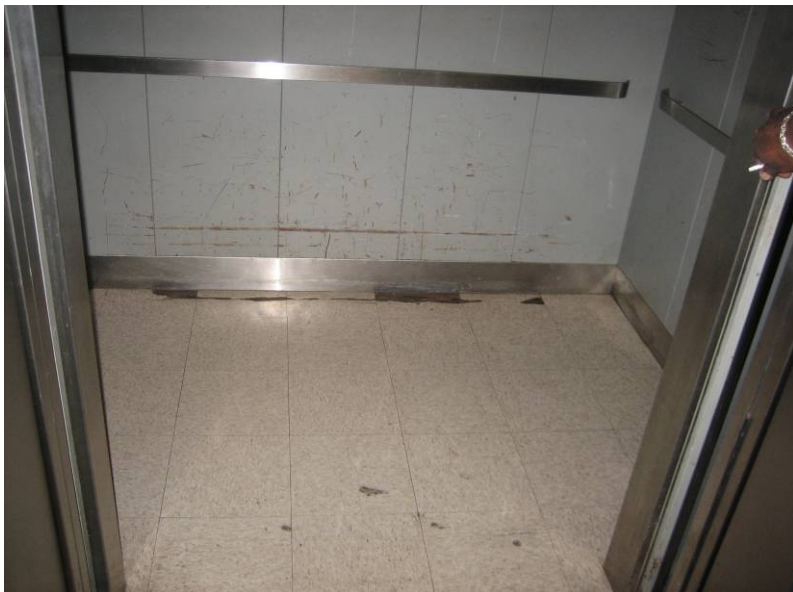
Photograph No. 23

Elevator Cab

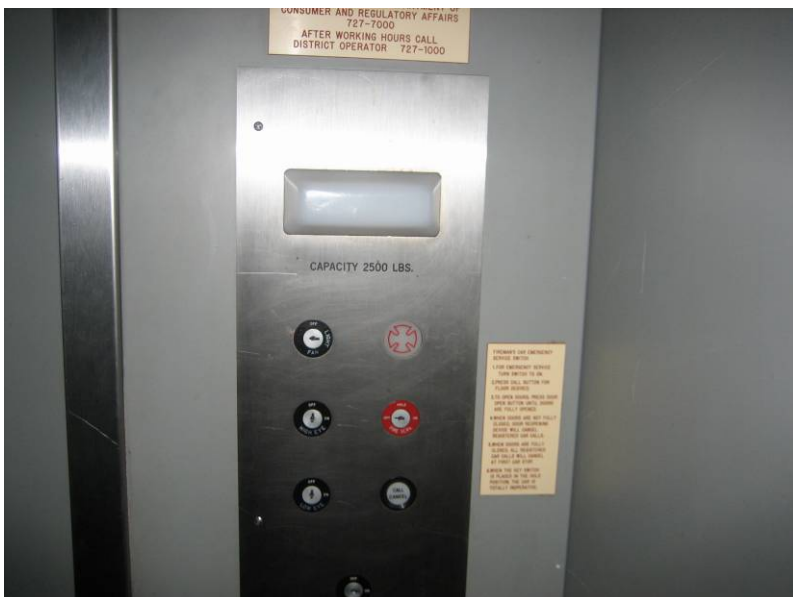
Photograph No. 24

Elevator Control Panel

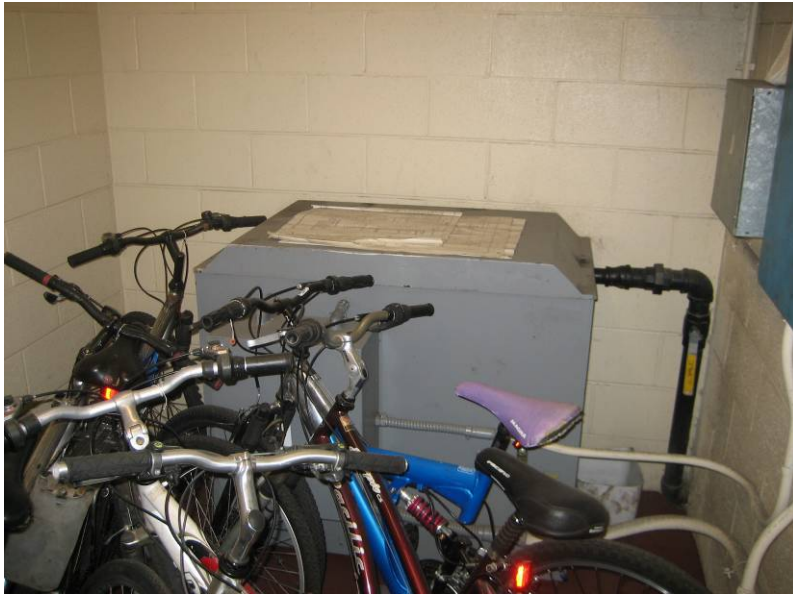
Photograph No. 25

Elevator Machine Room

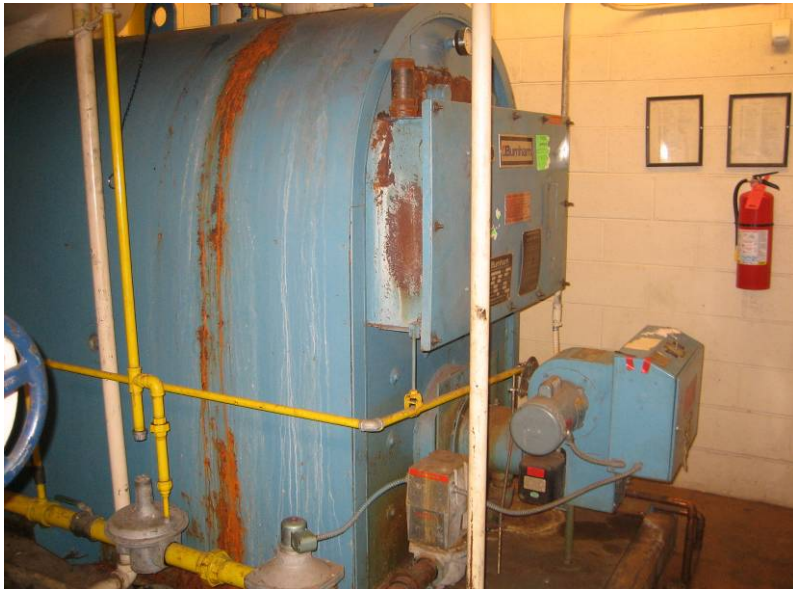
Photograph No. 26

Heating for the building is provided by a gas-fired hot-water boiler. The boiler is located in the basement level mechanical room (reference Photograph 26 in Appendix C). The boiler is manufactured by Burnham and has an output capacity of 1,855 British Thermal Units per Hour (BTUH). A burner is provided and appears to be part of the original boiler installation. The nameplate for the burner is missing, but the motor was manufactured by Baldor.

Boiler

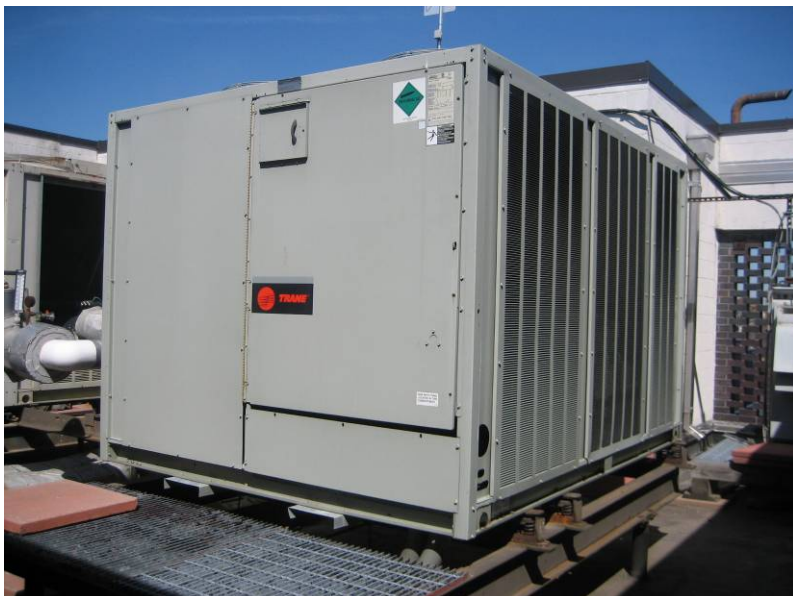
Photograph No. 27

Chilled water for cooling is generated by two rooftop air-cooled chillers (reference Photograph 27 in Appendix C). The chillers are products of Trane and have capacities of 60-tons and 80-tons of cooling.

Chiller

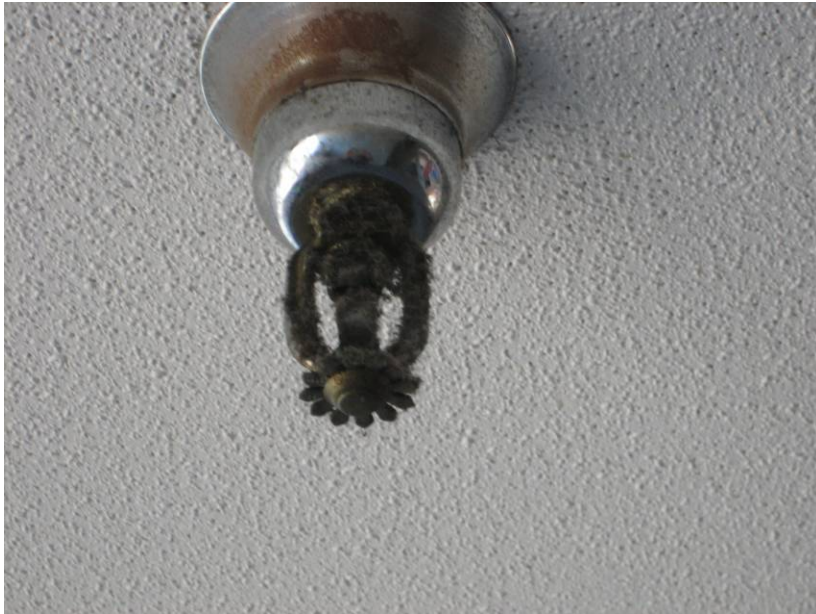
Photograph No. 28

The wet-pipe fire suppression sprinkler system appears to be in fair condition. The system was not tested. During our assessment we observed the condition of the sprinkler heads and noted a buildup of dirt and mold growth, in addition to localized surface corrosion at some of the heads (reference Photograph 28 in Appendix C). Sprinkler heads should be tested immediately.

Sprinkler Head

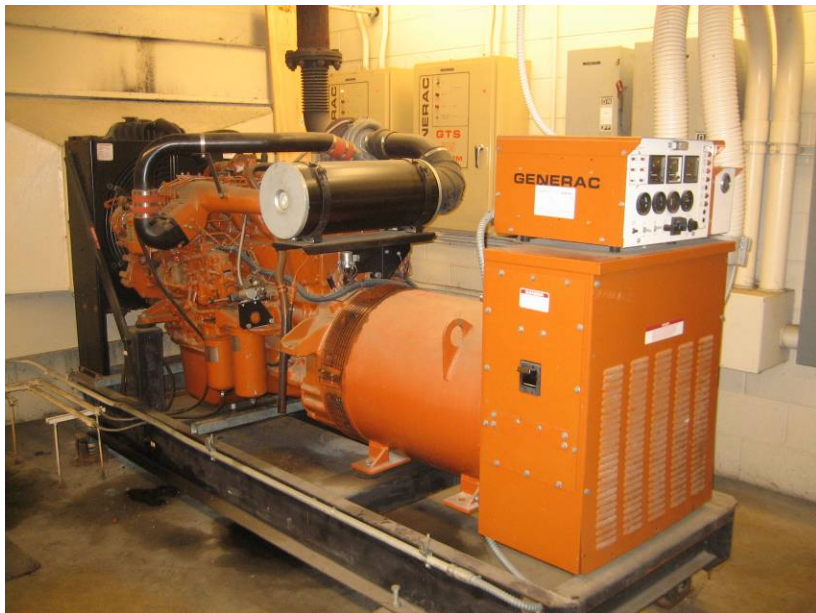
Photograph No. 29

A 180 kW/225 KVA diesel engine-driven generator set supplies emergency power for life safety loads in the building. The generator is located in the main electrical room at the basement level. It is manufactured by Generac (reference Photograph 29 in Appendix C).

Emergency Generator

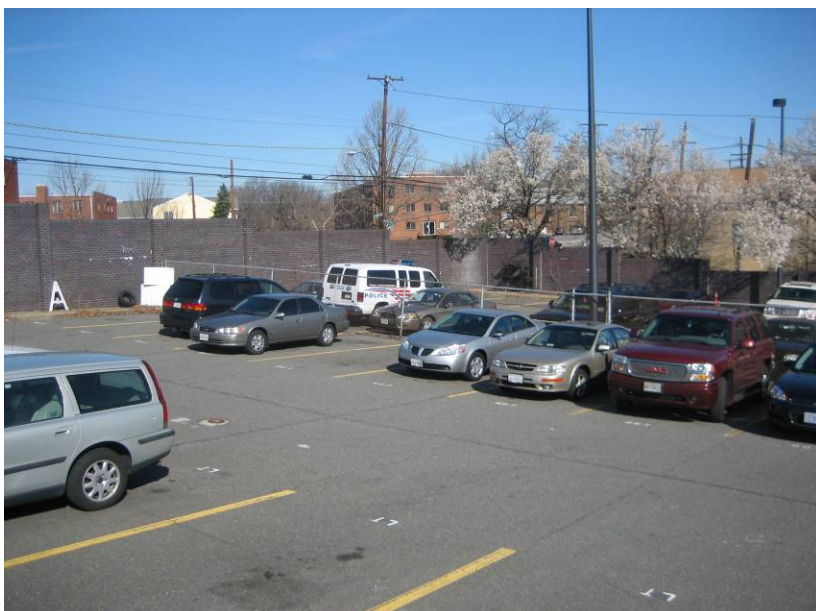
Photograph No. 30

The Property contains the main asphalt-paved parking area located at the rear and east elevation of the building (reference Photograph 30 in Appendix C). The main vehicular access to the parking area is provided from Knox Street SE. Additional access to the Property is provided from Alabama Avenue SE and Hartford Avenue SE. Public parking is located along adjacent streets to the Property. Employee parking is located at the rear parking lot. The construction design of the asphalt and concrete pavement is unknown. A portion of the parking area located adjacent to the vehicle maintenance building is concrete-paved. Table G10 summarizes the approximate area of the asphalt and concrete site features.

Main Parking Area

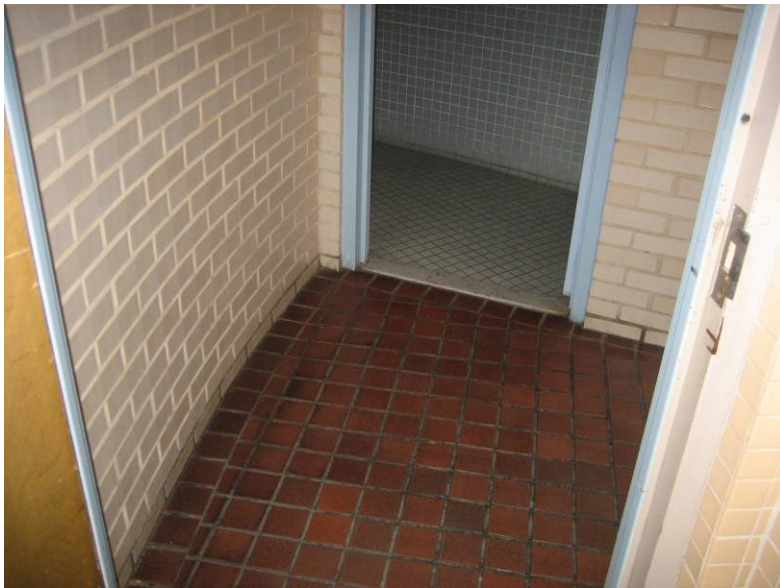
Photograph No. 35

The third priority emphasizes those measures that will provide individuals with disabilities with access to restroom facilities. The building contained restrooms located on each floor throughout the building. Restrooms were typically compliant with the ADAAG. However, the male and female handicap accessible restrooms provided on the first floor contained non-compliant entrance doors (reference Photograph 35 in Appendix C).

Non ADA Compliant Restroom Entrance Doors

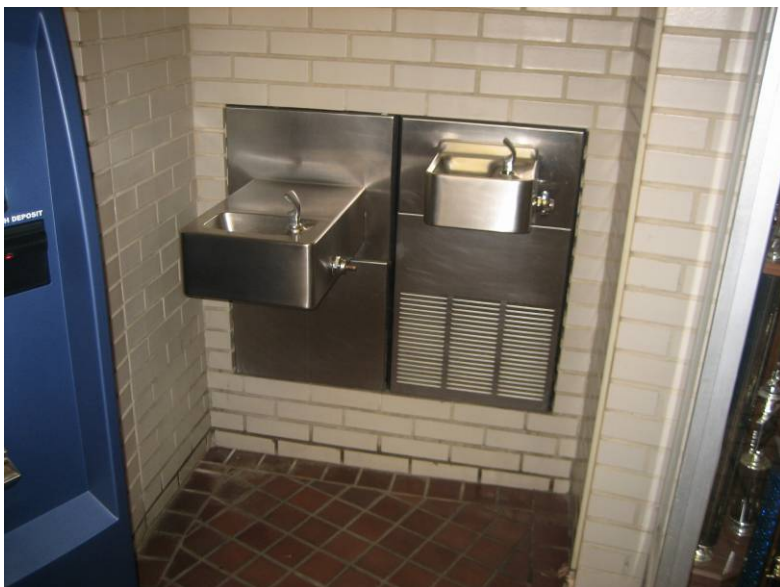
Photograph No. 36

Wall-mounted and free-standing water fountains are provided on each floor (reference Photograph 36 in Appendix C). The drinking fountains appear to be compliant with Section 4.15 of the ADAAG. However, we noted an active leak at the fountain at the second floor. The leak appeared to be caused by a loose coupling valve. We anticipate that this can be addressed as part of routine maintenance.

Reduced Height Drinking Fountain
