**Amendment 001
Request for Proposal (RFP)**

**Design-Build Services
Adelaide Davis Elementary School Swing Space (DCAM-16-CS-0140)**

Attachment A1
2014 Roof Assessment Report

Davis Elementary School 2014*
4430 H St SE
Washington, DC 20019

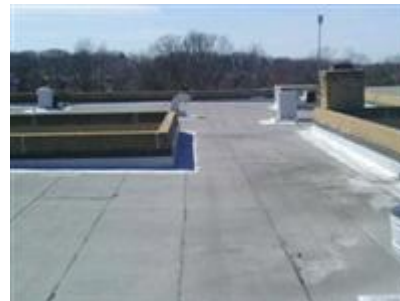
Roof Condition Score: 44 (Unsatisfactory)

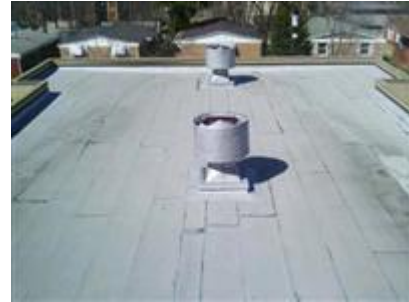
**Roof Condition Score:** 39 (Unsatisfactory)**Section ID: C - C****Area:** 7,136 SF**Roof Type:** Modified bitumen**Layers:**

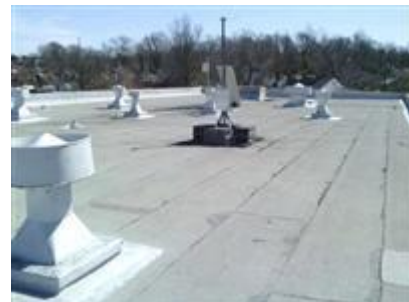
**Roof Condition Score:** 66 (Degraded)

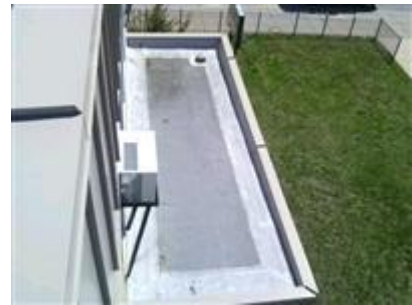
**Roof Condition Score:** 70 (Degraded)

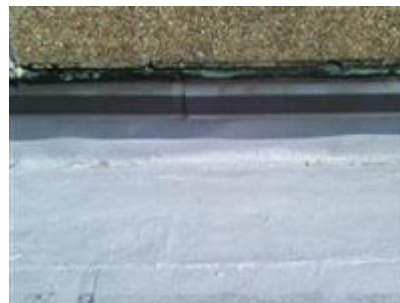
Parapet counter flashing

Associated Defect: #3 , #4 - Metal flashing defects (LF)

Defect: Metal flashing defects (LF).

Severity: Missing or damaged metal joint covers, obvious water penetration.

Recommendation: New metal flashing should be fabricated to match the existing. The new flashing should be securely anchored with appropriate fasteners.
