Facility Condition Assessment

**Anacostia High School
1601 16th Street SE
Washington, DC
20020**

Date of Report: August 31, 2018

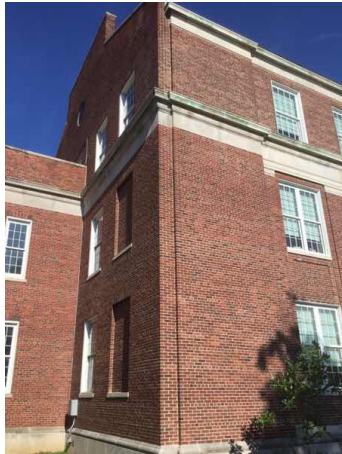
Item	Description
Clay Brick, Painted, Exterior, = 3 Stories	Clay Brick Exterior Wall
Condition	Fair - Good
Quantity	46,032 SF
Remaining Useful Life (RUL)	15 Year(s)

Uniformat	Component Description	Plan Type	Year	Expenditures
B2011	Repoint Brick Veneer, Exterior, 3+ Stories	CRP	2018	\$8,832

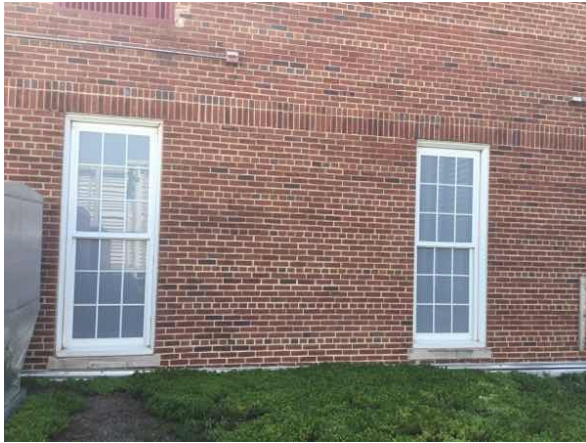
Item	Description
Aluminum Fixed Window, = 3 Stories, 24 Sq Ft	Aluminum Fixed Window
Condition	Good
Quantity	376 EA
Remaining Useful Life (RUL)	24 Year(s)

Uniformat	Component Description	Plan Type	Year	Expenditures
B2021	Repair Glazing for Windows	CRP	2018	\$1,786

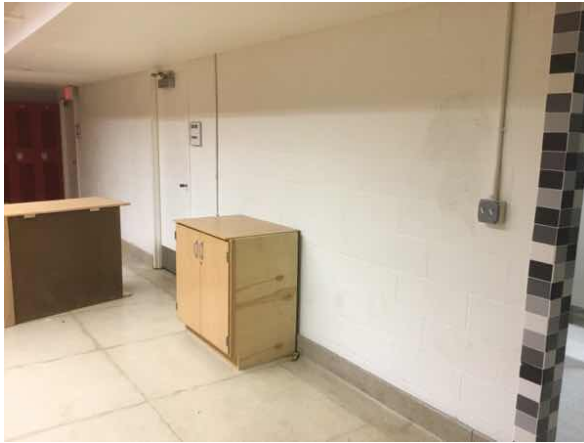
Item	Description
Concrete Block, Interior Wall Finish	Concrete Block Interior Wall Finish
Condition	Fair - Good
Quantity	10,357 SF
Remaining Useful Life (RUL)	15 Year(s)

Uniformat	Component Description	Plan Type	Year	Expenditures
C3012	Repoint Concrete Block, Exterior	CRP	2018	\$5,967

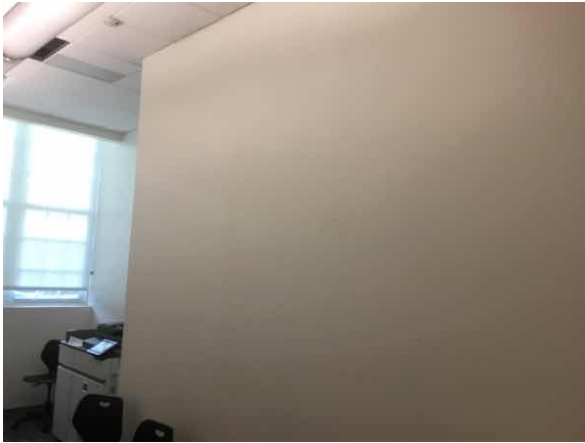
Item	Description
Gypsum Board, Interior Wall Finish	Gypsum Board Interior Wall Finish
Condition	Good
Quantity	51,786 SF
Remaining Useful Life (RUL)	34 Year(s)

Uniformat	Component Description	Plan Type	Year	Expenditures
C3012	Repair Gypsum Board/Plaster, Interior Wall	CRP	2018	\$1,908

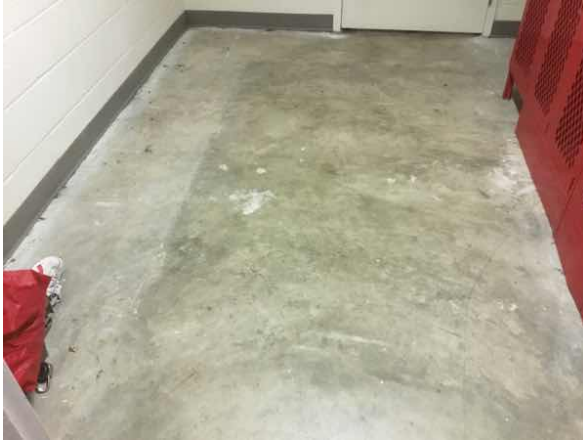
Item	Description
Concrete Flooring	Concrete Flooring
Condition	Fair - Good
Quantity	16,500 SF
Remaining Useful Life (RUL)	12 Year(s)

Uniformat	Component Description	Plan Type	Year	Expenditures
C3024	Repair Concrete Slab	CRP	2018	\$4,092

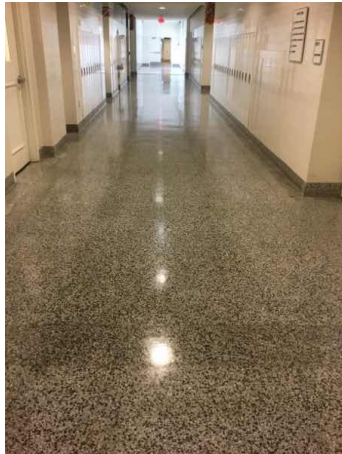
Item	Description
Floor Finish, Terrazzo, Authentic	Terrazzo Floor Finish
Condition	Fair - Good
Quantity	18,500 SF
Remaining Useful Life (RUL)	8 Year(s)

Uniformat	Component Description	Plan Type	Year	Expenditures
C3024	Repair Terrazzo Flooring	CRP	2019	\$17,438
C3024	Replace Terrazzo Floor Finish	CRP	2026	\$476,930

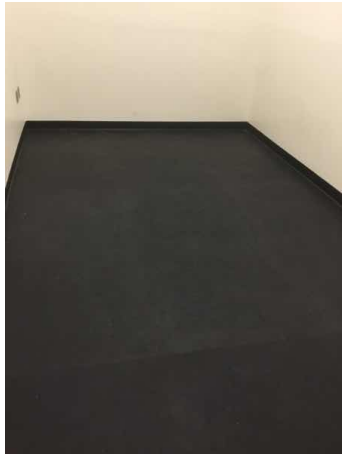
Item	Description
Floor Finish, Tile, Rubber	Rubber Floor Finish
Condition	Fair
Quantity	3,942 SF
Remaining Useful Life (RUL)	4 Year(s)

Uniformat	Component Description	Plan Type	Year	Expenditures
C3024	Replace Rubber Floor Finish	CRP	2022	\$29,171

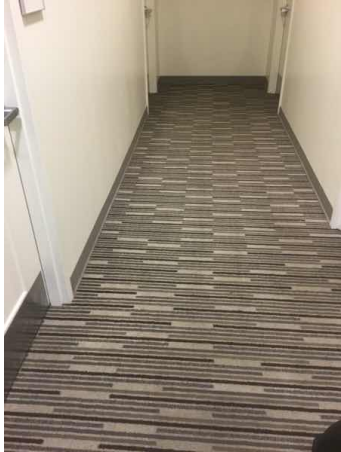
Item	Description
Carpet, Nylon, High Traffic, 20 oz	Carpet Floor Finishes
Condition	Fair
Quantity	13,360 SF
Remaining Useful Life (RUL)	4 Year(s)

Uniformat	Component Description	Plan Type	Year	Expenditures
C3025	Replace Carpet Floor Finishes	CRP	2022	\$79,866

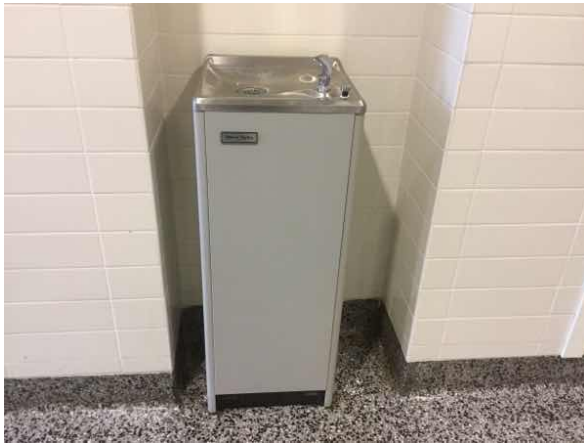
Drinking Fountain

Item	Description
Plumbing Fixt (SF), Drinking Fountain, Wall Mount, Dual-Height	Drinking Fountains
Condition	Fair - Good
Quantity	204,105 SF
Remaining Useful Life (RUL)	9 Year(s)

Uniformat	Component Description	Plan Type	Year	Expenditures
D2018	Replace Drinking Fountains	CRP	2027	\$48,985

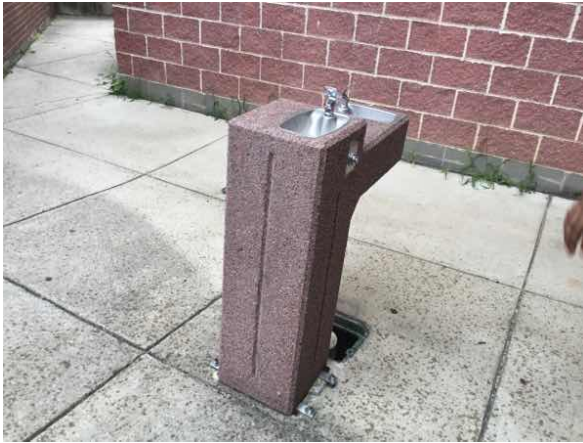
Drinking Fountain

Item	Description
Plumbing Fixt, Drinking Fountain, Floor Mount	Drinking Fountains - Annex
Condition	Fair - Good
Quantity	4 EA
Remaining Useful Life (RUL)	9 Year(s)
Location	Exterior

Uniformat	Component Description	Plan Type	Year	Expenditures
D2018	Replace Drinking Fountains - Annex	CRP	2027	\$5,200

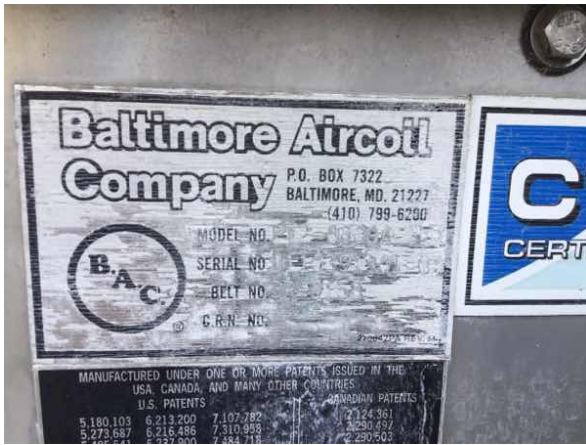
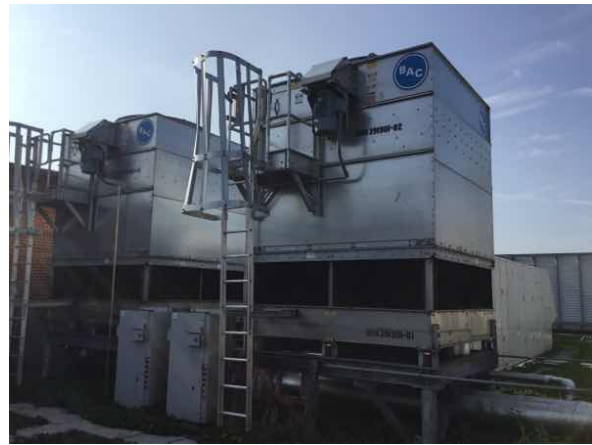
Cooling Towers

Item	Description
Cooling Tower, 250 Ton	Cooling Tower, 250 Ton (x2)
Condition	Fair - Good
Quantity	2 EA
Remaining Useful Life (RUL)	9 Year(s)
Location	Roof

Uniformat	Component Description	Plan Type	Year	Expenditures
D3031	Replace Cooling Tower, 250 Ton (x2)	CRP	2027	\$79,524

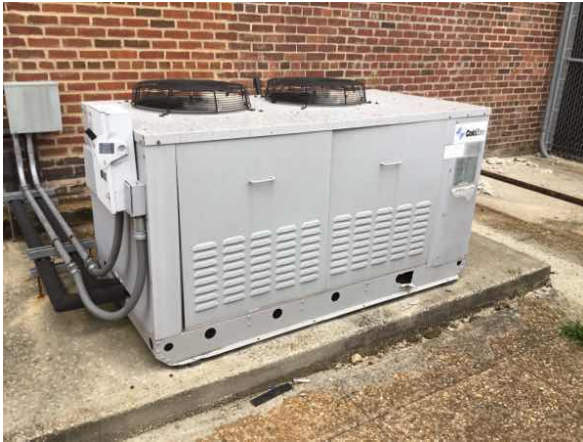
Item	Description
Condensing Unit / Compressor (Refrigeration) 5.0 HP (~1.0 Ton), Air Cooled	Condensing Unit, ~5 HP
Condition	Poor - Fair
Quantity	1 EA
Remaining Useful Life (RUL)	9 Year(s)
Location	Exterior

Uniformat	Component Description	Plan Type	Year	Expenditures
D3032	Replace Condensing Unit, ~5 HP	CRP	2027	\$5,967

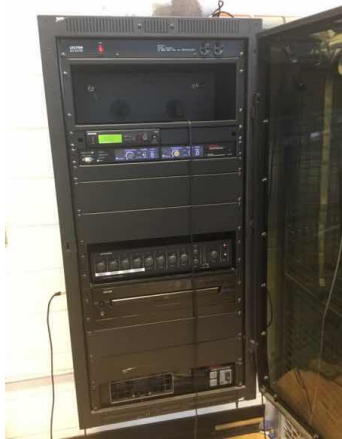
Sound System

Item	Description
Sound System, 7 Channel	Sound System, 7 Channel
Condition	Fair - Good
Quantity	6 EA
Remaining Useful Life (RUL)	9 Year(s)

Uniformat	Component Description	Plan Type	Year	Expenditures
D5031	Replace Sound System, 7 Channel	CRP	2027	\$12,406

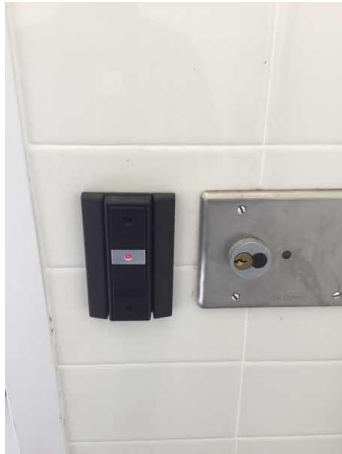
Item	Description
Card Reader	Card Reader
Condition	Fair - Good
Quantity	18 EA
Remaining Useful Life (RUL)	9 Year(s)

Uniformat	Component Description	Plan Type	Year	Expenditures
D5038	Replace Card Reader	CRP	2027	\$16,660

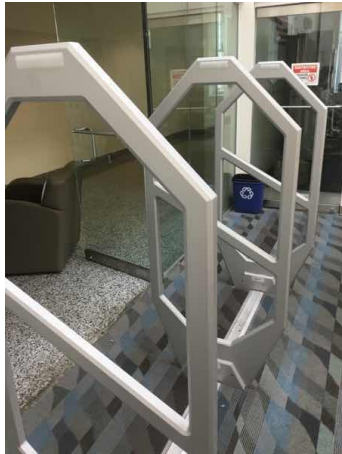
EAS Anti Theft System

Item	Description
Magnetic Lock	Electronic Article Surveillance System (EA)
Condition	Fair - Good
Quantity	2 EA
Remaining Useful Life (RUL)	9 Year(s)
Location	Library

Uniformat	Component Description	Plan Type	Year	Expenditures
D5038	Replace Electronic Article Surveillance System (EA)	CRP	2027	\$1,490

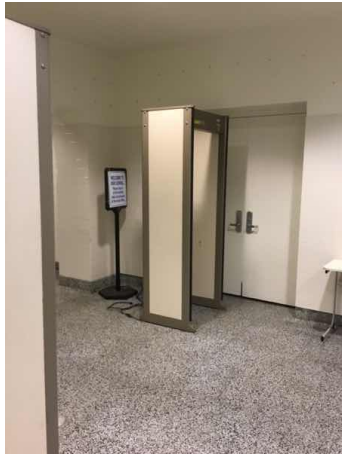
Metal Detector

Item	Description
Screening Magnetometer	Screening Magnetometer
Condition	Fair - Good
Quantity	4 EA
Remaining Useful Life (RUL)	9 Year(s)

Uniformat	Component Description	Plan Type	Year	Expenditures
D5038	Replace Screening Magnetometer	CRP	2027	\$12,689

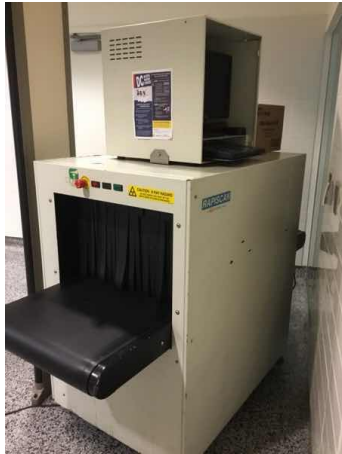
X Ray Machine

Item	Description
Screening X-Ray Machine	Screening X-Ray Machine
Condition	Fair - Good
Quantity	3 EA
Remaining Useful Life (RUL)	9 Year(s)

Uniformat	Component Description	Plan Type	Year	Expenditures
D5038	Replace Screening X-Ray Machine	CRP	2027	\$139,509

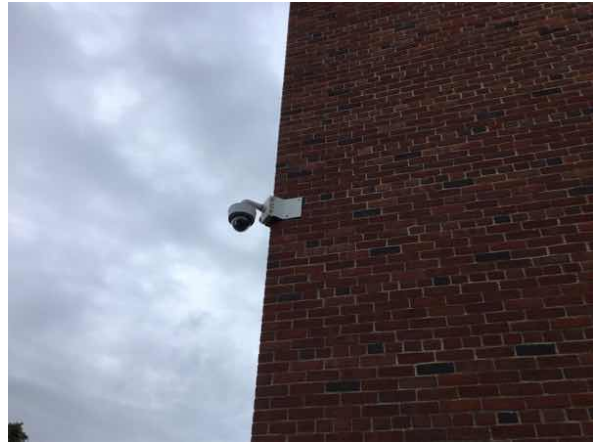
Surveillance Camera

Item	Description
Security (LF), Surveillance, Exterior Perimeter	Security (LF), Surveillance, Exterior Perimeter
Condition	Fair - Good
Quantity	1,961 LF
Remaining Useful Life (RUL)	9 Year(s)
Location	Exterior

Uniformat	Component Description	Plan Type	Year	Expenditures
D5038	Replace Security (LF), Surveillance, Exterior Perimeter	CRP	2027	\$58,418

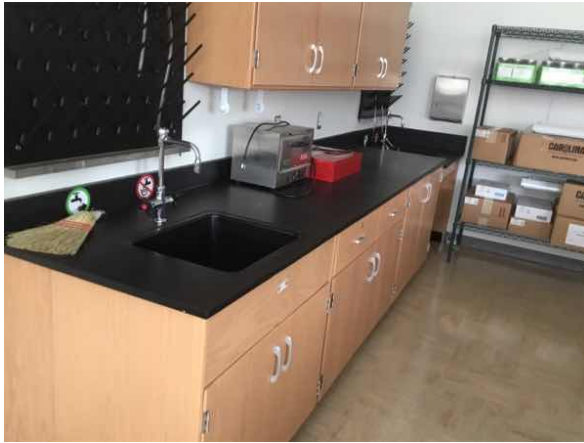
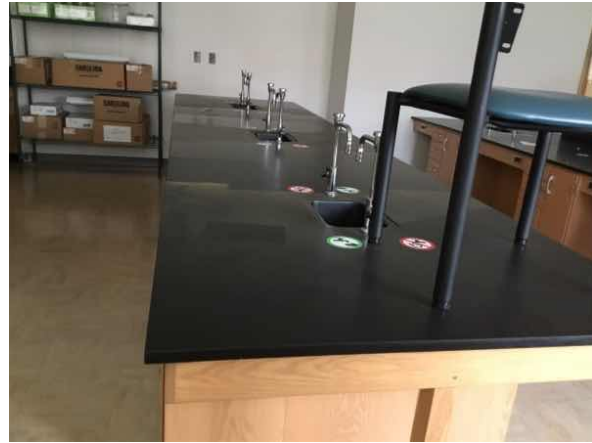
Item	Description
Sink, Epoxy Resin, Laboratory	Laboratory Sinks
Condition	Fair - Good
Quantity	84 EA
Remaining Useful Life (RUL)	9 Year(s)

Uniformat	Component Description	Plan Type	Year	Expenditures
E1027	Replace Laboratory Sinks	CRP	2027	\$44,371

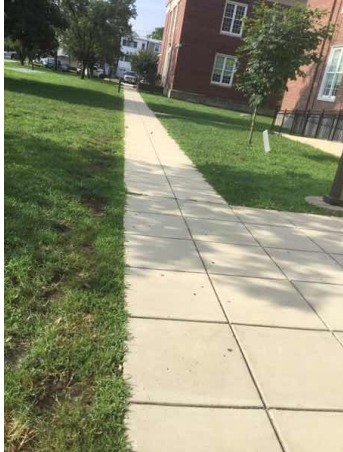
Item	Description
Concrete Pavement	Concrete Pavement
Condition	Fair - Good
Quantity	13,995 SF
Remaining Useful Life (RUL)	10 Year(s)

Uniformat	Component Description	Plan Type	Year	Expenditures
G2022	Repair Concrete Pavement	CRP	2018	\$1,771

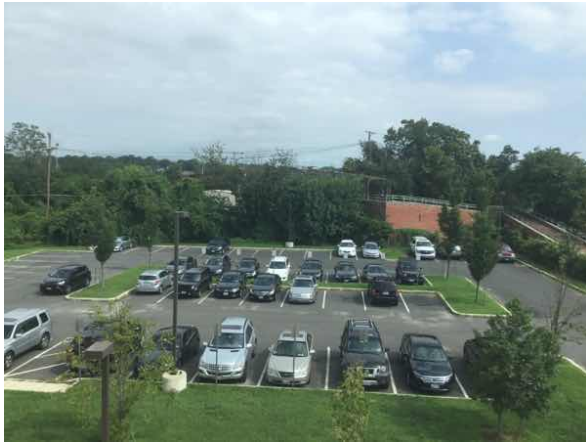
Item	Description
Parking Lot, Asphalt Paved, High Cost	Asphalt Paved Parking Lot
Condition	Fair - Good
Quantity	20,610 SF
Remaining Useful Life (RUL)	8 Year(s)

Uniformat	Component Description	Plan Type	Year	Expenditures
G2022	Replace Asphalt Paved Parking Lot	CRP	2026	\$92,745

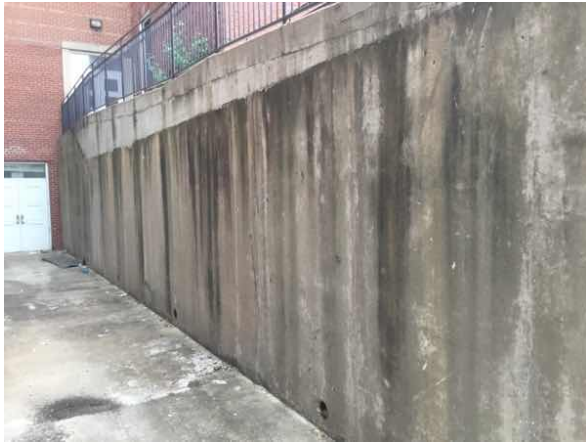
Item	Description
Retaining Wall, Cast in Place Concrete	Retaining Wall Cast in Place Concrete
Condition	Fair - Good
Quantity	86 LF
Remaining Useful Life (RUL)	8 Year(s)

Uniformat	Component Description	Plan Type	Year	Expenditures
G2042	Replace Retaining Wall Cast in Place Concrete	CRP	2026	\$12,241

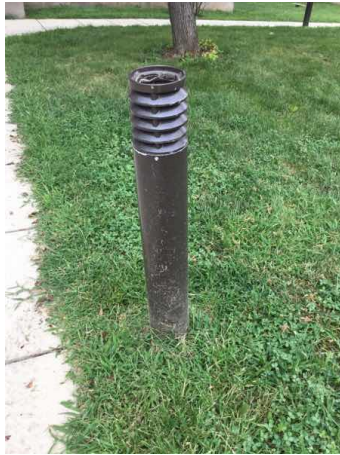
Bollard Light

Item	Description
Site Lighting, Bollard, 175W MH	Site Lighting, Bollard, 175W MH
Condition	Poor
Quantity	5 EA
Remaining Useful Life (RUL)	2 Year(s)
Location	M318 Telecom Room

Most of the lights are damaged and need to be replaced.

Uniformat	Component Description	Plan Type	Year	Expenditures
G4021	Replace Site Lighting, Bollard, 175W MH	CRP	2020	\$5,706

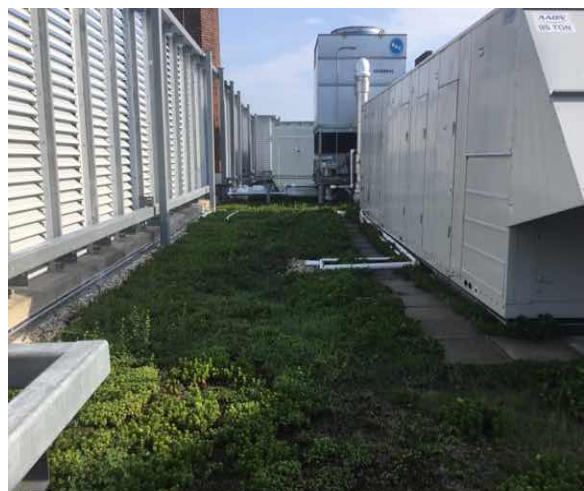
B3011 Roof Finishes:- View of Inverted Membrane Roof Covering

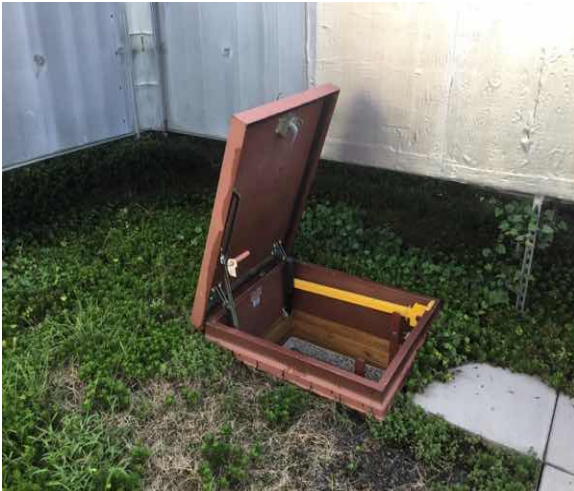
B3022 Roof Hatches:- View of Aluminum Roof Hatch

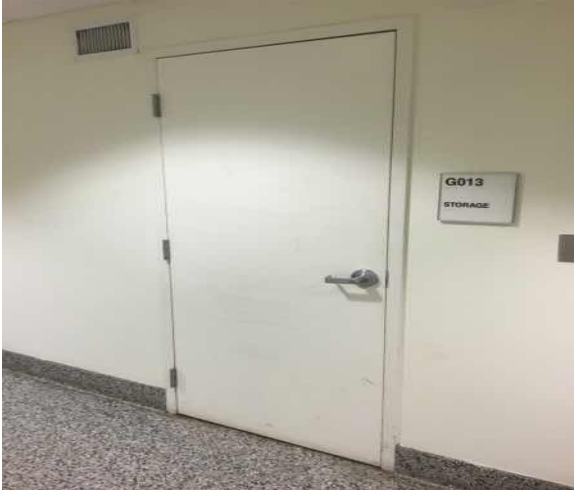
C1021 Interior Doors:- View of Steel Interior Door

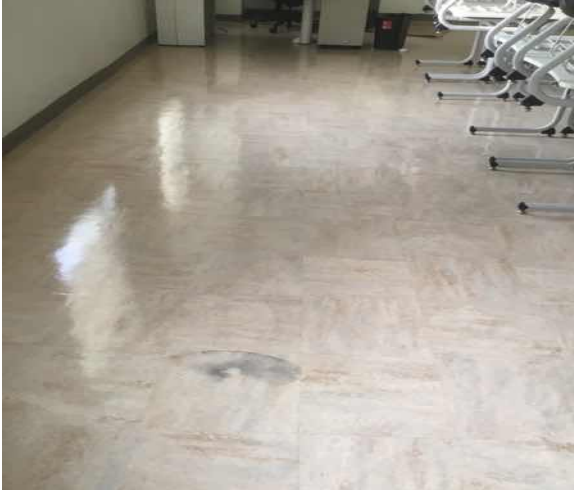
C3024 Flooring:- View of Vinyl Tile Flooring

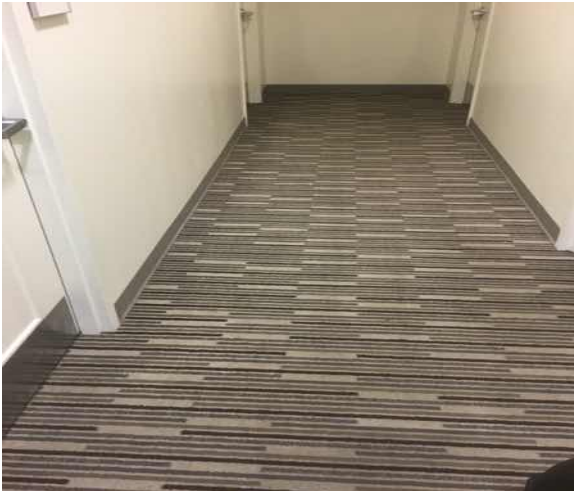
C3025 Carpeting:- View of Carpet Floor Finishes
