## ***Condition Assessment Report***

CDF Master 2015  
1901 S Street SE  
Washington, DC 20003

***Inspection Date:*** Tuesday, March 17, 2015

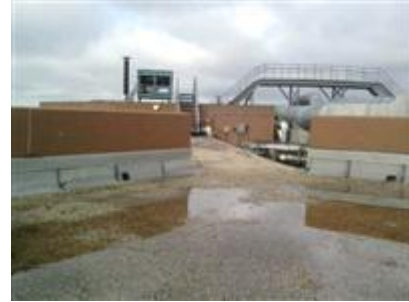
**Roof Condition Score: 65 (Degraded)****Section ID: B - B****Area:** 2,124 SF**Roof Type:** Built-up membrane**Layers:**

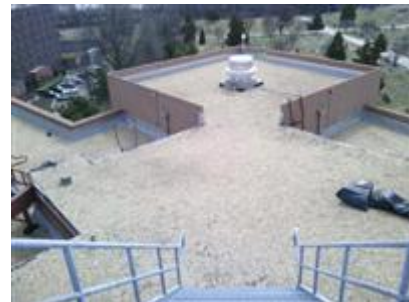
**Roof Condition Score: 66 (Degraded)**

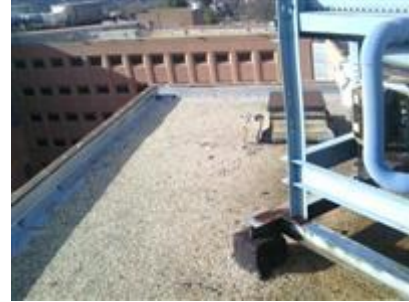
**Roof Condition Score: 63 (Degraded)****Section ID: C - C****Area:** 3,419 SF**Roof Type:** Built-up membrane**Layers:**

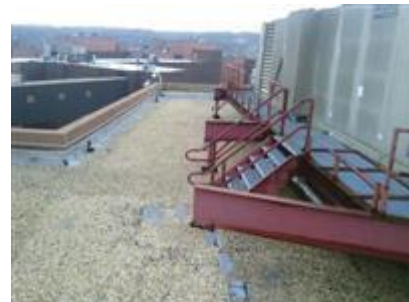
**Roof Condition Score: 65 (Degraded)**

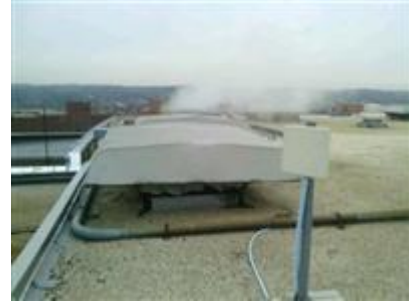
**Roof Condition Score: 54 (Unsatisfactory)**

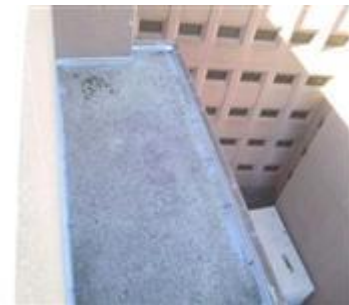
**Roof Condition Score: 61 (Degraded)**

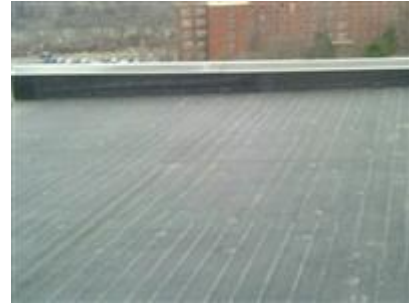
**Roof Condition Score: 83 (Adequate)****Section ID: HH - HH****Area:** 995 SF**Roof Type:** Thermoset (Single ply - rubber)**Layers:**

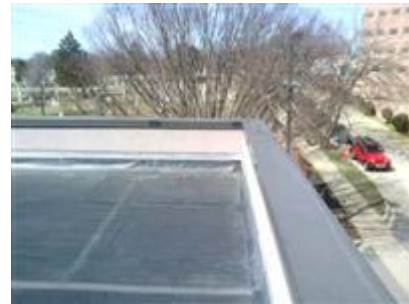
**Roof Condition Score: 53 (Unsatisfactory)**

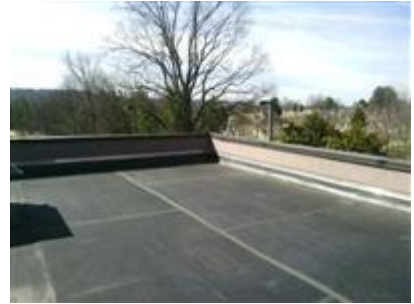
**Section ID:** HH - HH (Photo #2)

**Roof Condition Score:** 53 (Unsatisfactory)

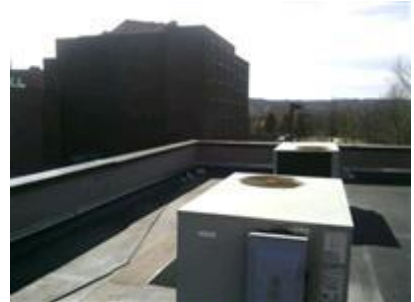
**Section ID:** HH - HH (Photo #3)

**Roof Condition Score:** 53 (Unsatisfactory)

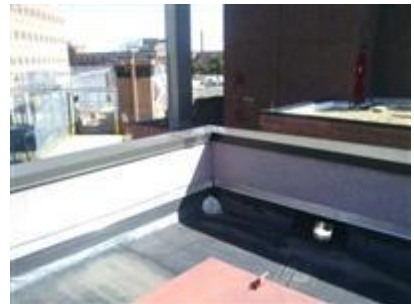
**Section ID:** HH - HH (Photo #4)

**Roof Condition Score:** 53 (Unsatisfactory)

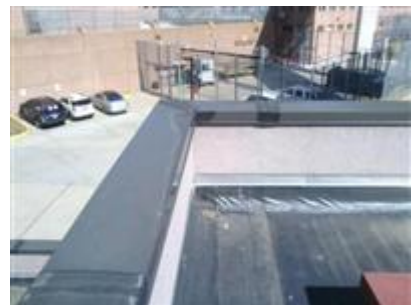
**Section ID:** HH - HH (Photo #5)

**Roof Condition Score:** 53 (Unsatisfactory)

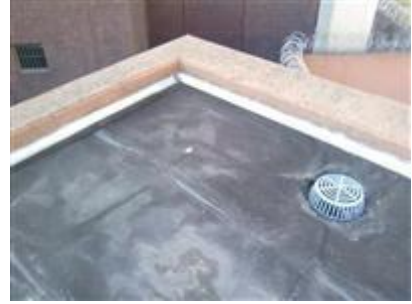
**Section ID:** II - II (Photo #2)

**Roof Condition Score:** 48 (Unsatisfactory)

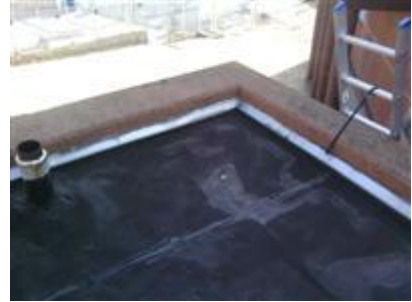
**Section ID:** II - II (Photo #3)

**Roof Condition Score:** 48 (Unsatisfactory)

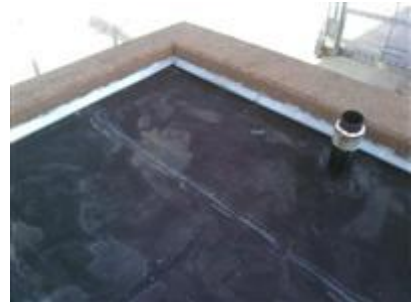
**Section ID:** II - II (Photo #4)

**Roof Condition Score:** 48 (Unsatisfactory)

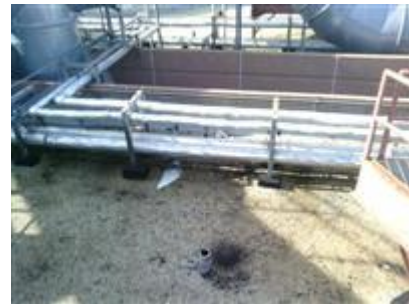
**Section ID:** K - K (Photo #2)

**Roof Condition Score:** 59 (Unsatisfactory)

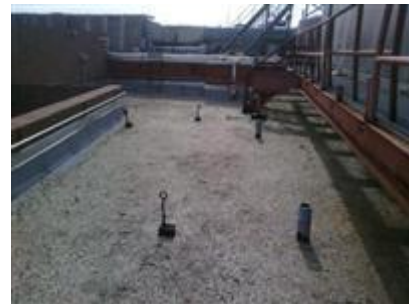
**Section ID:** K - K (Photo #3)

**Roof Condition Score:** 59 (Unsatisfactory)

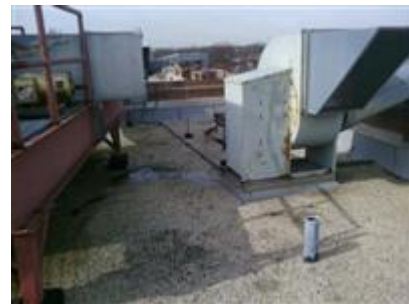
**Section ID:** K - K (Photo #4)

**Roof Condition Score:** 59 (Unsatisfactory)

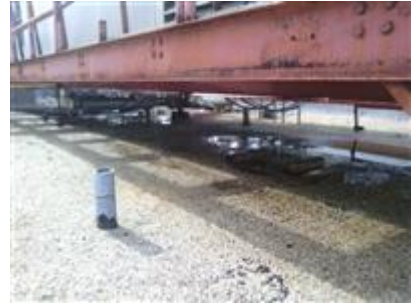
**Section ID:** K - K (Photo #5)

**Roof Condition Score:** 59 (Unsatisfactory)

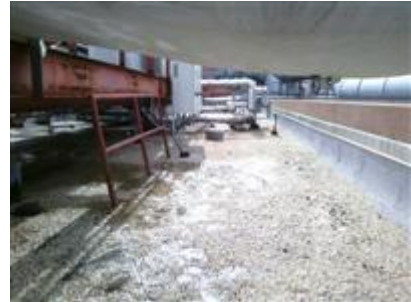
**Section ID:** K - K (Photo #6)

**Roof Condition Score:** 59 (Unsatisfactory)

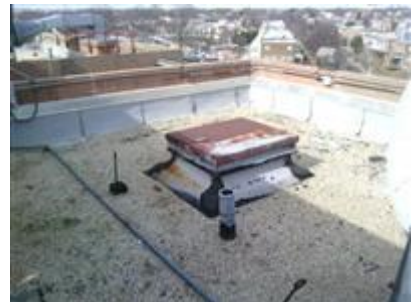
**Section ID:** K - K (Photo #7)

**Roof Condition Score:** 59 (Unsatisfactory)

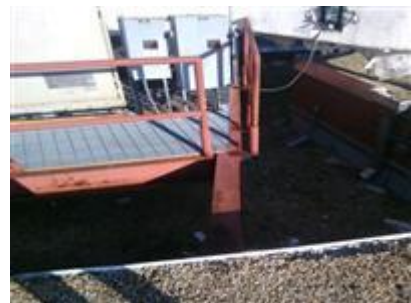
**Section ID:** L - L (Photo #2)

**Roof Condition Score:** 66 (Degraded)

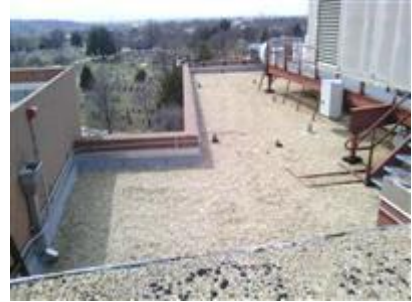
**Section ID:** L - L (Photo #3)

**Roof Condition Score:** 66 (Degraded)

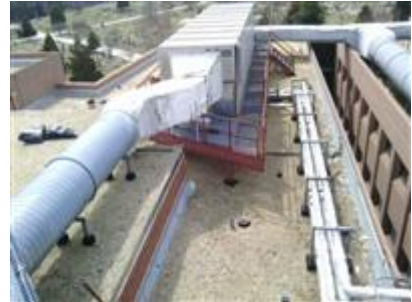
**Section ID:** L - L (Photo #4)

**Roof Condition Score:** 66 (Degraded)

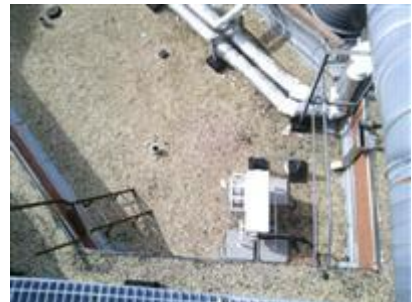
**Section ID:** L - L (Photo #5)

**Roof Condition Score:** 66 (Degraded)

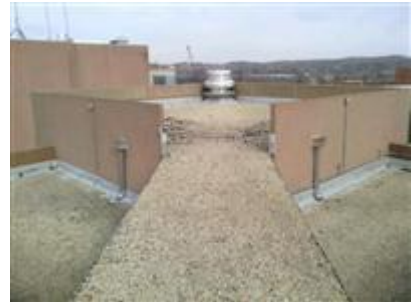
**Section ID:** N - N (Photo #2)

**Roof Condition Score:** 56 (Unsatisfactory)

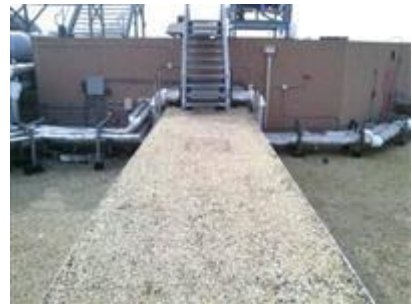
**Section ID:** N - N (Photo #3)

**Roof Condition Score:** 56 (Unsatisfactory)

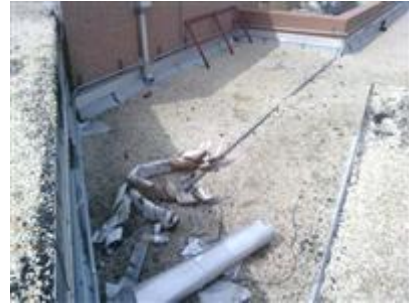
**Section ID:** R - R (Photo #3)

**Roof Condition Score:** 64 (Degraded)

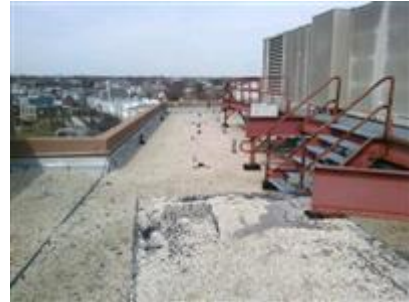
**Section ID:** R - R (Photo #4)

**Roof Condition Score:** 64 (Degraded)

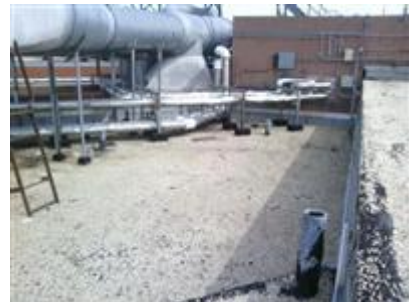
**Section ID:** R - R (Photo #5)

**Roof Condition Score:** 64 (Degraded)

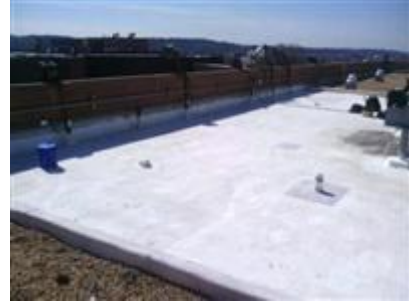
**Section ID:** V - V (Photo #4)

**Roof Condition Score:** 43 (Unsatisfactory)

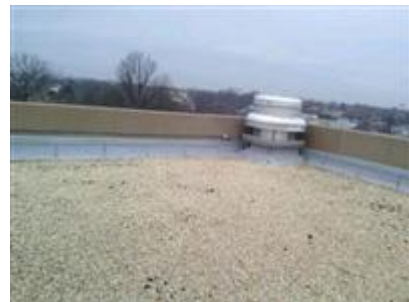
**Section ID:** W - W (Photo #2)

**Roof Condition Score:** 60 (Unsatisfactory)

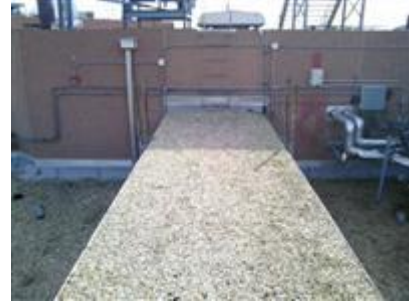
**Section ID:** W - W (Photo #3)

**Roof Condition Score:** 60 (Unsatisfactory)

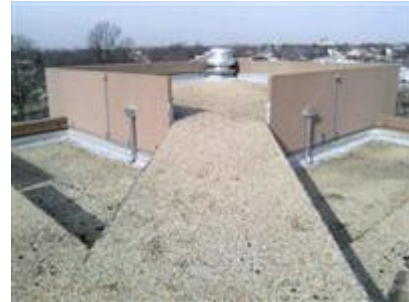
**Section ID:** W - W (Photo #4)

**Roof Condition Score:** 60 (Unsatisfactory)

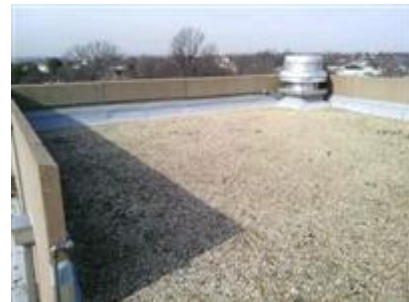
**Section ID:** W - W (Photo #5)

**Roof Condition Score:** 60 (Unsatisfactory)

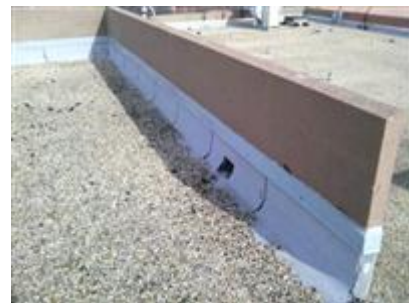
**Section ID:** W - W (Photo #6)

**Roof Condition Score:** 60 (Unsatisfactory)

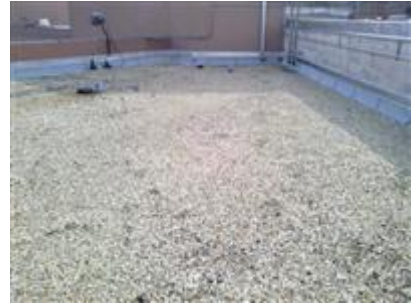
**Section ID:** X - X (Photo #4)

**Roof Condition Score:** 58 (Unsatisfactory)

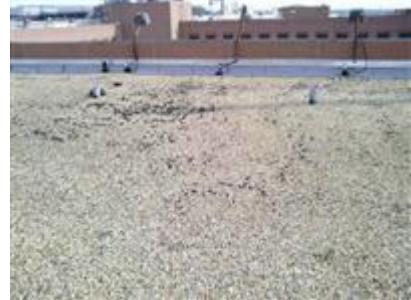
**Section ID:** X - X (Photo #5)

**Roof Condition Score:** 58 (Unsatisfactory)

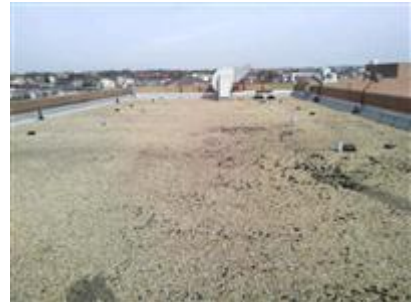
**Section ID:** X - X (Photo #6)

**Roof Condition Score:** 58 (Unsatisfactory)

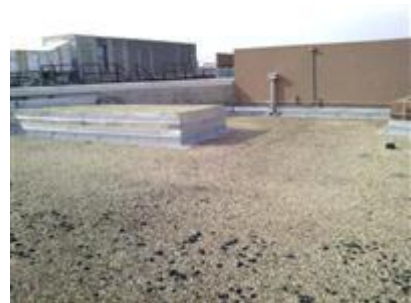
**Section ID:** X - X (Photo #7)

**Roof Condition Score:** 58 (Unsatisfactory)

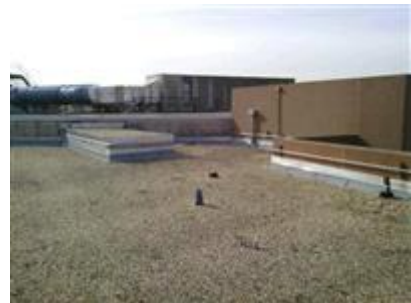
**Section ID:** X - X (Photo #8)

**Roof Condition Score:** 58 (Unsatisfactory)

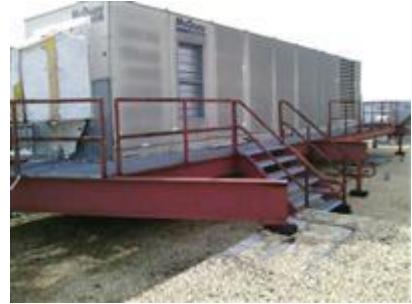
**Section ID:** Z - Z (Photo #4)

**Roof Condition Score:** 46 (Unsatisfactory)

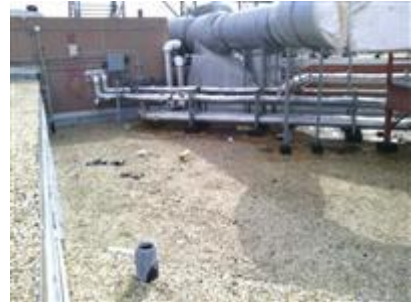
**Section ID:** Z - Z (Photo #5)

**Roof Condition Score:** 46 (Unsatisfactory)
