**Attachment B- Feasibility Study  
Part 1**

**DISTRICT OF COLUMBIA PUBLIC SCHOOLS**  
**JOHN EATON ELEMENTARY SCHOOL MODERNIZATION**  
**FEASIBILITY ASSESSMENT AND CONCEPTUAL DESIGN**  
**JULY 3, 2018**

# EXISTING FACILITY CONDITION ASSESSMENTS & FEASIBILITY RECOMMENDATIONS

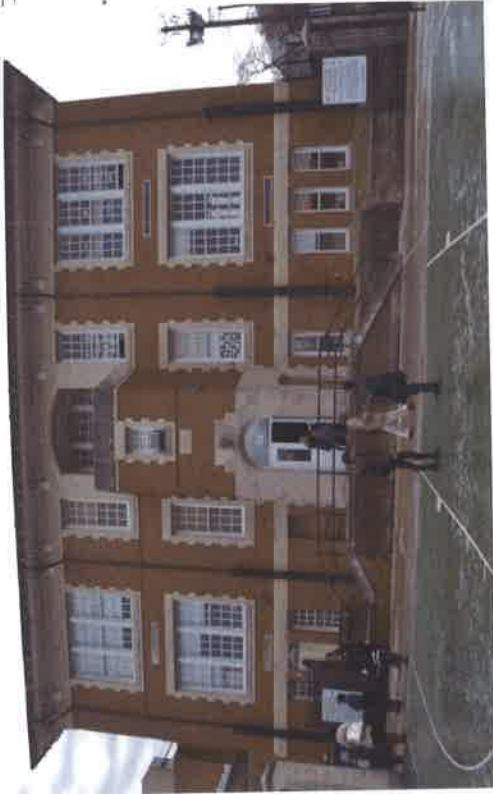
Typical perimeter downspouts

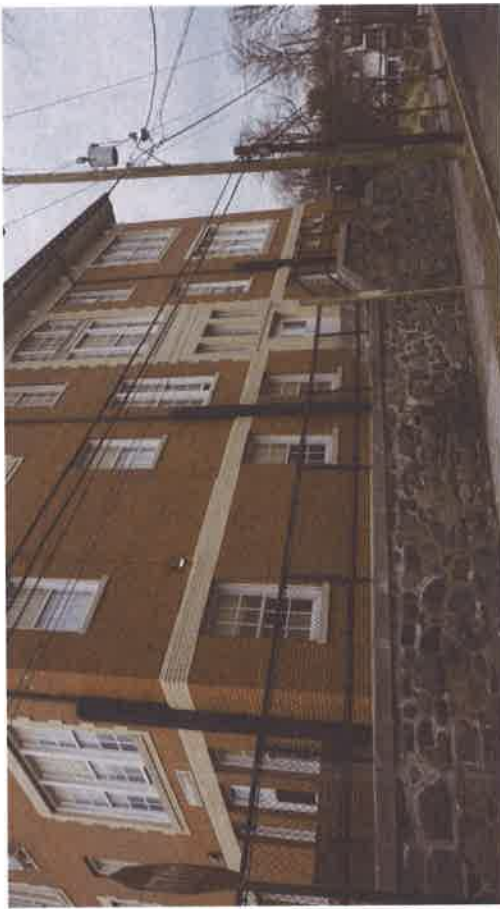
Figure 3 - Separation and isolation, 33rd Street wall

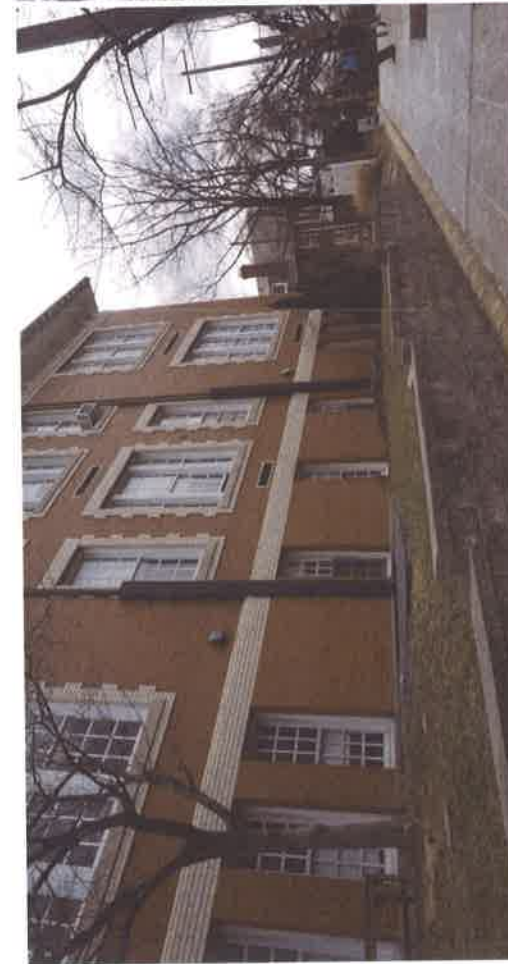
Figure 1 - Steep grade and retaining wall, 34th street

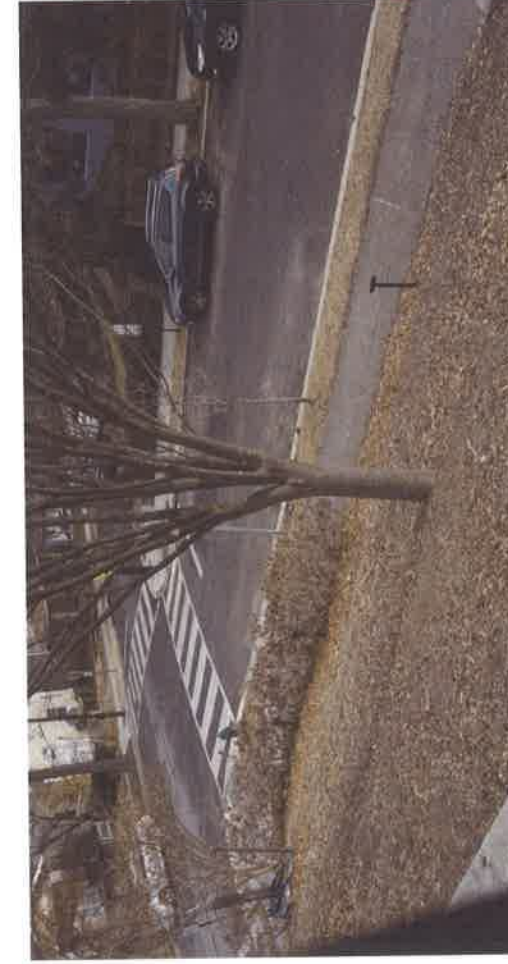
Figure 2 - Steep grade and retain wall, 33rd Street

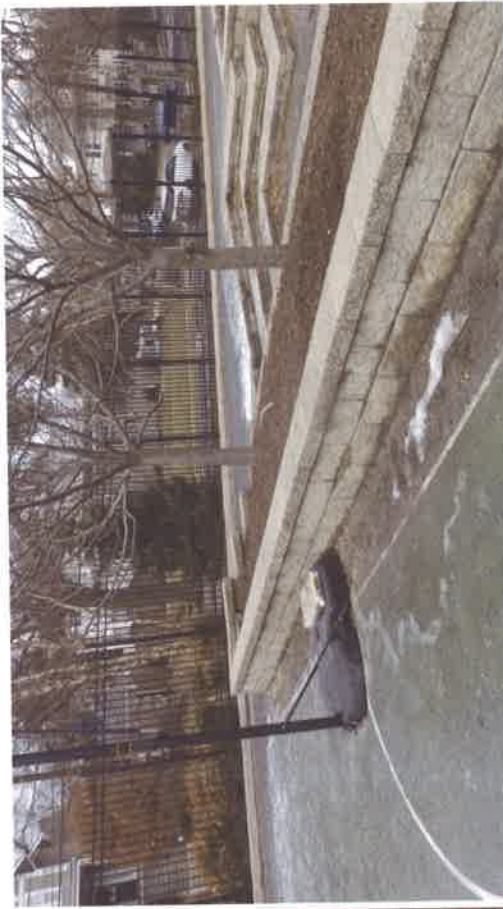
Figure 3 - Limited functional space, half basketball court, currently used for morning assembly

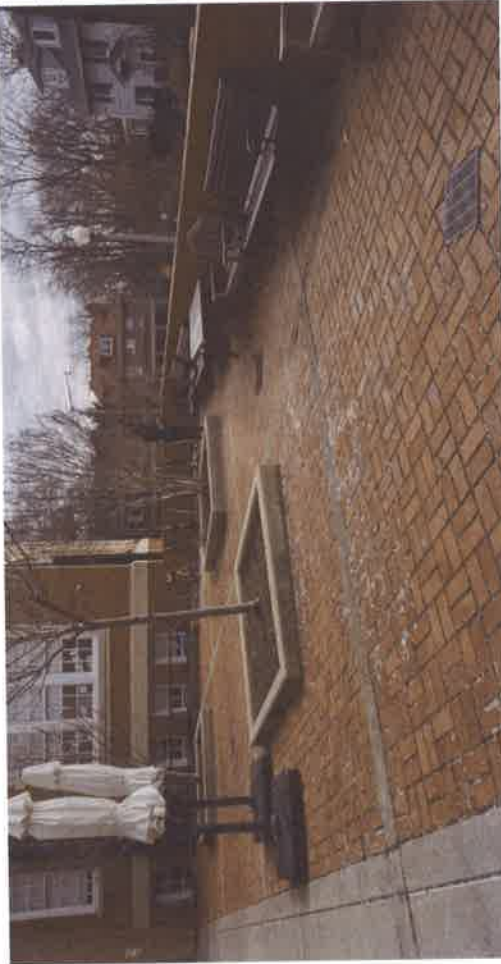
Figure 1 - limited functional space, school front entrance

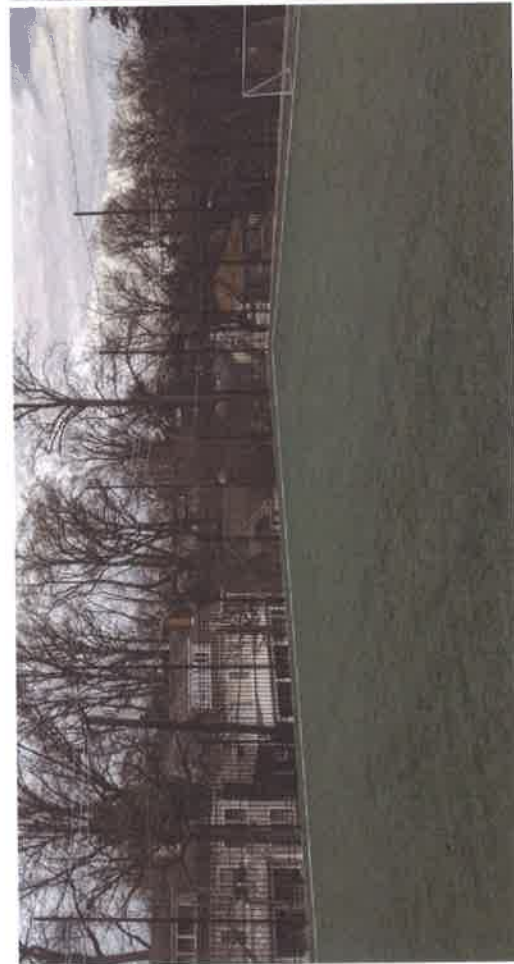
Figure 1 - Existing synthetic turf undersized sports field

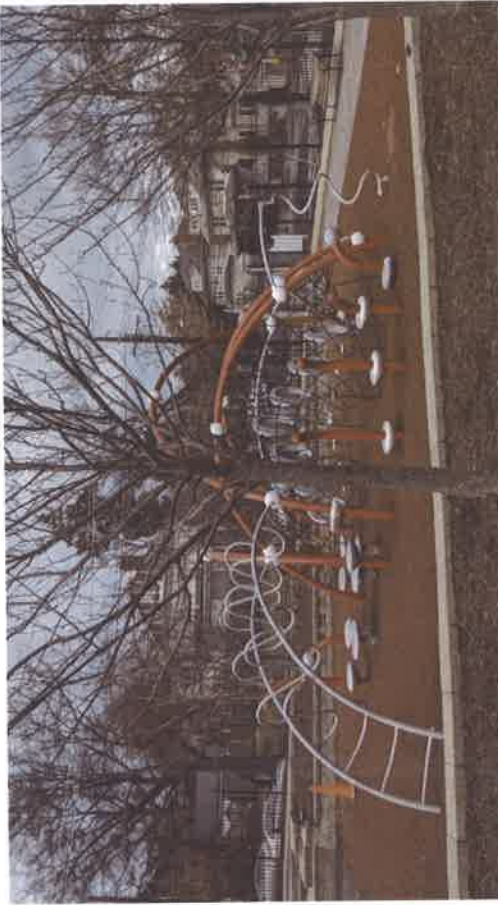
Figure 3 - Existing 5-12 play equipment on rubber surfacing

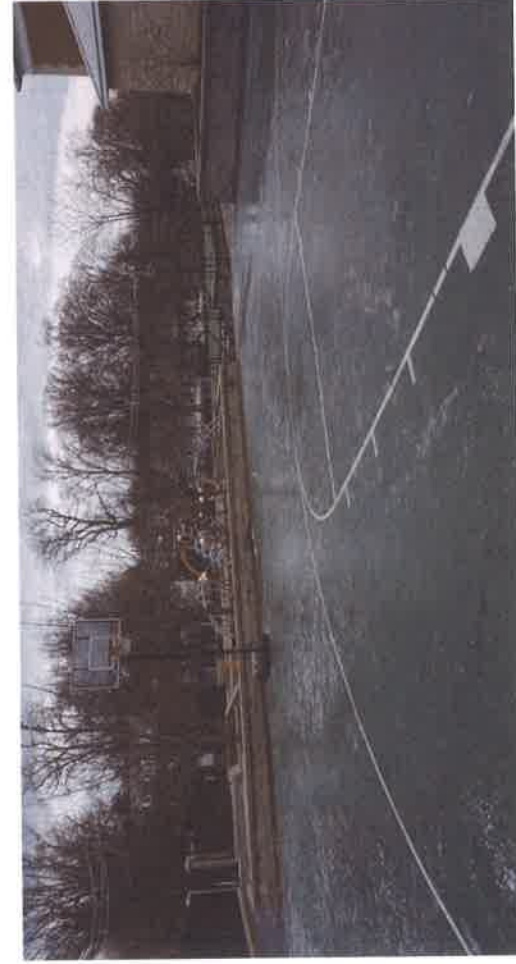
Figure 2 - Existing half size basketball court
